REVETTING AND SUPPORTING RIVER BANKS

4.7 Bank revetment using low steel sheet piling and coir rolls

RIVER THAMES

LOCATION - Clifton Lock Cut, Oxfordshire SU 544944

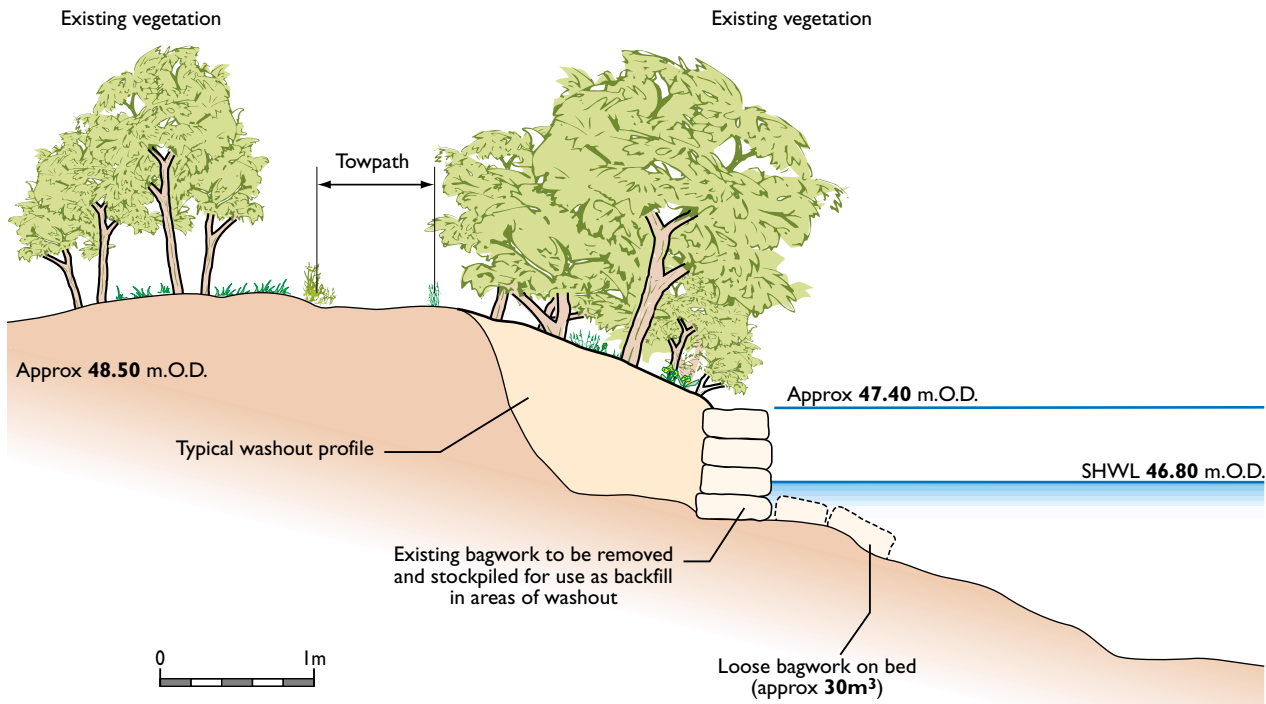
Figure 4.7.1
SECTION SHOWING TYPICAL BANK AND WASHOUT PROFILE

At Clifton lock cut the old concrete bagwork revetment was beginning to disintegrate and allow wash-out of the unprotected bank back towards the

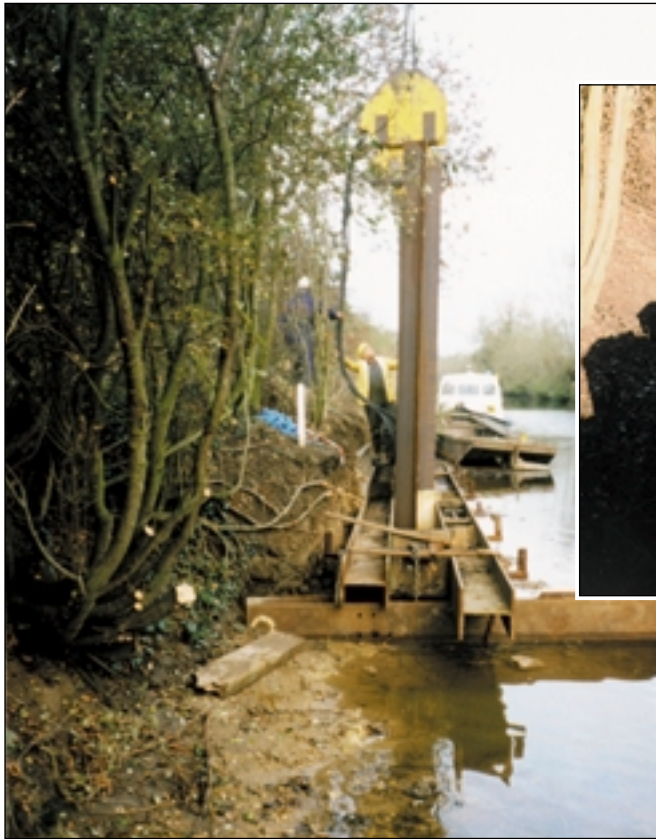
Initial sheet piling after bagwork removal, over existing trees

of sheet piling (to allow continued maintenance dredging) with an above-water 'soft' approach promoting vegetation growth. The sheet piling was carried out using a land based crane with floating pontoon to support the piling frame, thus reducing the degree of trimming and removal of existing bankside vegetation.

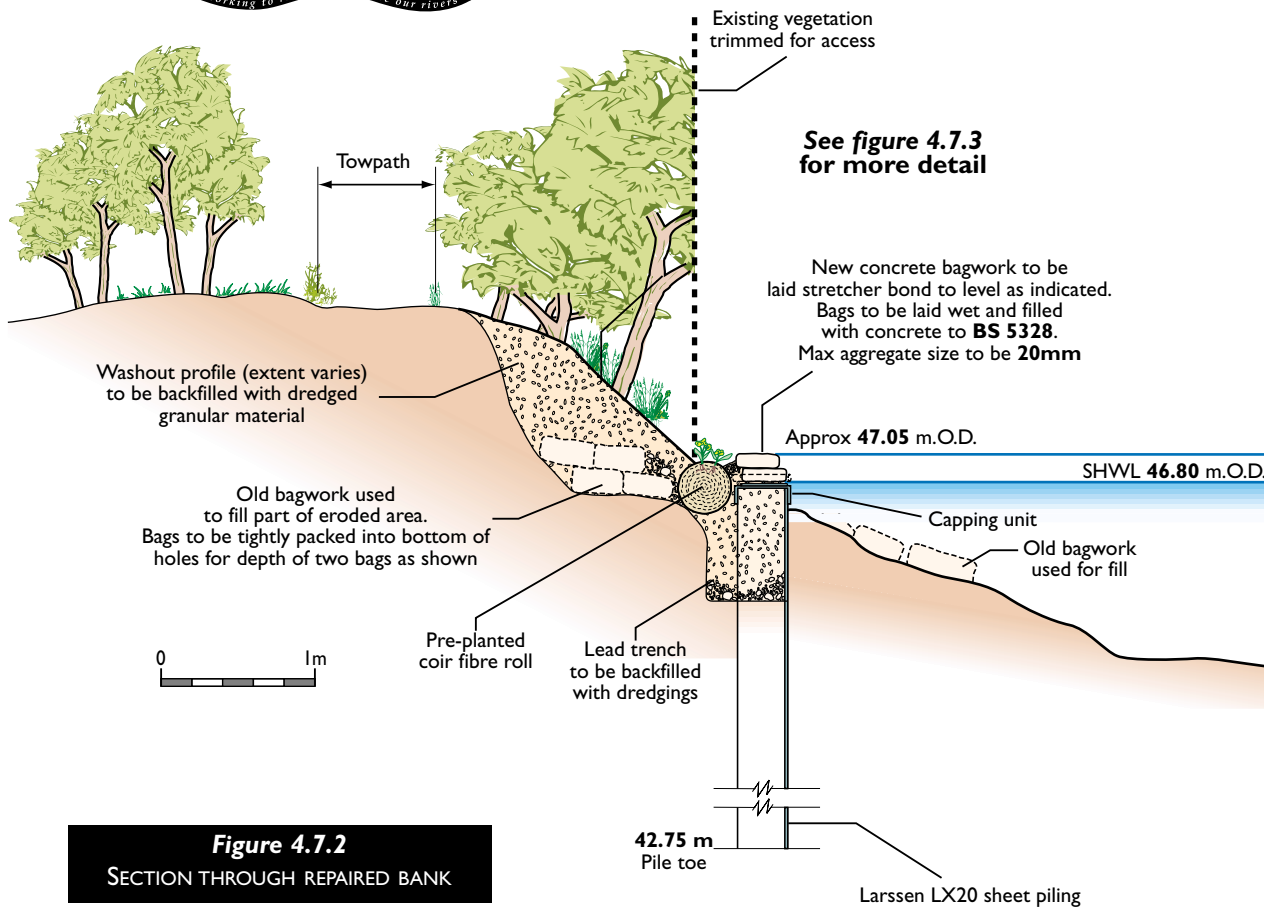
Figure 4.7.2
SECTION THROUGH REPAIRED BANK

The old bagwork was removed to be used as backfill. To ensure stability at the toe of the bank, short sections of sheet piling were driven to below water level. The piling was capped with an inverted steel channel section with mesh welded to the top to prevent movement of the above two courses of new bagwork, ending just below 'standard head' water level (fig 4.7.3).

The sheet piling and bagwork was backfilled with the old bagwork and dredgings from the channel, then capped with a pre-planted (Pond Sedge, Reed Canary-Grass and Iris) coir fibre roll. The dredgings were stockpiled and allowed to de-water before being used as backfill.

The roll provides both retention of the backfill, preventing wash-out, and a medium for reedy marginal vegetation establishment. The vegetation, when established, provides an effective natural defence against boatwash, habitat for bankside wildlife and is visually more pleasing.

In addition, 50mm dia. UPVC ‘mammal’ pipes were incorporated between the lower level bagwork at 1500mm intervals.

The upper slope was formed from imported topsoil and covered with a biodegradable fibre mat to protect and retain the sloping surface. The mat was used along most of the reach, a necessity due to the timing of the works with little opportunity of vegetation establishment before high winter flows. The matting was pinned to the slope using wooden pegs, rising to the retained shrubline. The bank was not seeded to allow natural re-vegetation.

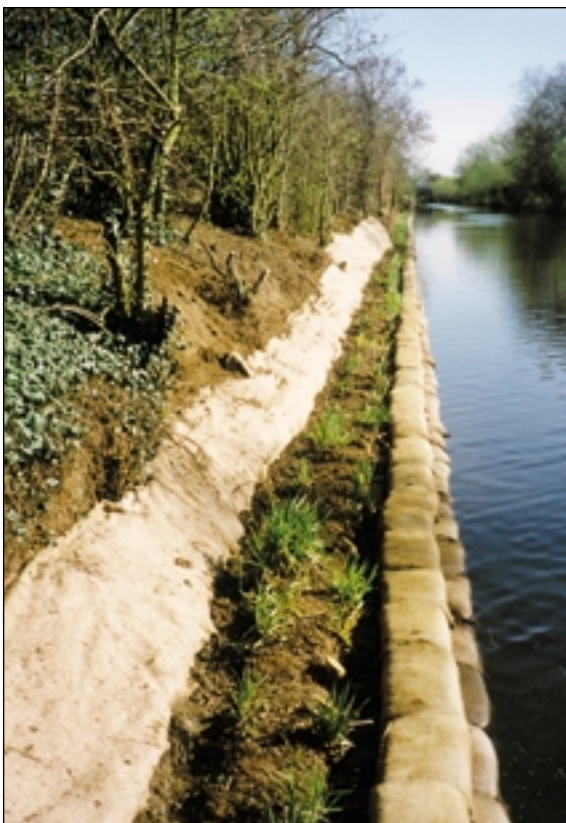
Flax mat secured, planted coir rolls installed and voids backfilled
