MANAGING OVERLAND FLOODWATERS

6.1 Floodplain spillways

RIVER COLE

LOCATION – Coleshill, Oxon/Wilts border, SU 234935

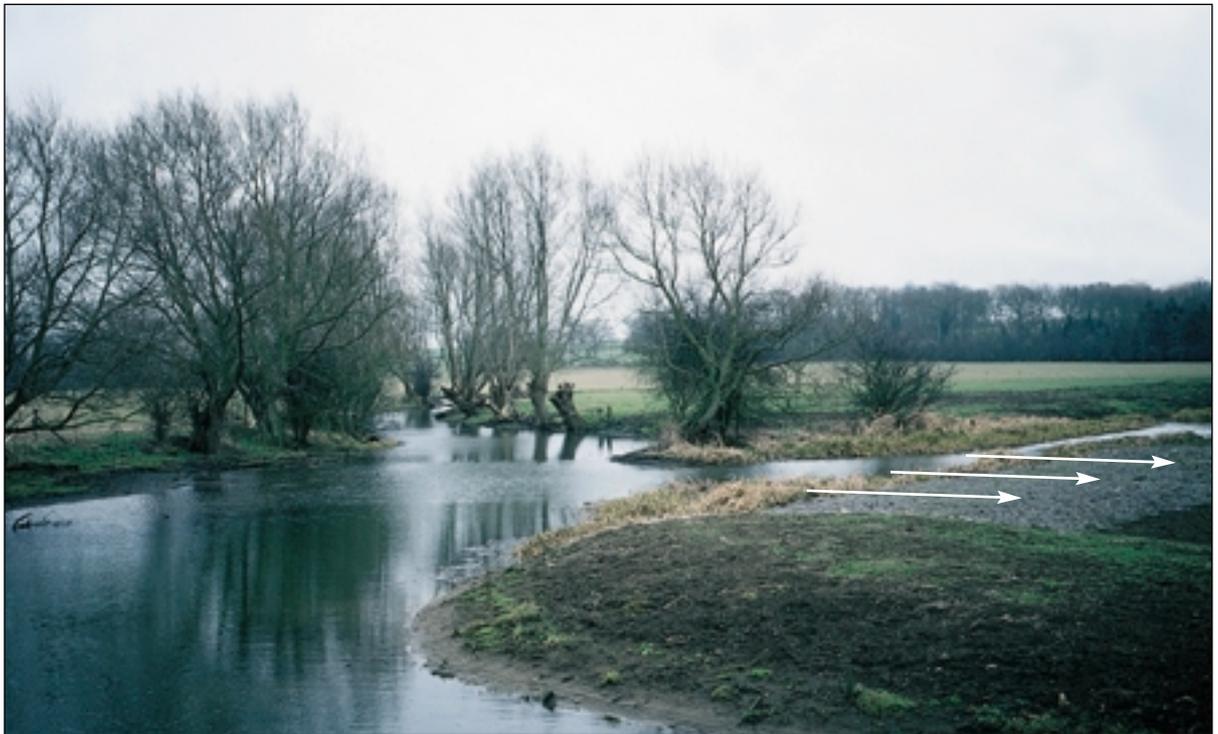
Spillway S2 . Flood flows indicated by the arrows overtop the spillway, merging with the new channel (not visible)

Spillway S2 begins to operate only after S1 has filled the new channel with water. Water spilling over S2 passes directly into the new channel causing it to overflow its banks and initiate field flooding. Scour of the overspill is minimal because this design ensures floodwaters from both S1 and S2 merge without excessive turbulence.

The level at which S2 is set is critical; it is 300mm lower than the floor of the mill further down river, to ensure floodwater is diverted away from the mill. In practice, S2 replaced an unsightly concrete cascade weir built at the mill to protect it from flooding. The cascade has been boarded off and will be infilled once the performance of S2 is proven to be satisfactory.

The length and longitudinal profile of S2 was also critically determined, by hydraulic modelling, to ensure sufficient flow of floodwater down the valley to avoid worsening 1 in 100 year flood levels for isolated properties on the fringes of the floodplain. The crest has a compound profile which is surfaced in stone over the lower part.

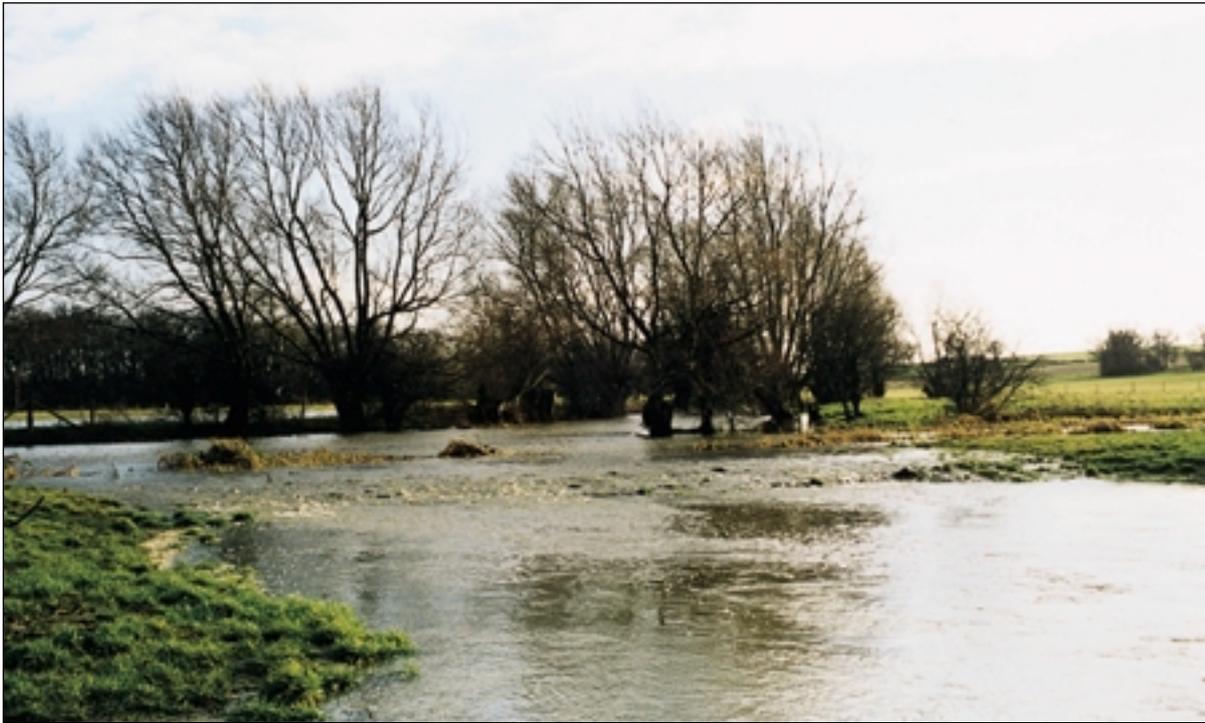
Spillway **S2** in flood

The stone surfacing of S1 and S2 suffered localised scour damage which was rectified by partial reconstruction, taking greater care to ensure the predominant stone size (200mm) was evenly distributed and well compacted into turfy soil that quickly generated root and sward binding. Level pegs were driven near S2 so that its designed crest could easily be checked for trampling by cattle or erosion by water..

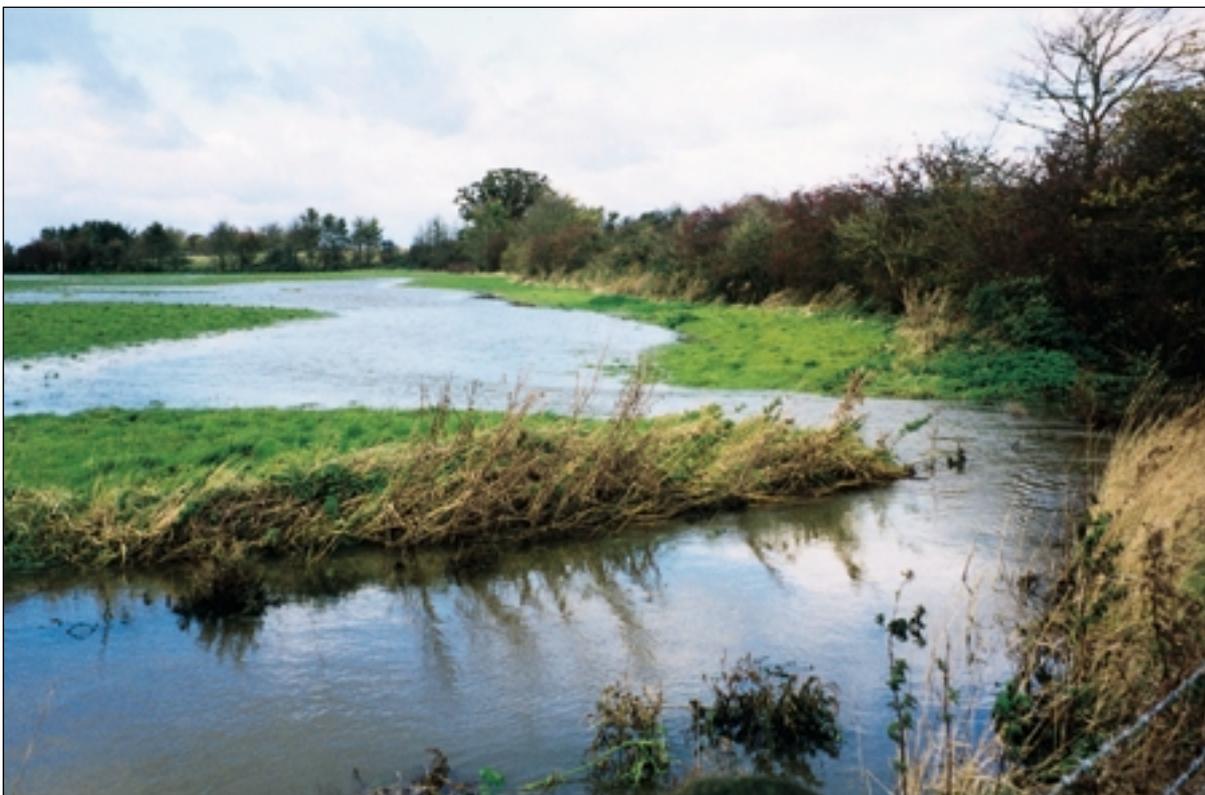
Spillway **S4**. Floodwaters spilling into field gully.

Spillway downstream of the main road (fig. 8.2.2)
Spillway S4 is located alongside a spring line drain that discharged to the river. The drain was firstly blocked with soil well back from the river to help keep the meadow damp. The redundant length of drain between the river and the staunch was then modified to carry floodwaters from the river out onto the floodplain. This was necessary because the land alongside the river is higher than the general field levels, thereby delaying the onset of natural flooding. The drain modifications overcome this problem.

form spillway S4. The spillway is located close to a natural gully that meanders down through the floodplain fields and probably marks an ancient river course. The spillway was completed by shallow excavation of the field to extend the gully right up to the bank of the drain.

An access bridge was built over the drain using two 1m diameter pipes, sized to allow reasonable volumes of floodwater to pass through. The top of the crossing was kept up at the prevailing river bank level so that livestock could be evacuated, after flooding commenced via the nearby spillway S4 (*see 8.2.*)
