SITE VISIT INFORMATION – CROXALL LAKES

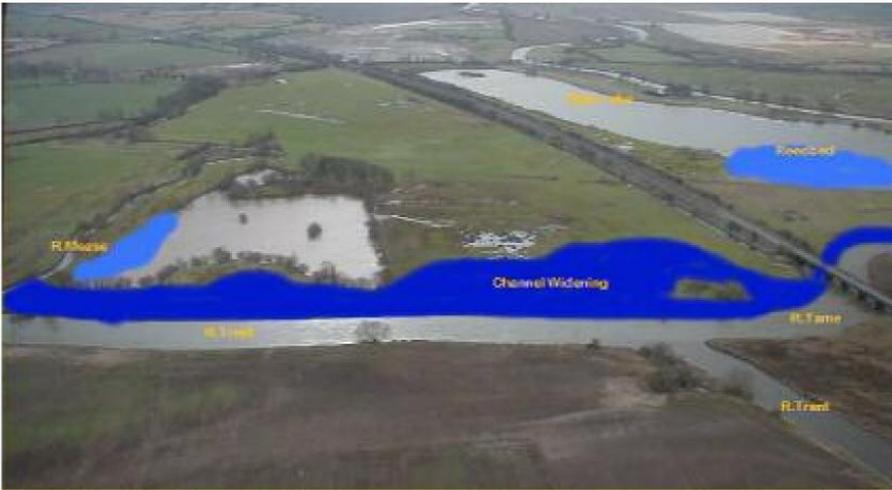
Figure 2 Annotated aerial photograph © Environment Agency.

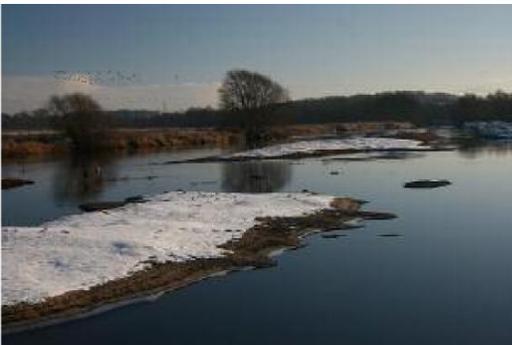
Figure 3 Widened channel with bars and islands

Along 400m of the Tame an underwater shelf about 4m wide was excavated to just below water level and the bank sloped back to an angle of 1:20 to a maximum of 30m at the point of the bend. The river in this reach had a very even width of about 25m before the works.

It became clear that a larger increase in cross section at high flows would have been desirable. In 2002, the 400m of land between the river and the lake (an area of about 2.7ha) was lowered by 750mm. The highest point was lowered from 1.6 to about 0.85m above normal water level. The river height at bank full level was thus similarly lowered thus reducing velocity and thus increasing deposition on the bend. The soil was again put into the lake to create shallows.

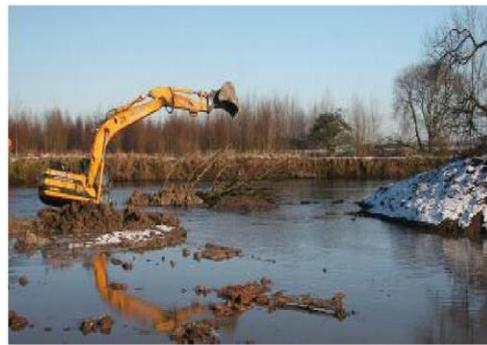
Figure 4 Islands being created
