Stoke Brook Restoration, Stoney Middleton

Techniques: Sediment removal, Riddling

the River Restoration Centre Case Study Series

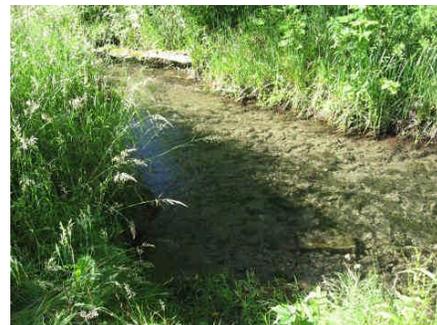
Stoke brook prior to cleanup

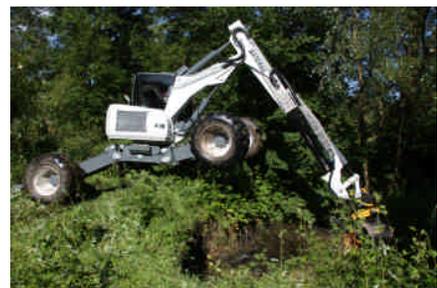
Walking excavator entering Stoke Brook

- An Italian designed and constructed 'walking excavator' was used as the key tool in removing sediment from the rivers whilst causing minimal impact to the river banks, and especially to water burrows and habitat. The excavated material (as much as 1000 tonnes) was returned to the mine. With low ground pressures and the ability to walk over fences and across the river banks and into the channel, this specialist equipment enabled remediation to occur with little impact on the associated river systems.
- Fine bed material was removed using a 'riddling' head on the walking excavator. Particles less than 4mm in diameter were extracted from the river and returned to the mine for reprocessing.
- In addition to these works, sections of floodplain were restored by creating off-line and on-line ponds and wetland areas (see separate case study).

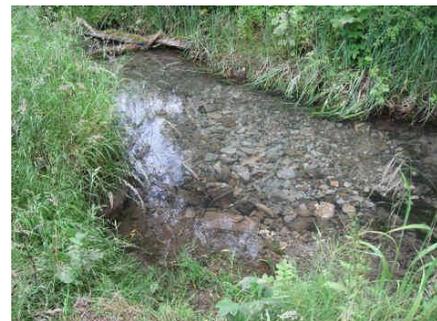
Stoke Brook after cleanup

Almost immediately after the sediment was removed from Stoke Brook, fish were observed within the channel. A programme of monitoring will be taking place over the next 5 years to survey the invertebrate and fish populations. The work has removed almost all evidence of sediment deposited by the flood. The project is an excellent example of the ability to get in and out of the channel, causing little or no impact to the surrounding habitat. For example, Large Woody Debris was retained within the channel, whilst water vole banks were un-damaged.
