River Restoration NEWS

Issue 34
December 2009

Newsletter of the RIVER RESTORATION CENTRE

RRC's Houting Outing to Western Denmark

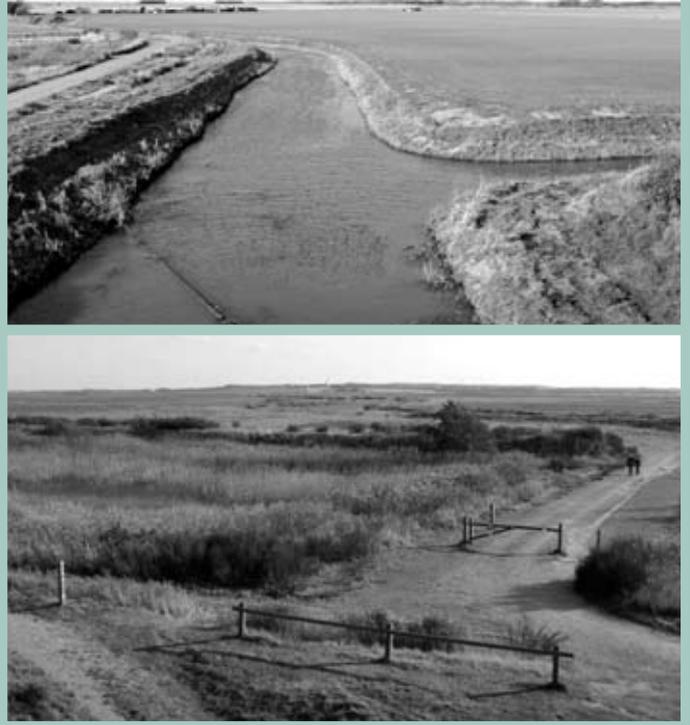
Figure 1:

The straightened river system alongside drained and agricultural land depicts the old Skjern landscape (top), while the array of developing wetland habitats shows the return of its former mosaic floodplain (bottom).

Skjern project originally aimed to restore watercourses that were straightened for intensive farming in the 1960s, and historical mapping from 1871 was used to inform the restoration of river meanders and 2220 hectares of surrounding wetland habitat (*Figure 1*). During the works a total of 2.7 million cubic metres of soil was removed, enough to fill a series of dumper trucks from the Skjern to Rome, and the length of the Skjern was increased by four kilometres. Straightened sections that were not infilled have been retained as linear ponds.

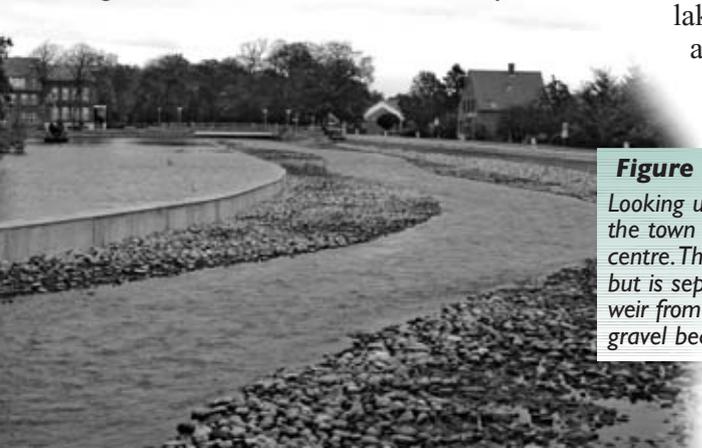
Figure 2:

Looking upstream from the old Mill in the town of Tonder towards the town centre. The mill pond level is retained, but is separated by a lateral overspill weir from the new 'free-flowing' river with gravel bed and banks. October 2009

The aim of a £1.1 million project in the town of Tonder on the River Vida is to restore houting passage, retain parts of an old millpond as a nursery area, and create spawning grounds. While the mill wheel was no longer present at the start of the project, a two metre high weir created a physical obstruction to houting migration. The pond and the river have now been separated with the creation of a lateral sheet-piled, concrete-faced, broad-crested weir. Gravel bed and banks have been installed (*see Figure 2*) and an otter pass has been built under the bridge just downstream of the reach shown. Two sluice gates and a fish ladder upstream of the mill bridge have been removed and downstream Tonder rowing club also have a new access point to the river to minimise disturbance. Flood banks on the northern side have been set back to ensure flood risk doesn't increase and eighty hectares of shallow-water lakes will form new nursery areas for houting fry. From Tonder, the watercourse

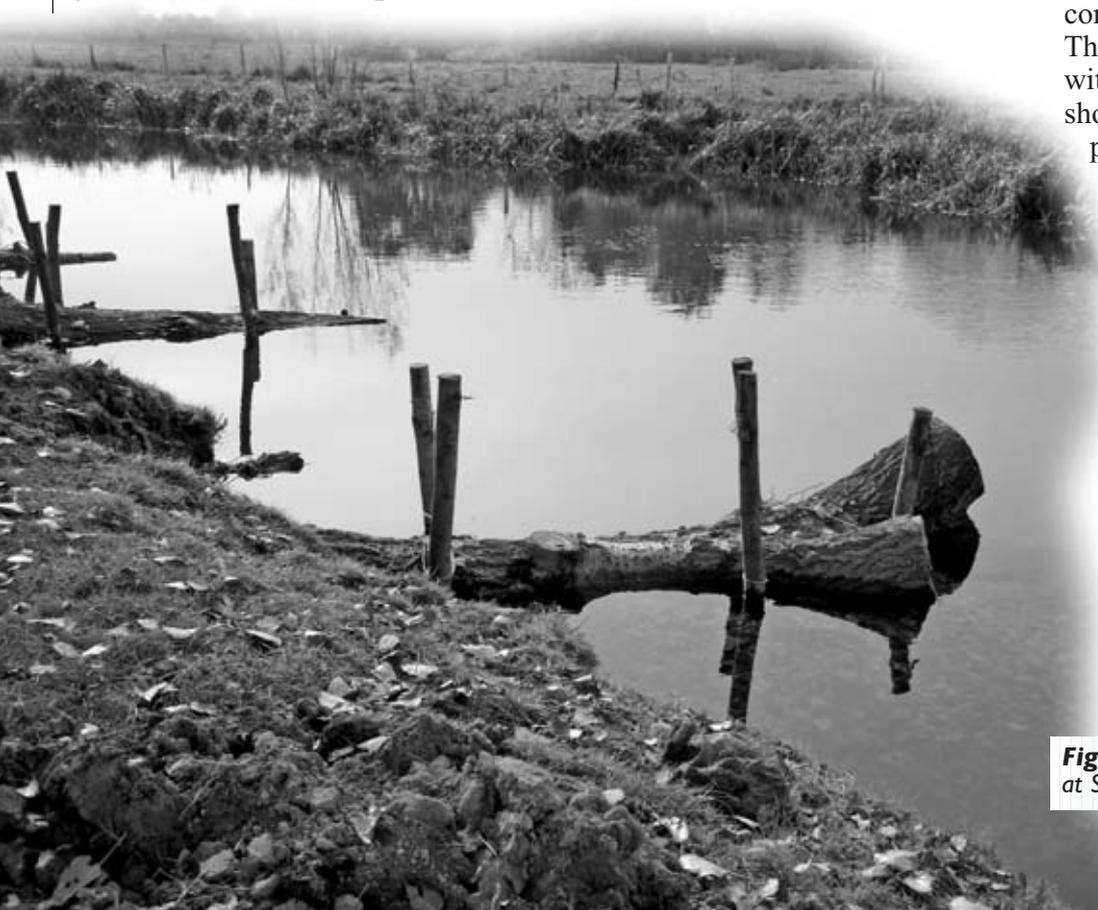
Figure 1. Wood deflectors installed at Seven Hatches

restoration works assessments, so this took between 2 and 4 years to complete for each site. The projects were divided into discreet reaches each of which was assessed separately. Repeat photography was also carried out at all of the assessment stages (see *Figures 1 and 2*).

vegetated, further reducing the channel width. Throughout the project an adaptive management process was adopted so that the lessons learnt from one site could be applied to the next. In terms of the deflectors, one lesson taken forward into later works was to increase the size of the trees used. The RRA process highlighted that changes to the hatch operation (for example the hatches being raised permanently), where it occurred, had the biggest immediate impact in the short term by reducing water depth and increasing velocities with the resultant removal of silt from the gravel substrate.

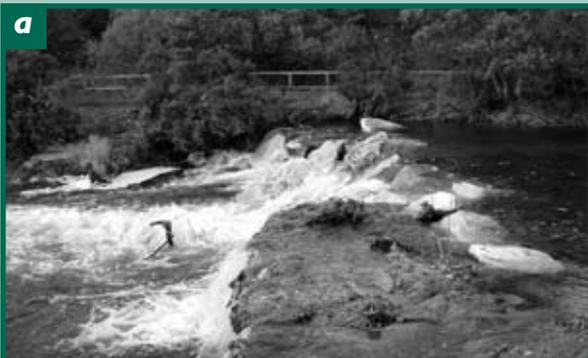
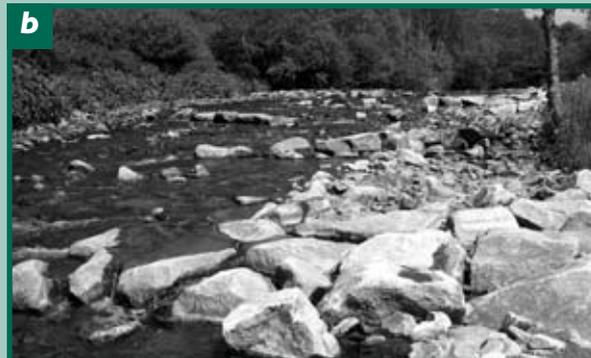
Figure 1: River Neb with (a) dilapidated weir (summer 2006), and (b) the rock ramp (spring 2007) which has replaced it

ensure passability only when weirs need to be replaced. A particularly good example was the installation in 2006 of a rock ramp to replace a dilapidated weir on the River Neb, which had for many years delayed upstream passage of salmon and sea trout, leaving them vulnerable to poachers (*see Figure 1*). The ramp incorporates a low-flow channel, thereby also aiding dispersion of resident brown trout. Although there is not enough monitoring data available to draw robust conclusions, surveys conducted in 2005 and 2007 revealed similar numbers of brown trout but a quadrupling of 0+ salmon at a few kilometres above the site. The ramp also resulted in considerable financial savings for the DoT when compared to a like-for-like replacement.

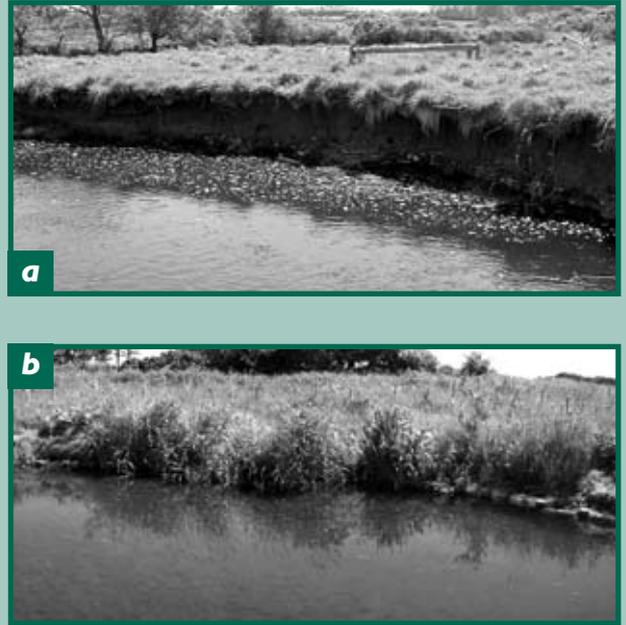
Figure 2:
Bend on the Silver Burn in
(a) August 2006, showing
cantilever erosion,
and (b) June 2009, three
years after 'green'
engineering

Until fairly recently, most bank revetments conducted by the DoT had employed traditional hard engineering solutions such as gabion baskets and 'stob and mesh' (post and wire-mesh barriers back-filled with stone). However, since 2006, greener solutions have been employed wherever possible. The first major example was the revetting of a bend prone to severe cantilever erosion above a large but passable weir on the Silver Burn (*see Figure 2*). 'Stob and mesh' techniques had

failed in the past leaving potential for the river to divert from the weir, an undesirable prospect in this instance. The work was used as a training exercise in soft engineering for the DoT's works gangs with Salix River & Wetland Services Ltd contracted to supply the design and supervision. Faggots topped with coir roll were used to construct the desired course and, after regrading and seeding, the bank was reinforced with NAG350 geotextile. In order that only plants of native Manx provenance were used, the coir roll was installed bare and later planted with marginals. A small backwater was also created at the site and a copse of native trees planted to further enhance the area's wildlife potential. The project has led to other green initiatives such as the creation of a lagoon for supplying pre-planted coir roll and the sourcing of faggots from the Manx Wildlife Trust using willow cut during coppice management of nature reserves.
