Case study 10. Padgate Brook River Restoration – part of the Warrington FRM Scheme

Main driver: flood risk, river restoration, improving floodplain connectivity

Project stage: Constructed 2016

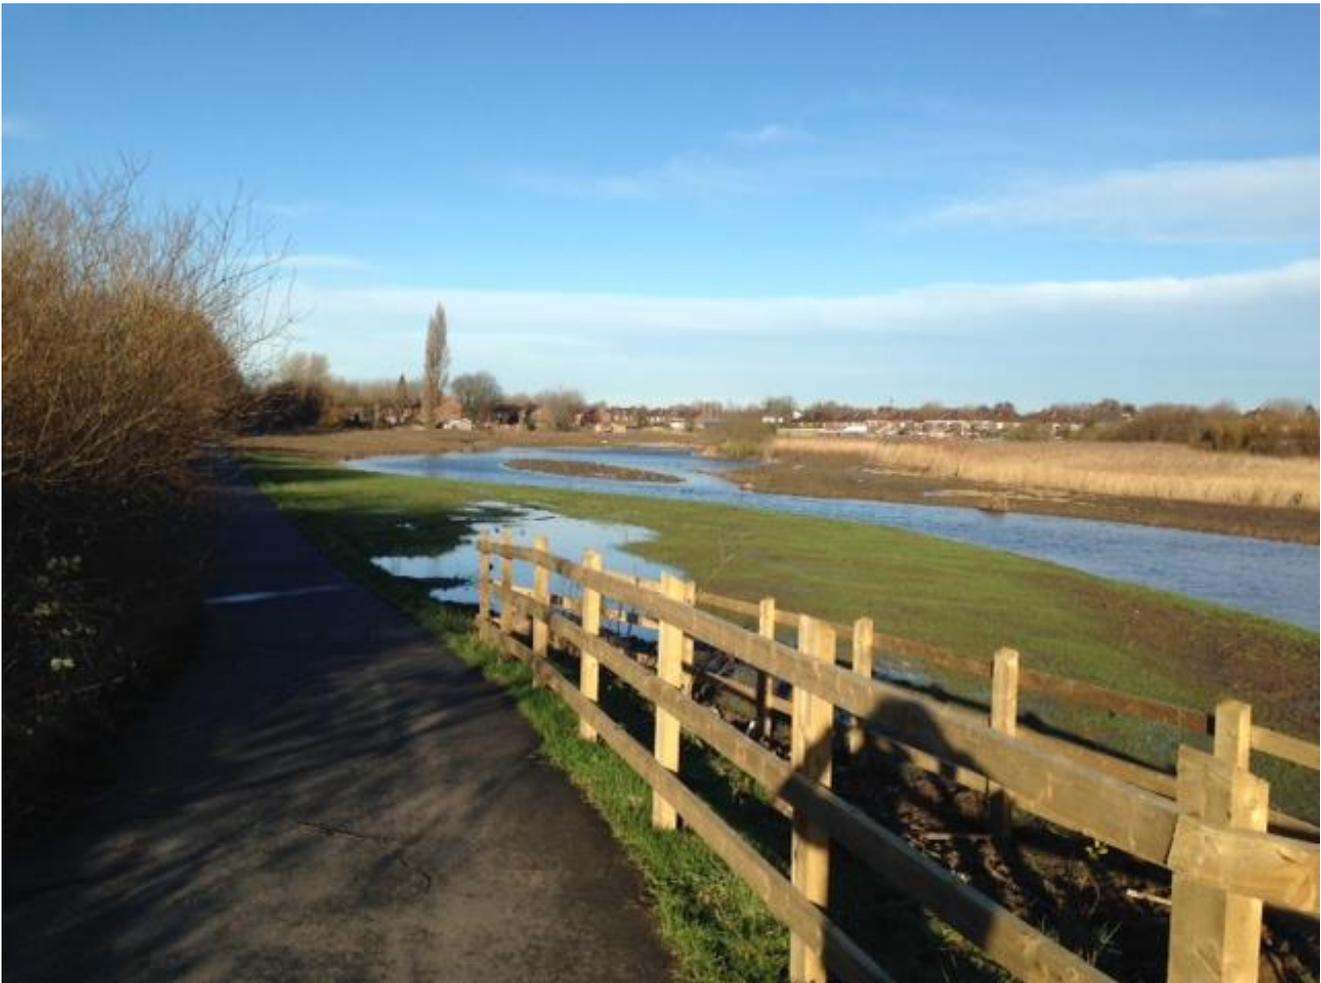
Photo 1: The Twiggeries, 2016 (source: Environment Agency)

Padgate Brook lies to the east of Warrington town centre (Map 1). It is a small watercourse which feeds into the River Mersey. The brook has been subject to a number of alterations over the years to reduce flood risk. One of the main changes was to straighten and deepen the brook through the Twiggeries and construct flood embankments along both banks. This effectively cut off the brook from the adjacent floodplain (Photo 1 and Appendix 1).
