Case study 1. New Forest LIFE III Project

Authors: Stephen Addy, Maxine Holden and Leanne Sargeant

Main driver: River and floodplain habitat restoration

Project stage: Completed over 2002 to 2006

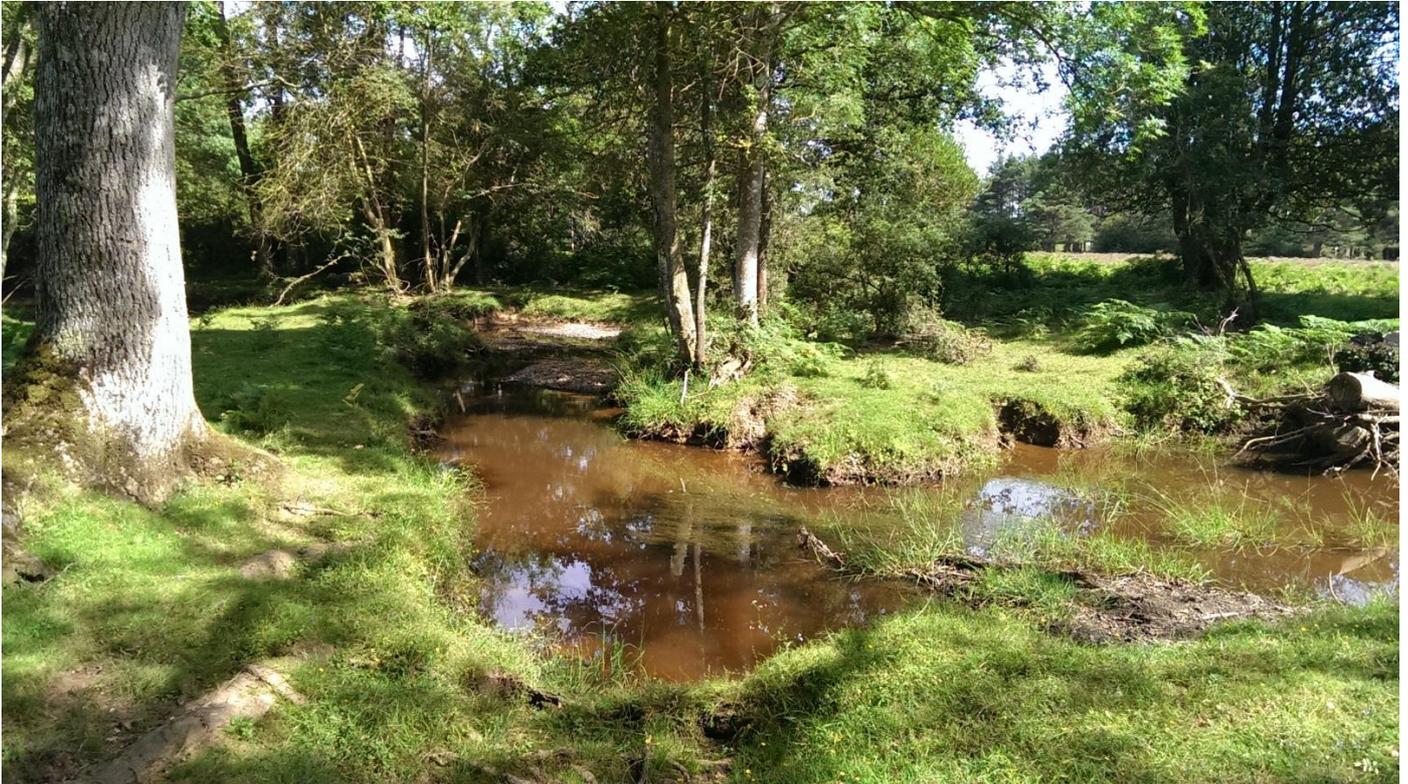
Photo 1: A section of the Black Water after its characteristic meandering stream morphology was restored (source: River Management Blog, Simon Dixon)

The natural meandering courses of streams that existed prior to straightening were reinstated through excavation (Photo 1). Together with the addition of wooden structures using locally sourced wood (Photo 2), these measures aimed to increase floodwater storage and slow the flow to aid attenuation through increasing roughness and improving floodplain connectivity. This also aimed to benefit the regeneration of riverine and bog woodland, which are priority European habitats. In addition, woodland management actions through removing invasive non-native species and conifers, and the coppicing of riparian trees was also carried out. Drains were also blocked by using heather bails to:

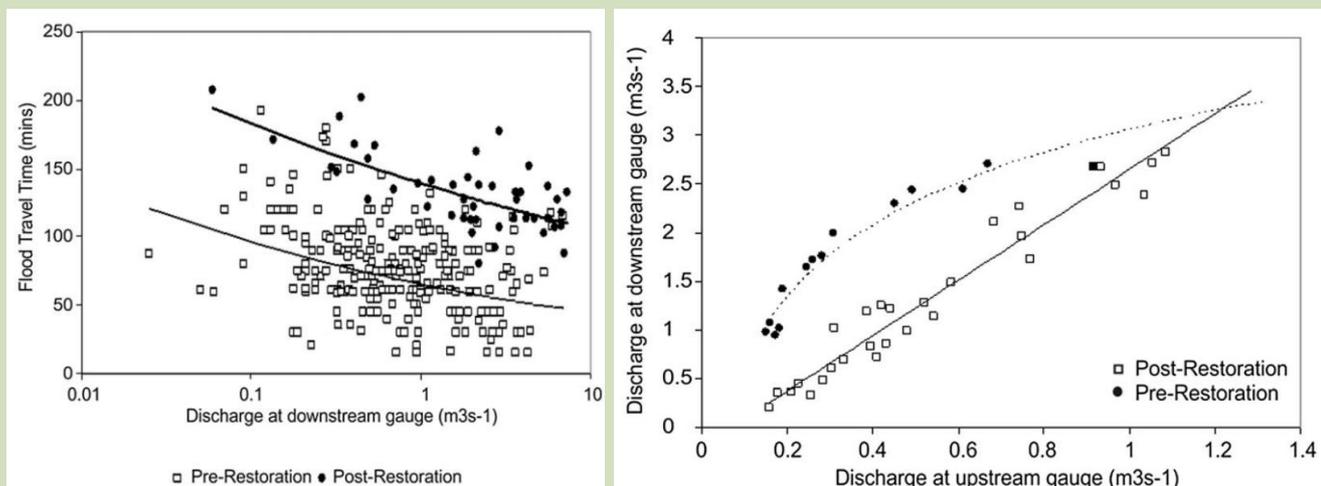
Figure 1: (Left) Empirical evidence of the increase in flood wave travel time (left) and discharge attenuation as a result of channel restoration and adding in-channel wood on the Highland Water (right) (after Kitts 2010; adapted from Figure 1 in Dixon et al. 2016).

Kitts (2010) found that the river and riparian restoration measures together resulted in a 21% reduction of flood peak magnitude and a 33% increase in flood peak travel time for flows that were less than $1\text{m}^3\text{s}^{-1}$ (equal to a 2-year recurrence interval; Figure 1). Dixon et al. (2016) hypothesised that flows over 2-year recurrence interval 'drown out' the influence of roughness features resulting in flood wave travel times similar to the pre-restoration conditions.

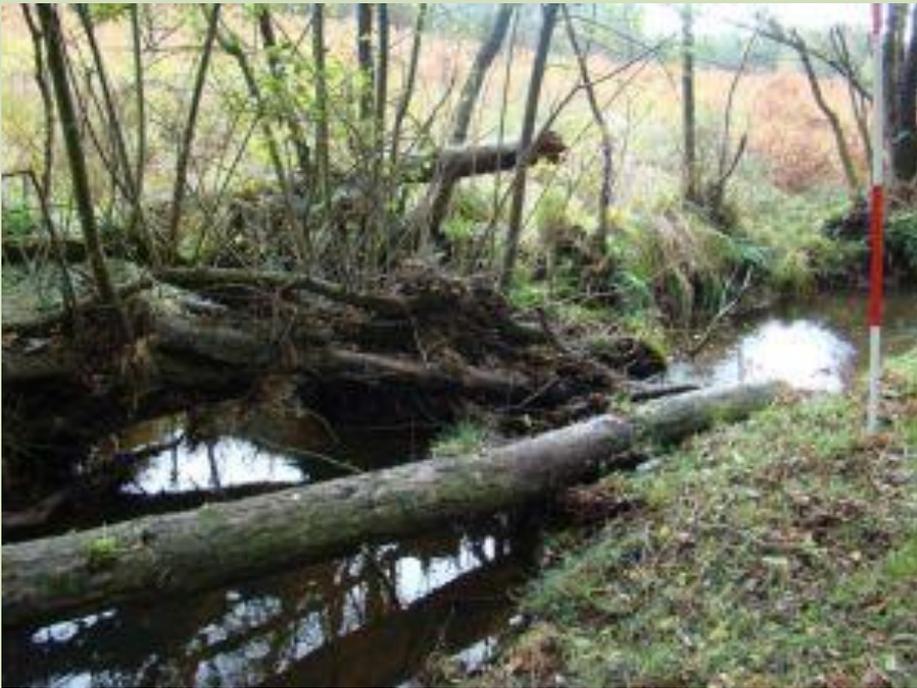
Photo 2: A naturally occurring log jam in the New Forest (source: River Management Blog, Simon Dixon)
