# Case study 56. Levington Saltmarsh Restoration, Suffolk

**Main driver: Beneficial use of dredging and habitat restoration**

**Project stage: Ongoing (1997 to present)**

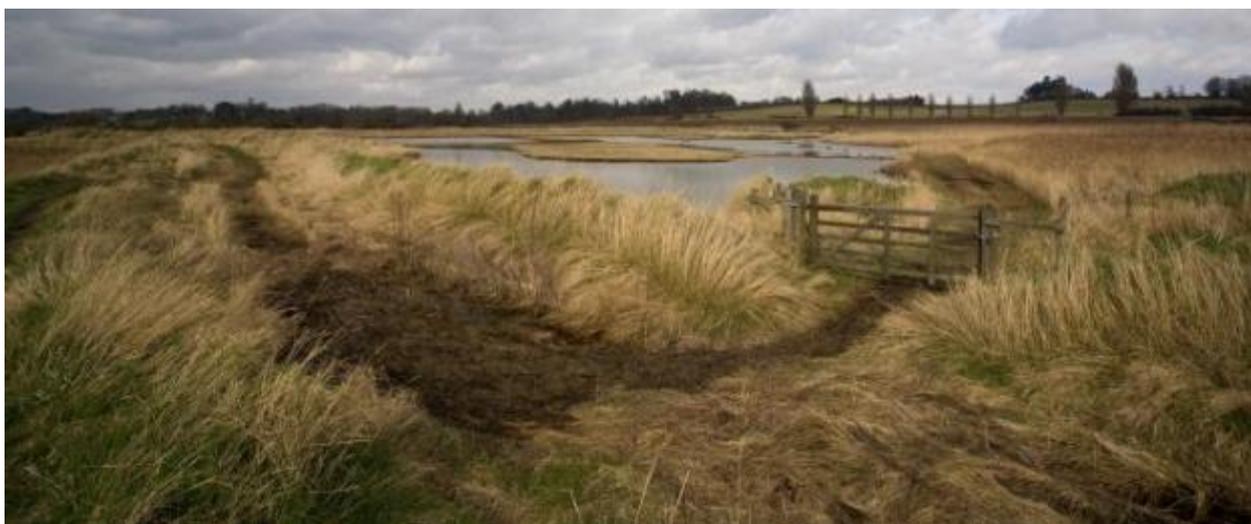
**Photo 1: Levington Lagoon (source: Suffolk Wildlife Trust)**

A Marine Management Organisation (MMO) licence is held by Suffolk Yacht Harbour for beneficial foreshore disposal. Dredged material is recovered as a slurry and conveyed by one of two fixed pipes to a deposition area east and west of the harbour where saltmarsh has been degraded and fragmented. The ends of the fixed pipes are moved each year to vary the location in which dredged material is discharged. Photo 1 shows the Levington Lagoon.

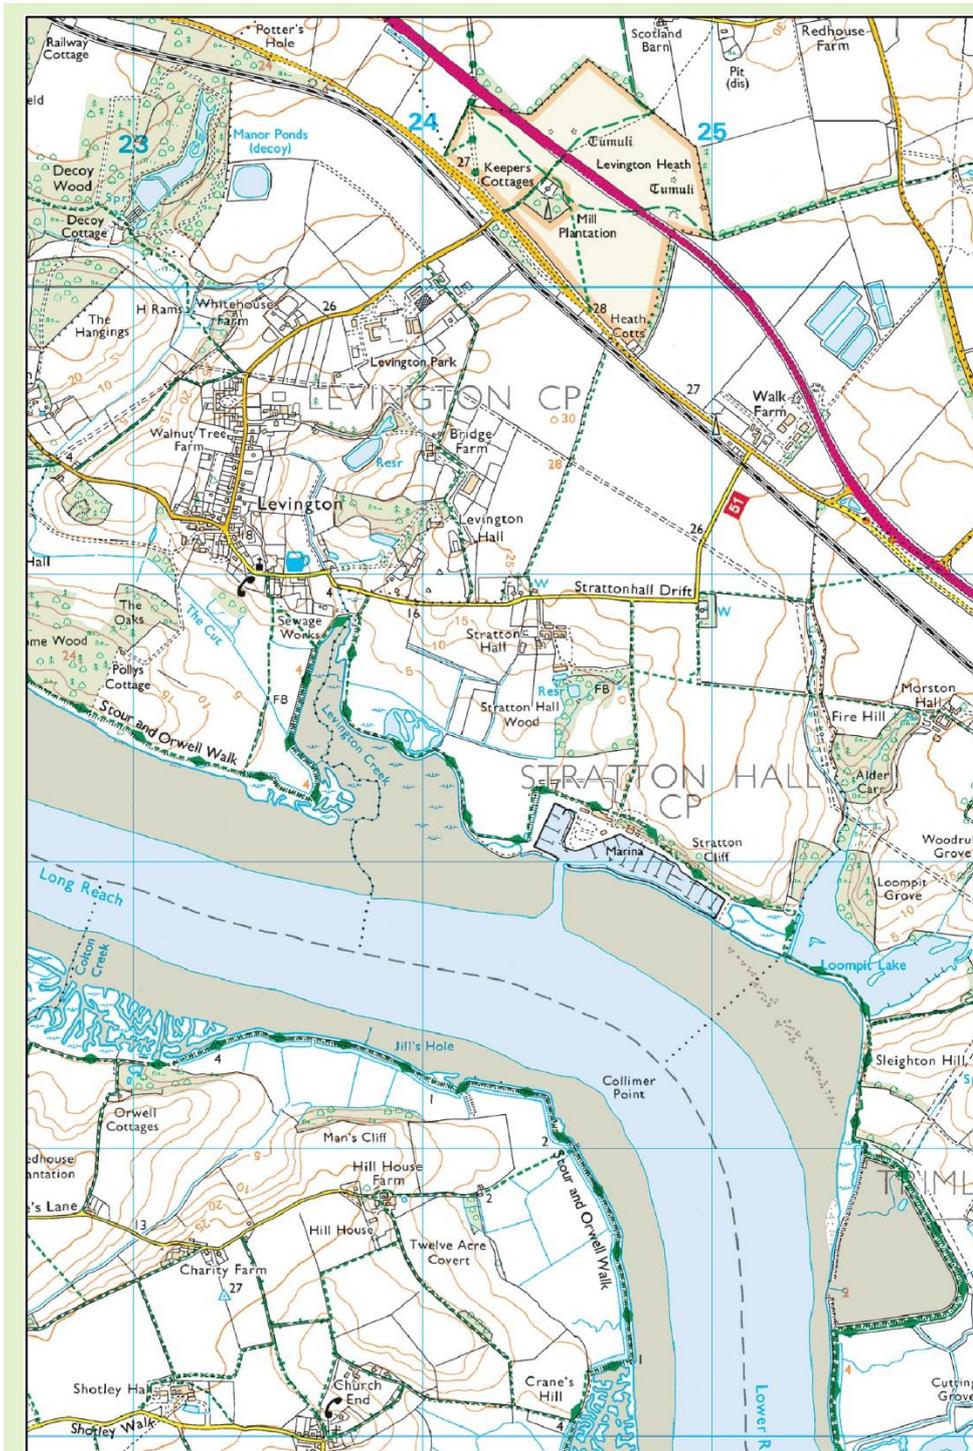
Map 1: Levington Marina (source: Ordnance Survey)

Levington Marina (Map 1) on the River Orwell in Suffolk is dredged each winter using a 10-foot cutter suction dredger to maintain water depths around the pontoons and berths. Since 2014, dredged material has been deposited in 2 beneficial placement schemes licensed by Defra and approved by Natural England. Each year 15,000–20,000m<sup>3</sup> of silt is dredged and placed on the foreshore. Operations are carried out between mid-November and early April.

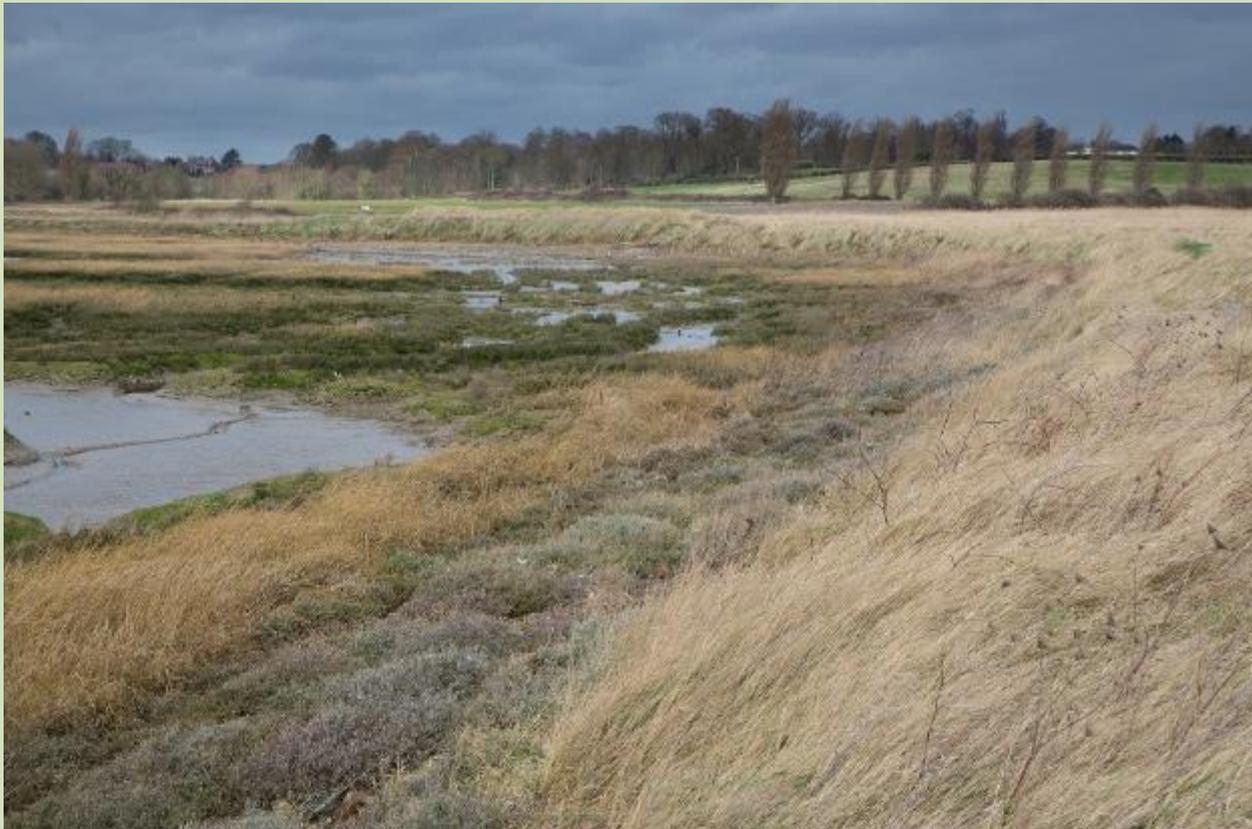
**Photo 2: West Marsh**

The West Marsh (Photo 2) is a substantial area of degraded saltmarsh between the entrance to Levington Creek and Suffolk Yacht Harbour. Seasonally there is a good crop of samphire (*Salicornia europaea*), cordgrass (*Spartina anglica*) and sea aster (*Aster tripolium*). However, there is insufficient overall elevation for this to progress any further beyond pioneer growth apart from a margin of middle marsh close to the defence wall and in isolated patches in the body of the marsh that have been colonised by sea purslane (*Halimione portulacoides*) and sea lavender (*Limonium vulgare*).

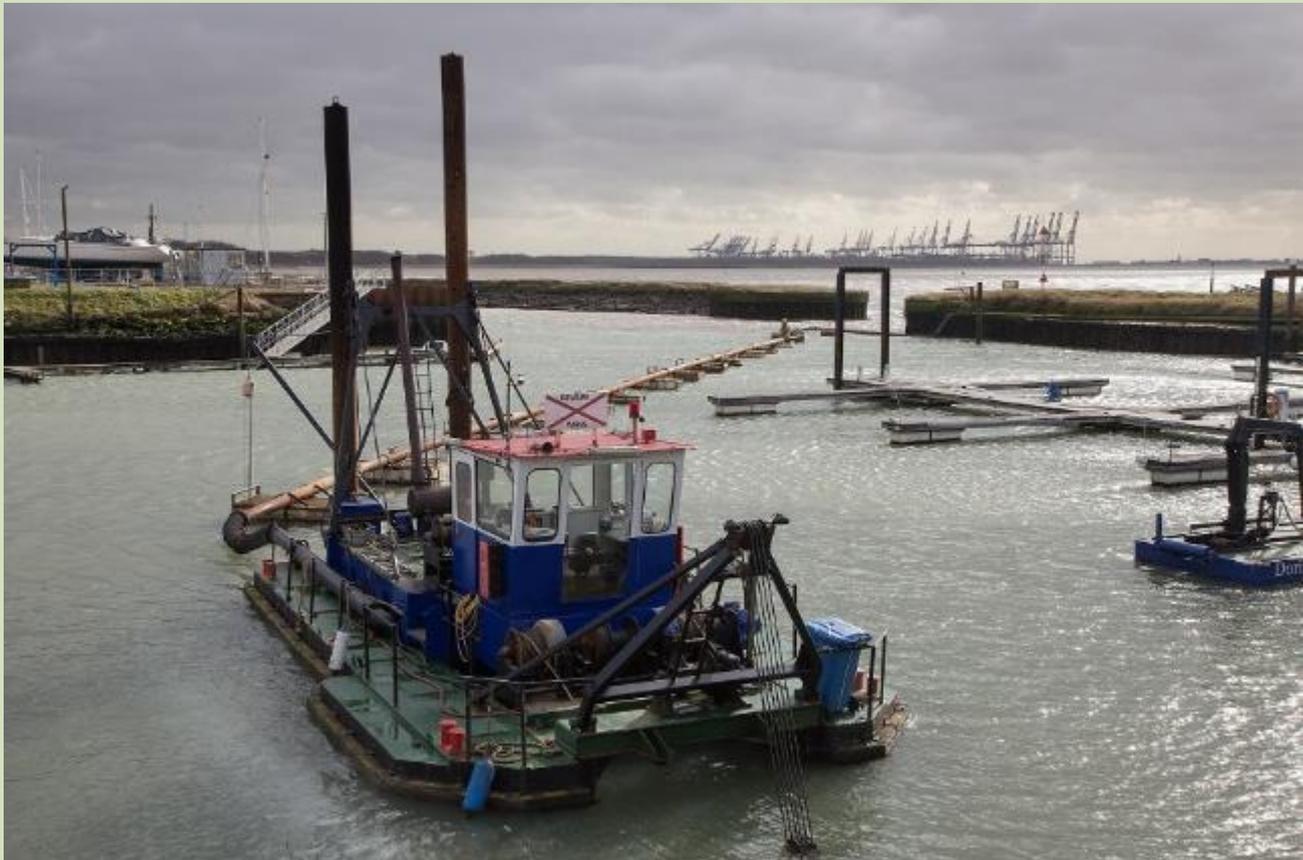
**Photo 3: Dredging machinery**

Dredging is carried out each winter using a 10-foot cutter suction dredger (Photo 3) to maintain water depths around the pontoons and berths. Dredge level of berths are -2.5m chart datum (CD), with a period of approximately 12 months between dredge operations. Different parts of the harbour are dredged in different years.

An MMO licence is held by Suffolk Yacht Harbour for beneficial foreshore disposal. Dredged material is recovered as a slurry and conveyed by one of two fixed pipes to deposition area east and west of the harbour. The ends of the fixed pipes are moved each year to vary the location in which dredged material is discharged.

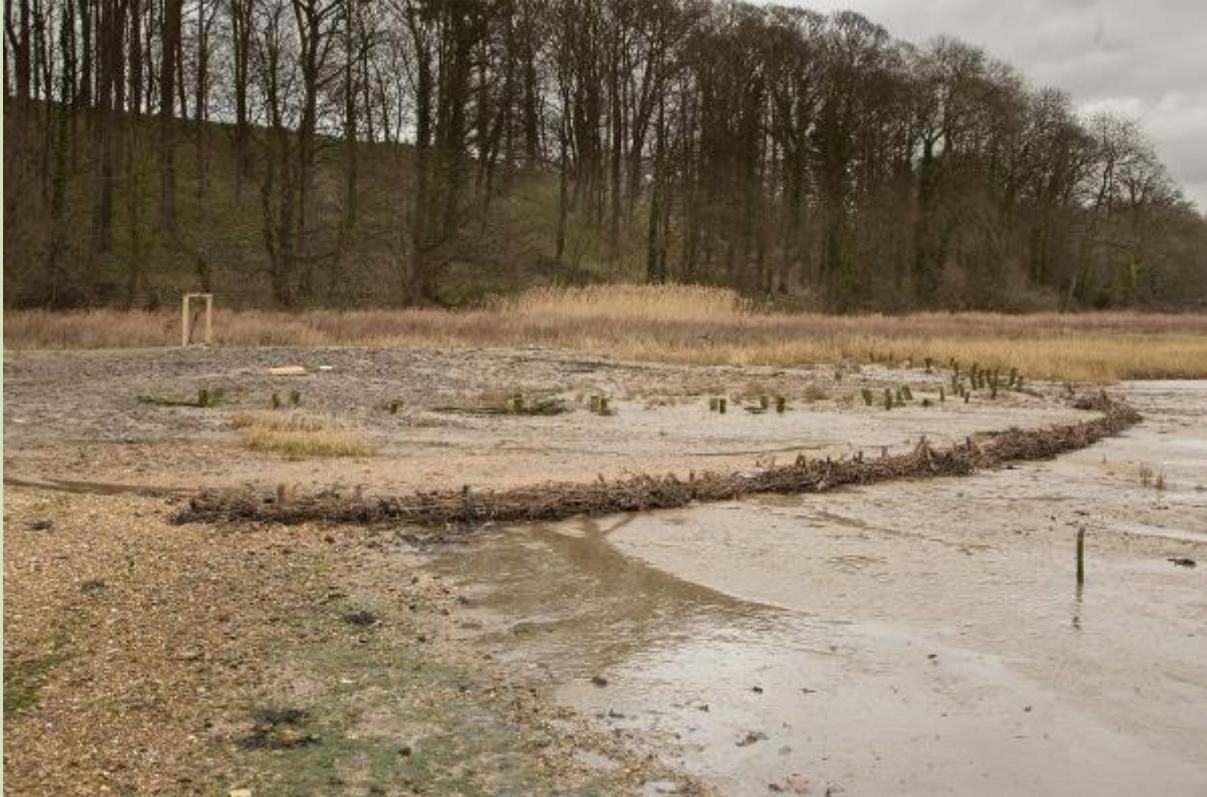
**Photo 4: Example of measures implemented at Levington**

Three further measures were put in place to the east side of the marina. Examples the measures are shown in Photo 4.

- The 2 main breaches in the original defence wall were blocked to ensure that the spoil would not be carried out directly into the tideway and that tidal exchange within the site was controlled.
- A pen of brushwood was constructed, backed up with coir logs, and using a coir blanket around the

outfall to mitigate the immediate effects of scour at the point of impact.

- A series of low bunds was constructed within the site to manage increased flow, discourage the tendency to form substantial drain channels and to encourage deposition as evenly as possible across the site. This is a low-key intervention using coir logs in a similar way to how they were deployed on the north marsh.
