# Case study 57. Rhymney Great Wharf

**Main driver: Improved defence and habitat enhancement**

**Project stage: Constructed 2005**

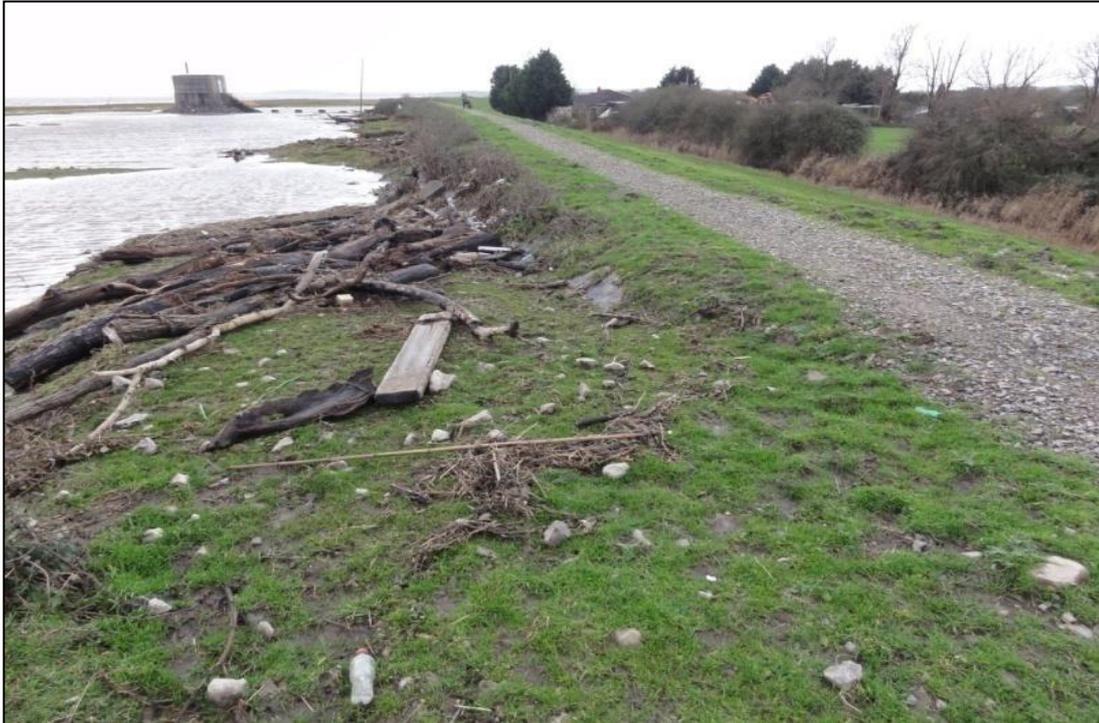
**Photo 1: Rhymney wharf flood embankment post 3 January 2014 tidal event (8.03m above Ordnance Datum at Newport 2 gauge)**

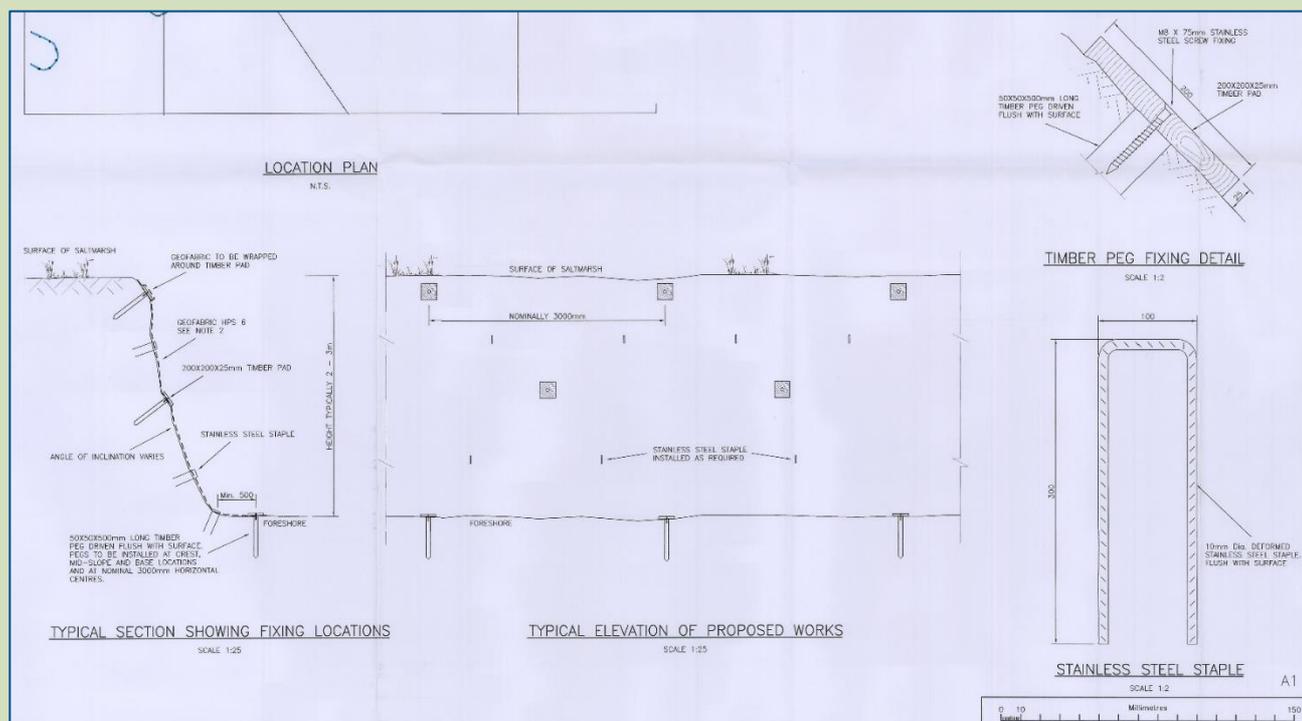
At the outset, the short-term work to stop the further erosion of the wharf scarp consisted of just placing geotextile over the eroding face and securing it in place with wooden stakes and stainless steel staples ( see Figure 1).

**Figure 1: Drawing of the details of the initial short-term erosion protection (source: Atkins)**

Unfortunately, these measures were not capable of dealing with the tidal energy at the location and after just the first tide of sufficient height to reach the work (3 days after installation) the system failed. It was then decided that harder, more traditional methods would be required in the form of block stone and, at locations of decreased energy, small aggregates were used (that is, rip-rap). Initially the intention was to reinstate/recharge the mudflats via direct placement of material dredged from Cardiff Bay. After a detailed study by Atkins on behalf of Environment Agency Wales was carried out into the proposal, however, it was concluded that this method was not suitable for the following reasons.

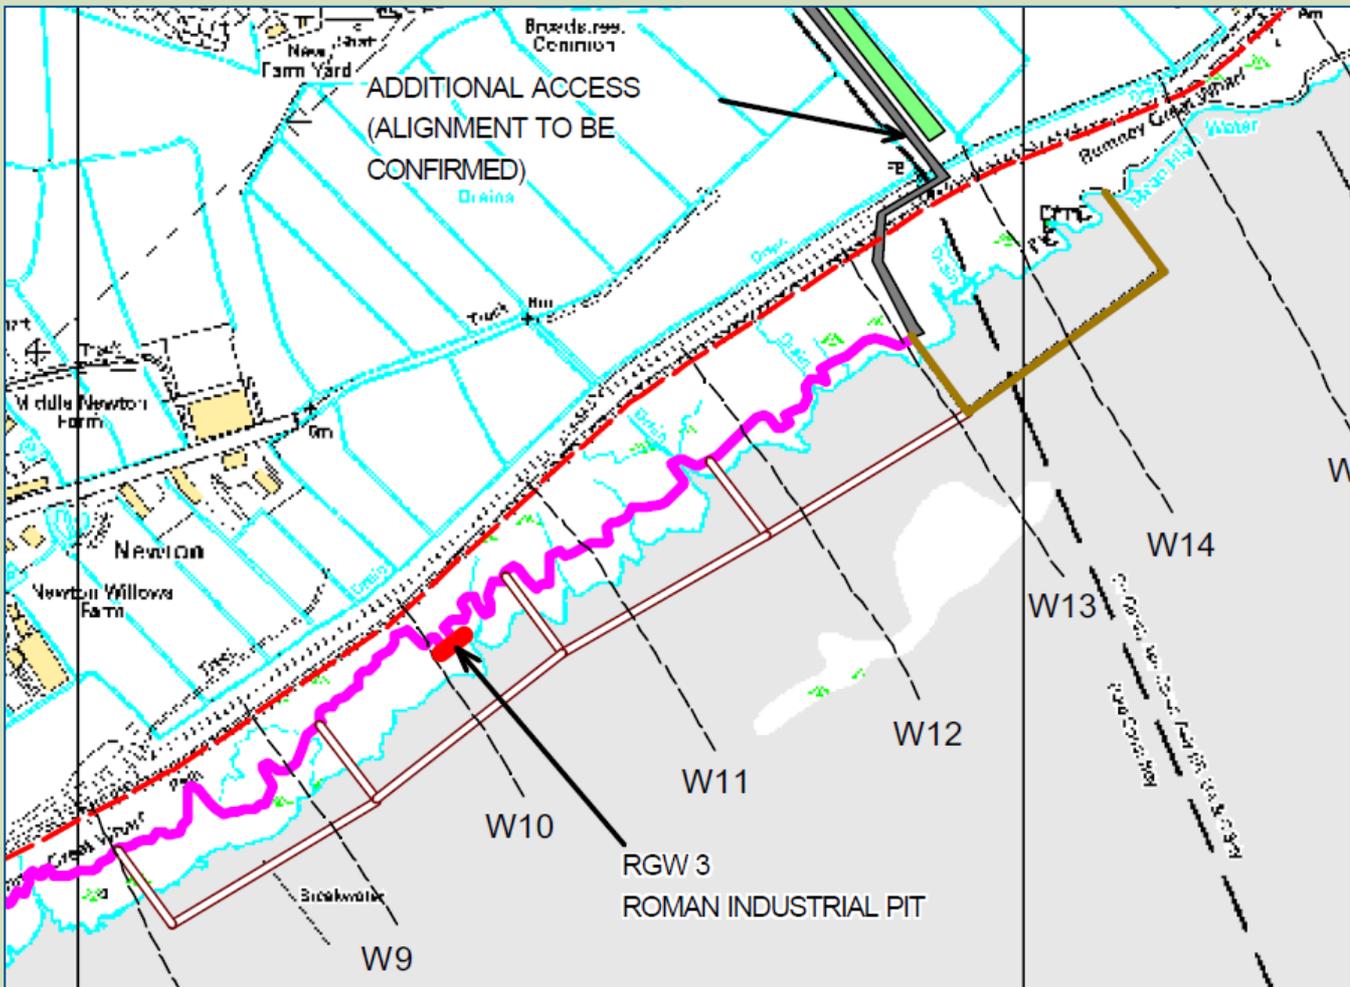
Because of the accreting nature of the area, the favoured option was to attempt to encourage increased deposition of material through the use of rows of larch stakes infilled with willow faggots placed in twin rows parallel and perpendicular to the coast to create 'cells' (see Map 2).

Map 2: Layout of the larch stakes/willow faggots on the site shown by brown parallel lines, with the alignment of the block stone protection to the wharf scarp shown as a pink line (source: Atkins 2006)

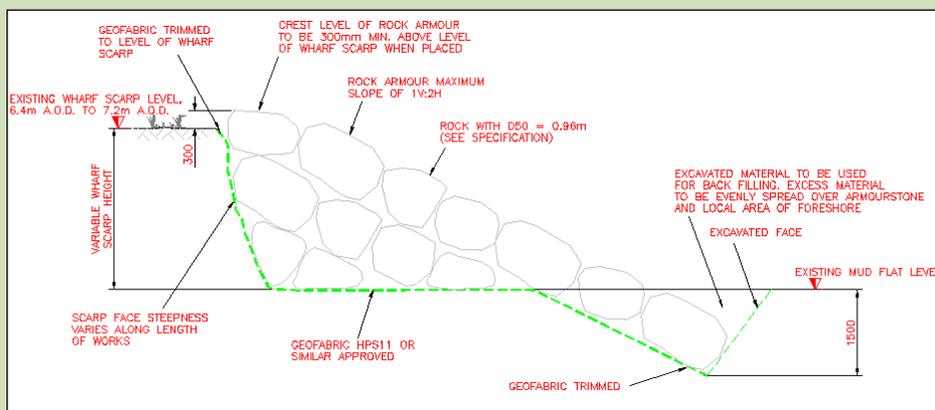
The drawing in Figure 2 shows how the more traditional and 'hard' engineered scarp protection was constructed. Photo 2 shows the scarp protection after construction in 2005 and again in 2010.

**Figure 2: Construction drawing for scarp protection (source: Atkins)**

The block stone revetment was designed to withstand and disperse the wave energy, while the geotextile was to help prevent washout of the fine wharf material.

A small amount of excavation was carried out on the mudflats in front of the scarp toe, grading it down to ~1,500mm into the mud. A geotextile was simply laid flat over the face of the scarp and the mud, before being pinned with steel staples to temporarily hold it in place where required. Block stone was then placed directly on top of the geotextile and built up to form a revetment. The toe of the revetment, due to the excavation, was lower than the level of the mudflat and the interface between them was backfilled with excess material.

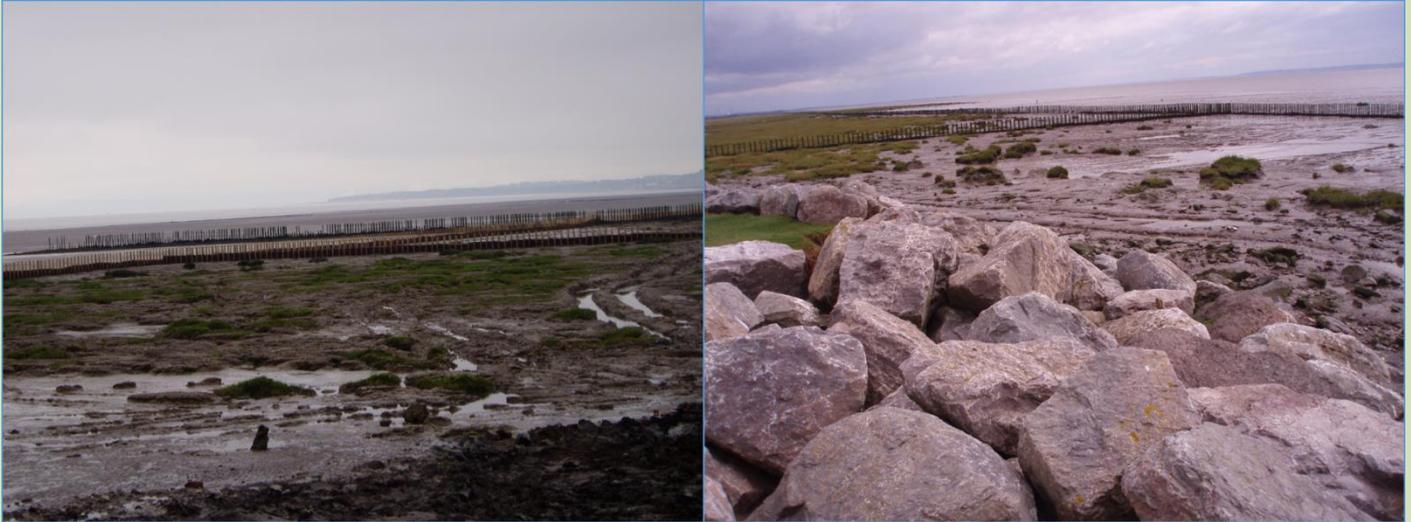
**Photo 2: Post construction in 2005 (left) and 2010 (right) (source: Natural Resources Wales)**

- The short-term measure to stop the erosion using geotextile covered with block stone has been a success. The retreat of the wharf scarp alignment has effectively stopped and, at present, the integrity of the defences remains. Further erosion has been very minimal; in the 12+ years since installation there have been isolated losses of up to 500mm around some of the block stones at the top of the wharf scarp in a few of the more exposed locations.
- Long-term measures to re-establish the mudflats in front of the wharf have been less successful. No notable accretion has been seen, albeit no real further loss.

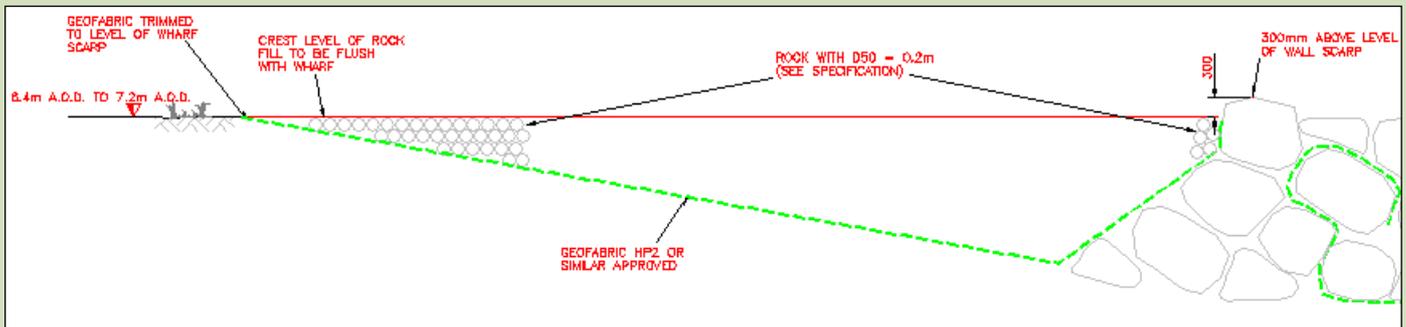
A similar method was used for the eroded channels that had formed along the top of the wharf, only using smaller aggregate as protection (see drawing in Figure 3).

**Figure 3: Construction drawing for channel erosion protection (source: Atkins)**

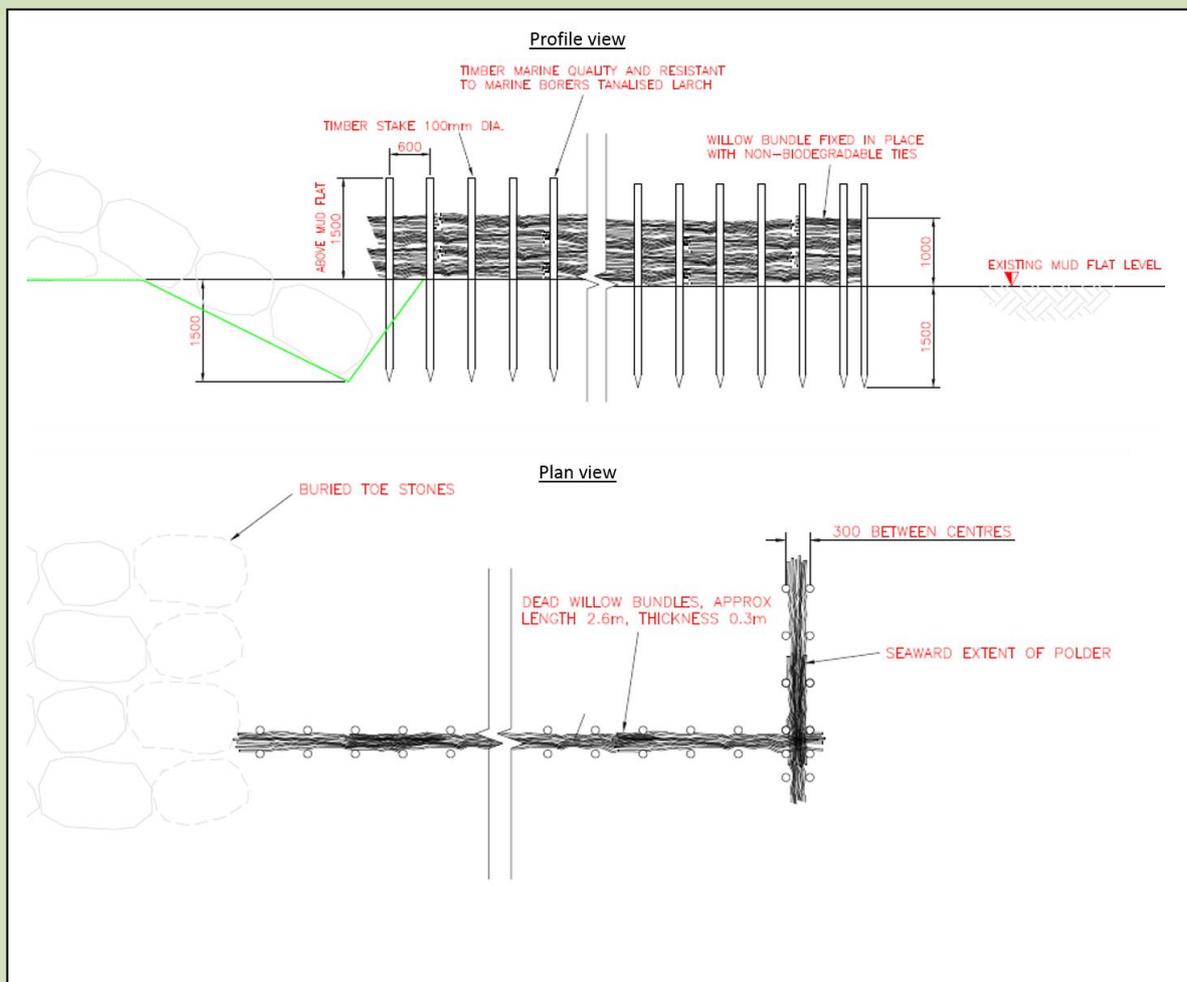
The attempt to encourage silt deposition and allow regeneration of the wharf and increase erosion protection to the wharf scarp was made by placing 2 rows of 3m long tanalised larch stakes at 600mm centres, rows 300mm apart driven 1.5m into the level of the mudflat. Willow bundles were then placed in between the stakes to a height of 1m. The construction drawings are shown in Figure 4.

**Figure 4: Construction drawing for polders (source: Atkins)**

<ul style="list-style-type: none"> <li>Lining of the eroded channels and infilling with block stone and rip-rap at required sites</li> </ul> <p>Use of 2 rows of 3m long tanted larch stakes at 600mm centres, rows 300mm apart driven 1.5m into the mudflat level, with willow bundles between to a height of 1m. This work was an attempt to capture sediment to reinstate the higher level of the mudflats and was carried out over a total length of ~2km.</p>
<b>Standard of protection for project as a whole:</b>	The existing defences were built to a 1 in 200 year standard of protection (thought to be about 1 in 140 year with current sea levels). The works carried out have acted to maintain this standard of protection. A percentage attributed to the WWNP cannot really be quantified.
<b>Estimated number of properties protected:</b>	Rhymney Great Wharf and the defences benefit the entire Wentlooge area (~32km <sup>2</sup> ). The pre-feasibility report states that 1,751 residential properties and 223 non-residential properties are protected (Chung 2006).

In the years since completion, very little damage has been caused to the stone revetment. However, the wood stakes and faggots of the polders have suffered a reasonable amount of damage, the major issue being the loss of willow material from in between the stakes. Although the required remedial work for such issues was stated in the health and safety file, no work has been carried out on the asset to repair the damage caused. This may be a reason why no real accumulation of mud has been seen on the mudflats.

The design of the polders used was perhaps unsuitable for the location given the higher energy environment. Greater success may have been achieved if a higher number of parallel rows had been used within each polder field. A point to take away is that it is difficult to generalise parameters for the appropriate use of soft engineering/NFM methods, especially in higher energy coastal environments. Sites need to be assessed for suitability on an individual basis. There needs to be a greater understanding of the capabilities and limitations of the differing techniques.
