# Case study 61. Pevensey Sea Defences

**Main driver: Improved defences and navigation maintenance**

**Project stage: Ongoing since 2000**

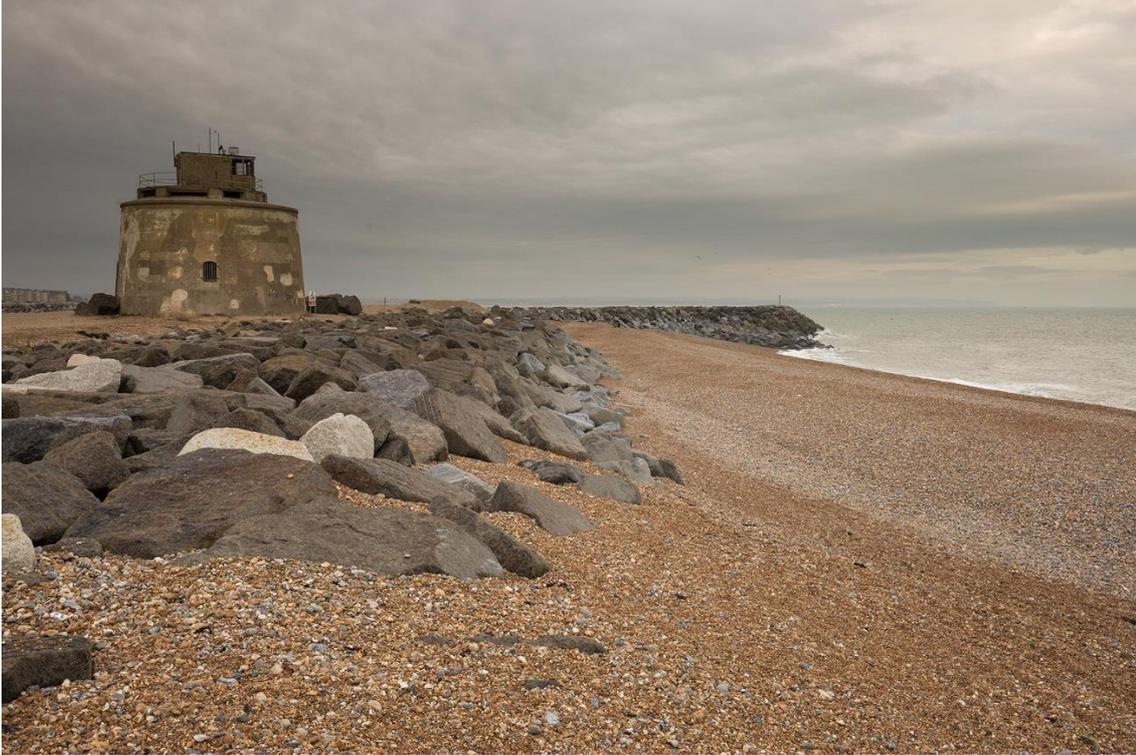
**Photo 1: Beach south of Sovereign Harbour from which material is taken to be bypassed (source: Robert Harvey)**

- Recharge from offshore – as dredged material from Owers Bank (near Littlehampton) is rainbowed onto the beach at the western end of the frontage.
- Bypassing of material accumulated against the southern harbour arm around Sovereign Harbour (Photo 1) by road lorries – some 4,000–25,000m<sup>3</sup> are moved per year with an annual average in recent years of 9,000m<sup>3</sup>. Under the PPP contract, PCD expects to receive 5,000m<sup>3</sup> of material and pays for any over this amount.

The general longshore transport direction moves beach material eastwards along the Eastbourne frontage towards Sovereign Harbour. Before the marina was constructed in 1993, this material would have found its way into Pevensey Bay but some of it now accumulates west of the harbour entrance, in the area between Langney outfall and the southern harbour arm. As the process of longshore transport continues, the beach against the harbour arm would keep growing and eventually spill round the harbour arm and into the entrance channel.

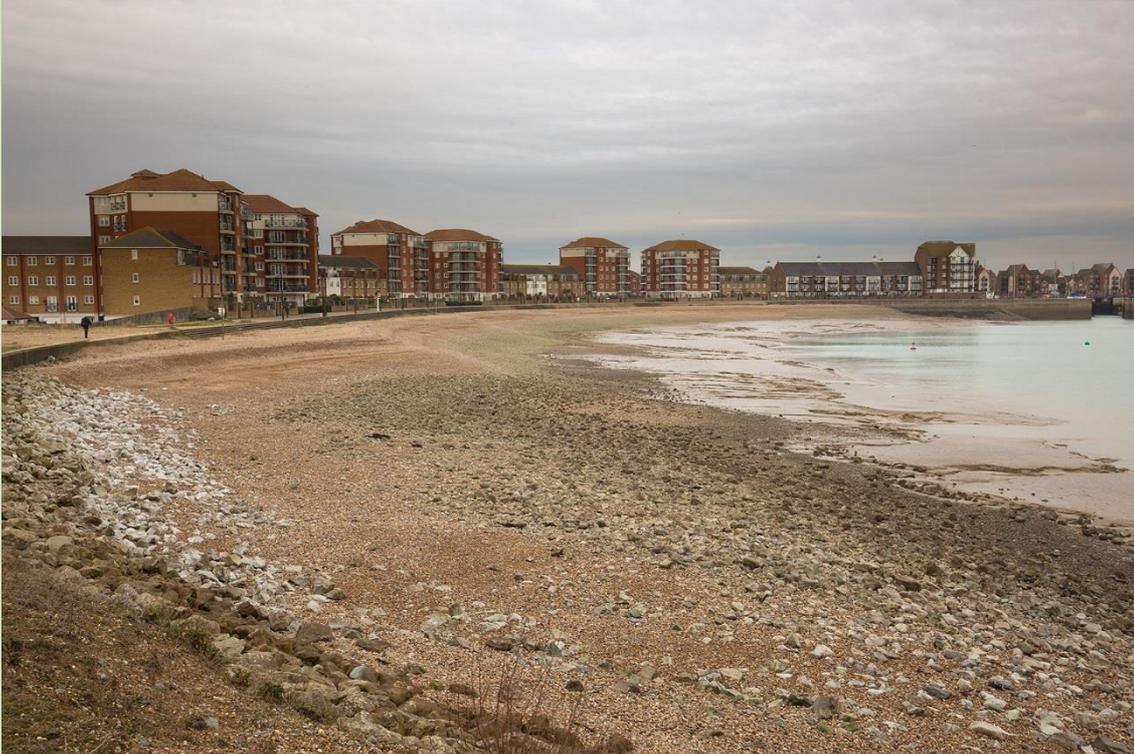
**Photo 2: Sovereign Harbour – material is dredged from the entrance channel (source: Robert Harvey)**

- Dredged material from the navigation channel adjacent to the harbour entrance is deposited on the beach. Although this material is finer than material taken from the beach and generally does not meet the specification for the beach above 0m OD, placing it on the lower shore increases the resilience of the beach. This activity is not part of the PPP contract but has been done in partnership with (and the support of) the Crown Estate, the Marine Management Organisation, Premier Marinas, Boskalis Westminster, Eastbourne Fishermen and Wealden District Council. No additional funding has been sought since PCD has been able to use savings generated from within the contract to cover costs that have arisen. There is no anticipation that the reuse of sand as is currently undertaken will be of direct benefit to the contract in the remaining 8 years, but is being done for the benefit of future coastal management.

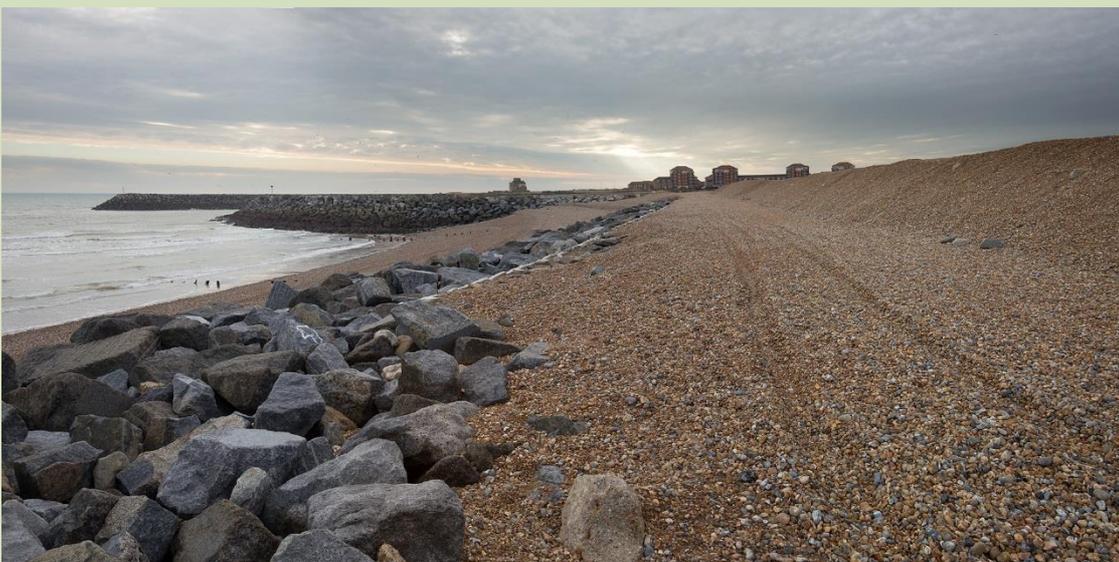
**Photo 3: Beach east of Sovereign Harbour on which bypassed and dredged material is placed, showing stockpile on right (source: Robert Harvey)**

Bypassed material is transported by lorry along an agreed 6km haul route between 1 October and 31 March each year. Typically equipment is mobilised for a 2 week bypassing campaign within this period. Bypassed material is placed either in a stockpile behind the north harbour's rock revetment or added directly to the scour hole at the eastern end of the revetment. The stockpile acts as an emergency source of material; it was last used in winter 2013 to 2014 and has been replenished since then.
