River Tat Restoration Scheme

Installation of woody debris, berms, pools and glides

Tributary and Main River: River Tat, River Wensum

the River Restoration Centre Case Study Series

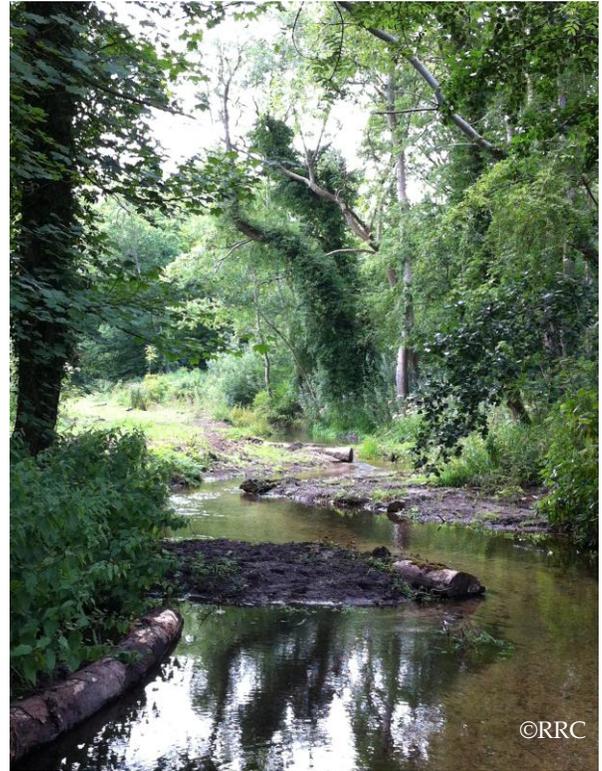
Newly installed berms, increasing sinuosity and significantly reducing the width of the channel in places – August 2013

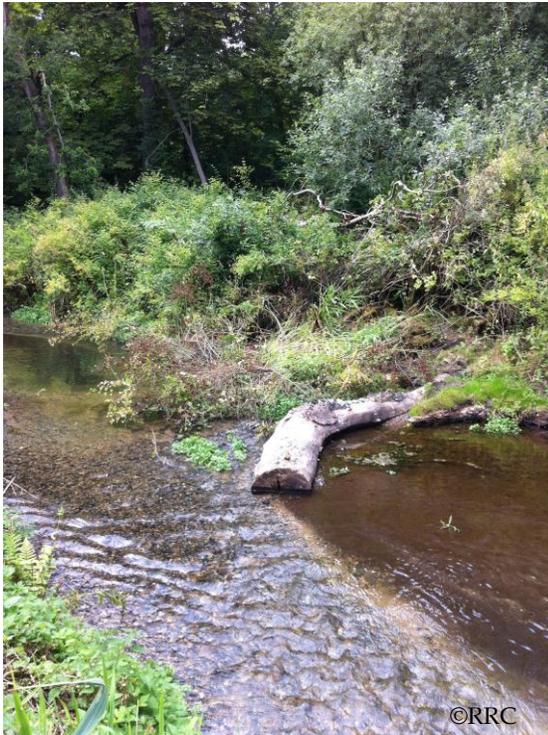
Site won woody debris installed to create flow and habitat diversity. Pool upstream and glide downstream – August 2013

A key restoration measure has been the installation of Large Woody Debris (LWD). Reducing tree cover in heavily shaded areas, by selective coppicing, provides a sustainable source of material. This also allows light onto the river, promoting marginal vegetation to establish. LWD has introduced flow diversity, helping keep the gravels free from silt and providing overhead cover for fish.

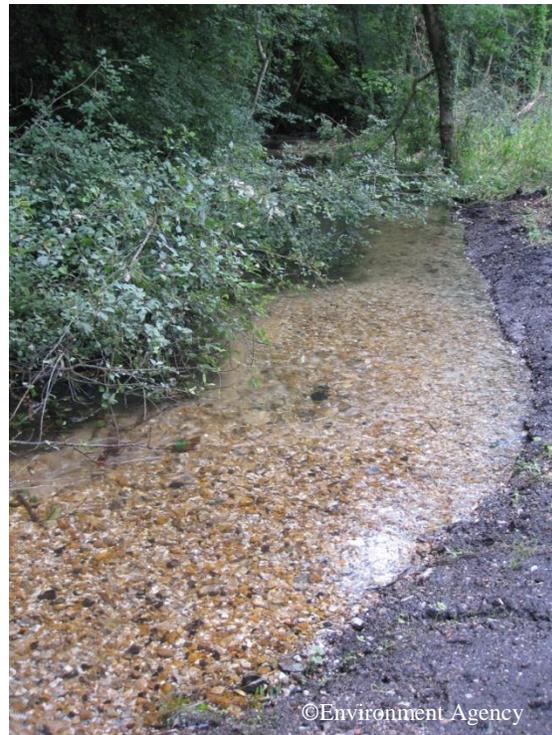
Narrowing the channel has re-suspended silt and sand deposits to expose the underlying gravels – August 2013

In locations where a gravel bed was present, albeit beneath a layer of sand/silt because of the homogeneous character of the water course, gravel glides have been restored by re-distributing the bed material to form glide-pool sequences. The water velocity has been increased by narrowing the channel, using features such as earth berms and woody debris, resulting in a clean gravel bed. Deep pools have been dug to introduce variations in bed levels, providing flow diversity and creating resting areas for fish.

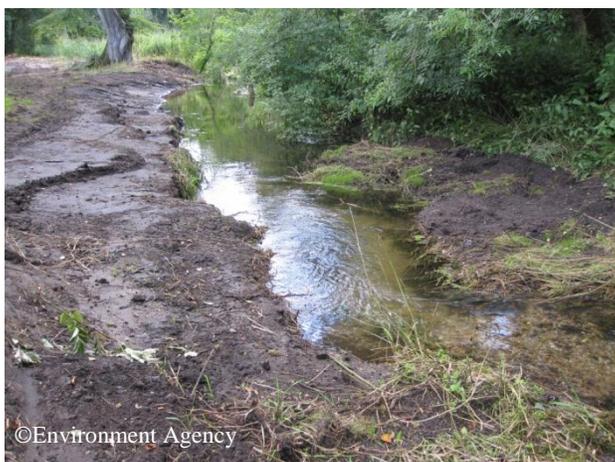
Channel narrowed with earth berms, and steep bank re-graded to encourage development of marginal plant species – August 2013

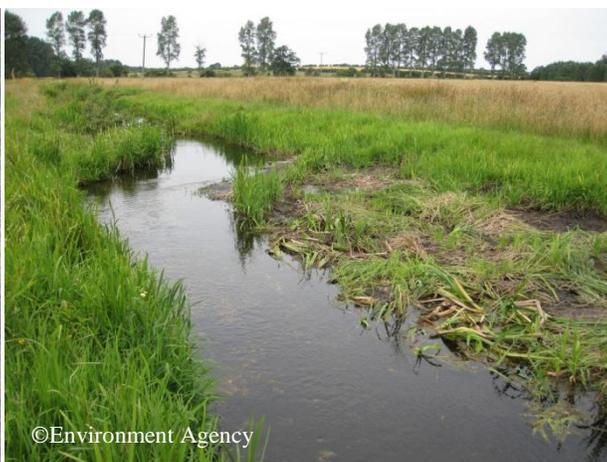
Installation of earth berm, capped with translocated bankside vegetation, to narrow channel and increase sinuosity – August 2013

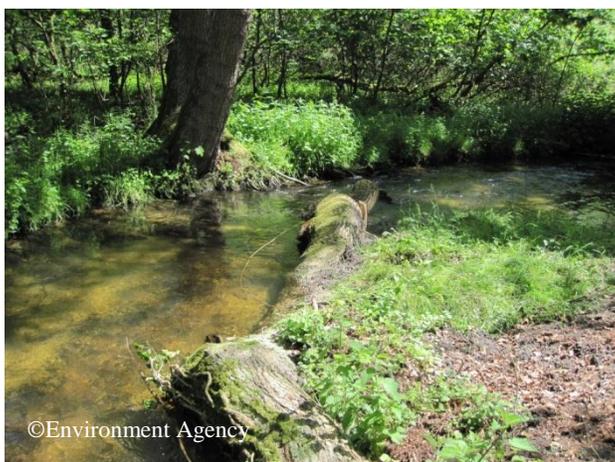
Channel narrowing using oak bough with soil infill on downstream side – June 2013

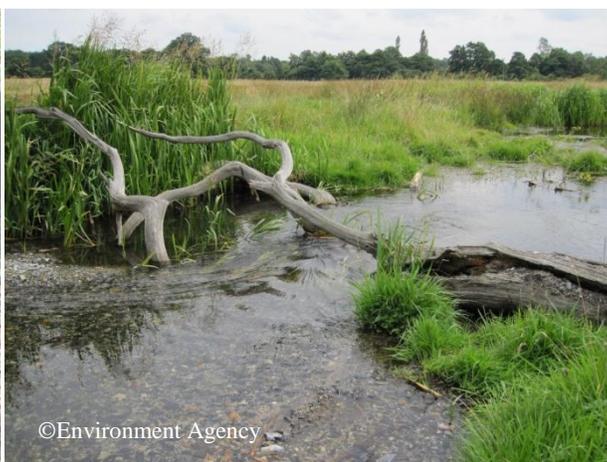
Redistribution of gravel and insertion of woody debris to enhance flow diversity – August 2013
