10.3 Cost-effective silt removal from an impounded channel

RIVER CHESSE

LOCATION – BLACKWELL HALL, LATIMER, BUCKINGHAMSHIRE SU 980997

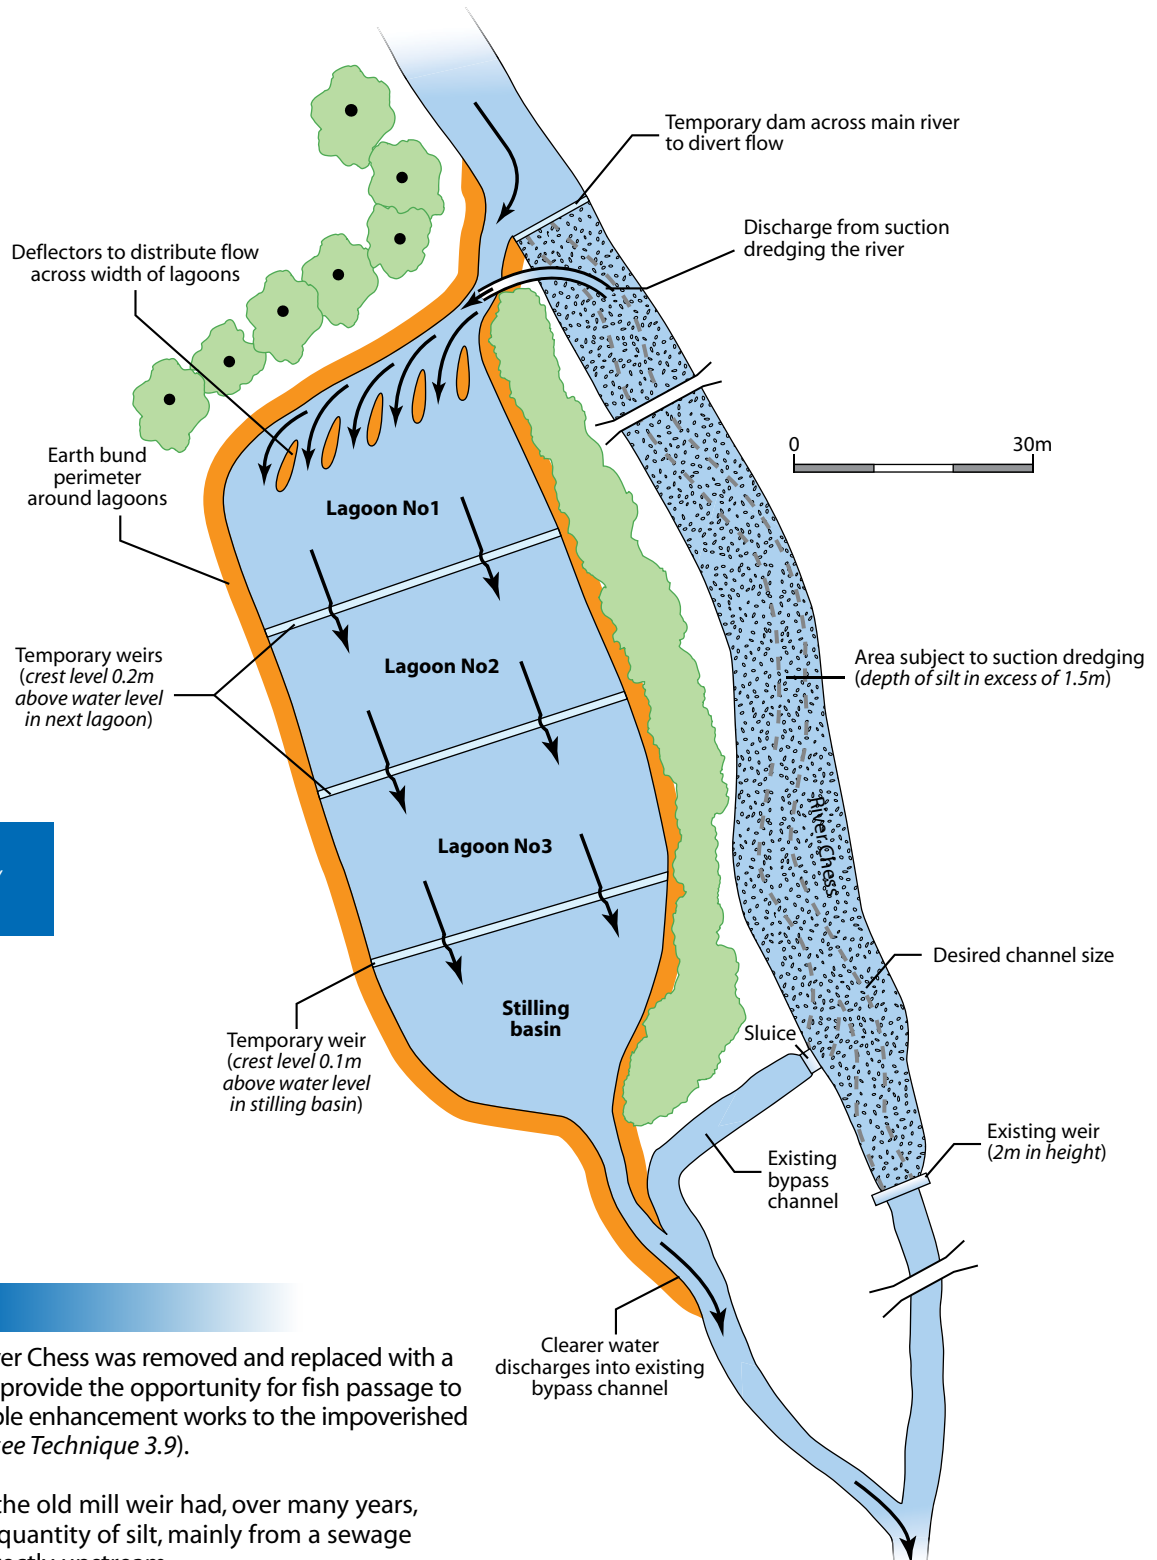
Figure 10.3.1

PLAN OF TEMPORARY
SILT TRAP LAGOONS

The silted river was temporarily dammed and de-watered via the old mill bypass sluice. The river was diverted via a bunded inlet channel through the 'silt-trap'. To remove the large volume of saturated silt, suction dredging was used, the discharge being pumped into the first lagoon. The silt laden river water proceeded through the 3 lagoons depositing its silt load before ultimately rejoining the existing bypass channel.

Retention time within the silt-trap was approximately 2-4 hours. In this way 1300m³ of excavated and suspended material was removed from the stream. The area of field used was circa 3000m² resulting in a maximum increase in height over the field of circa 0.2m.

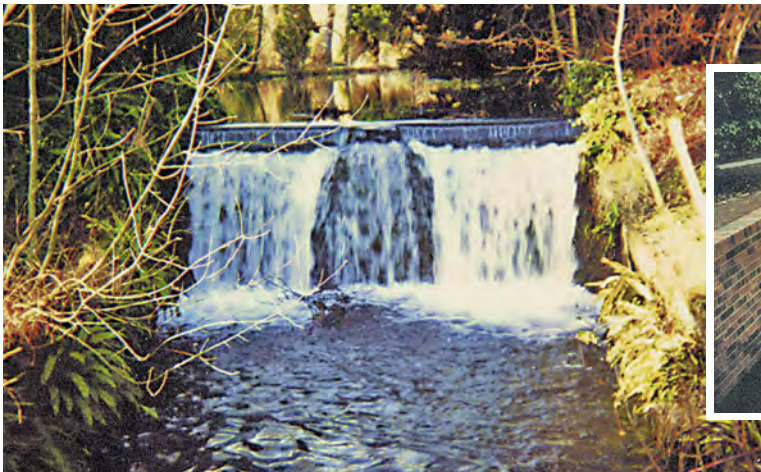
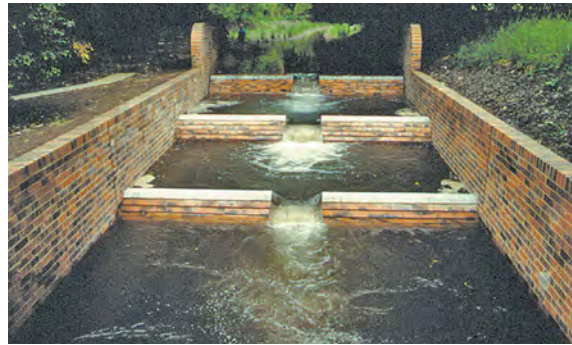
Mill weir and replacement fish-pass

A mill weir on the River Chess was removed and replaced with a fish-pass. This would provide the opportunity for fish passage to be restored and enable enhancement works to the impoverished channel upstream (see *Technique 3.9*).

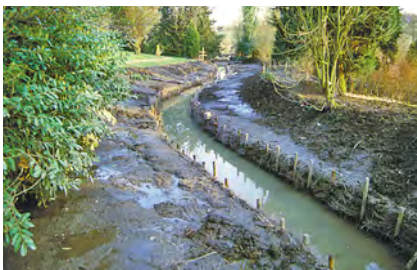
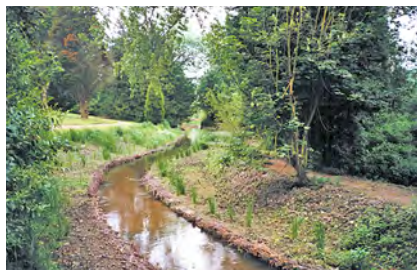
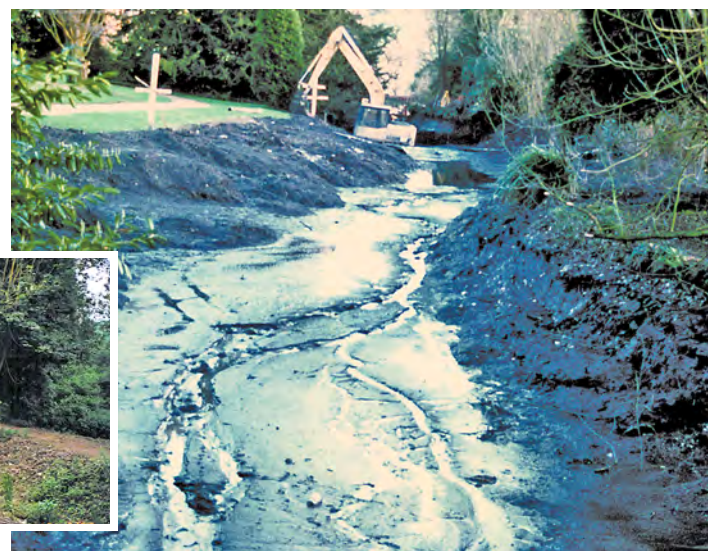
Main Photo (Top right): Exposed silt, looking towards mill weir.
Inset above left: Dredged. Inset above right: 4 years later

By lowering the water level, sufficient gradient was returned to the river to re-form a narrow sinuous channel within the previously deep over-widened and ponded section. The impounded channel size needed to be drastically reduced, both in width (8m to 2m) and in depth (in places silt was up to 1.5m deep).

To achieve this the accumulated silt retained by the old weir had to be removed. In order to avoid moving spoil off-site the dredged material was incorporated into an adjacent grass field. Removal off-site of such material is often expensive and, if sent to a landfill site, unsustainable.

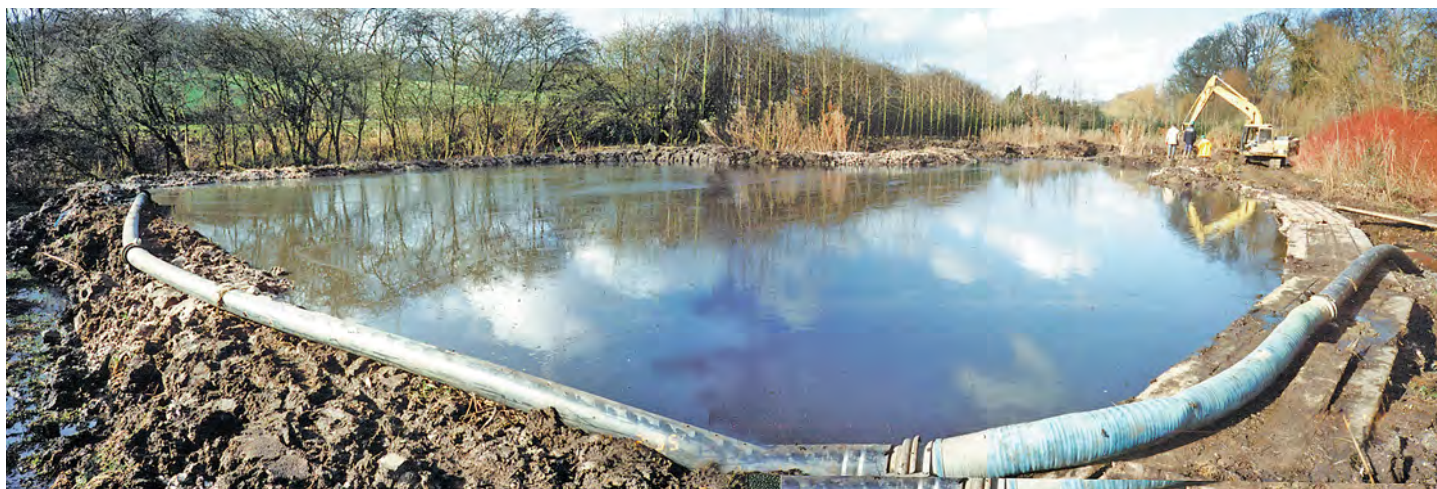
Lagoons and stilling basin – February 1995

Using an excavator a series of low bunds were constructed in the adjacent field. The earthworks followed the fall in land levels to allow gravity flow. These bunds formed three shallow lagoons and a stilling basin. The first lagoon incorporated deflectors to ensure an even distribution across the width of the lagoon. The lagoons were separated by low temporary earth weirs (Figures 10.3.2 and 10.3.3).

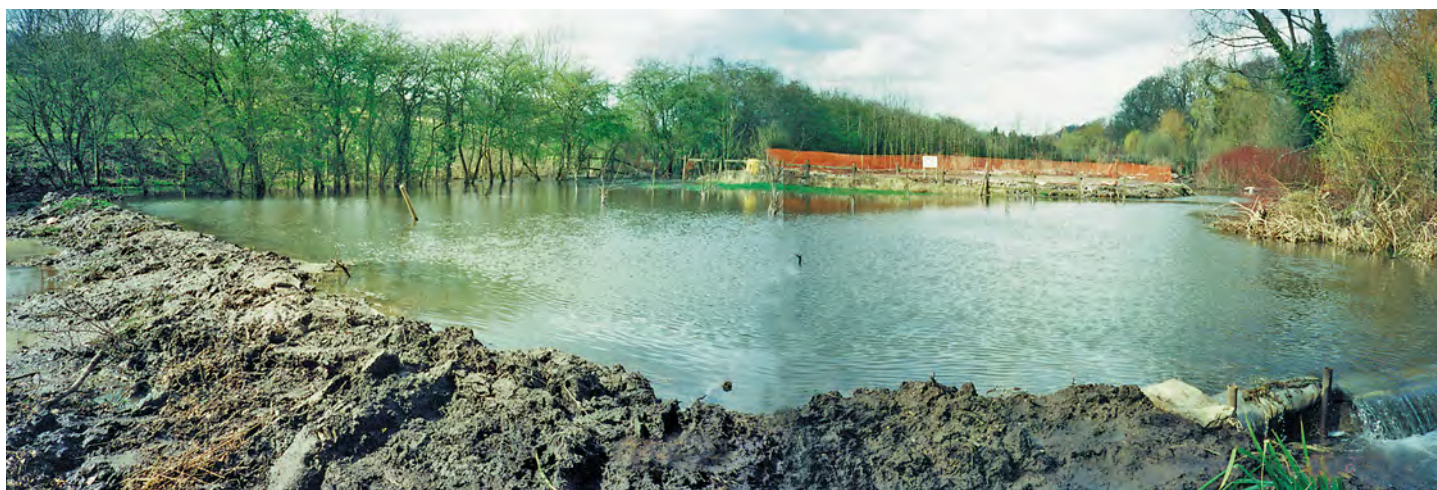
Lagoons, stilling basin and overspill – March 1995

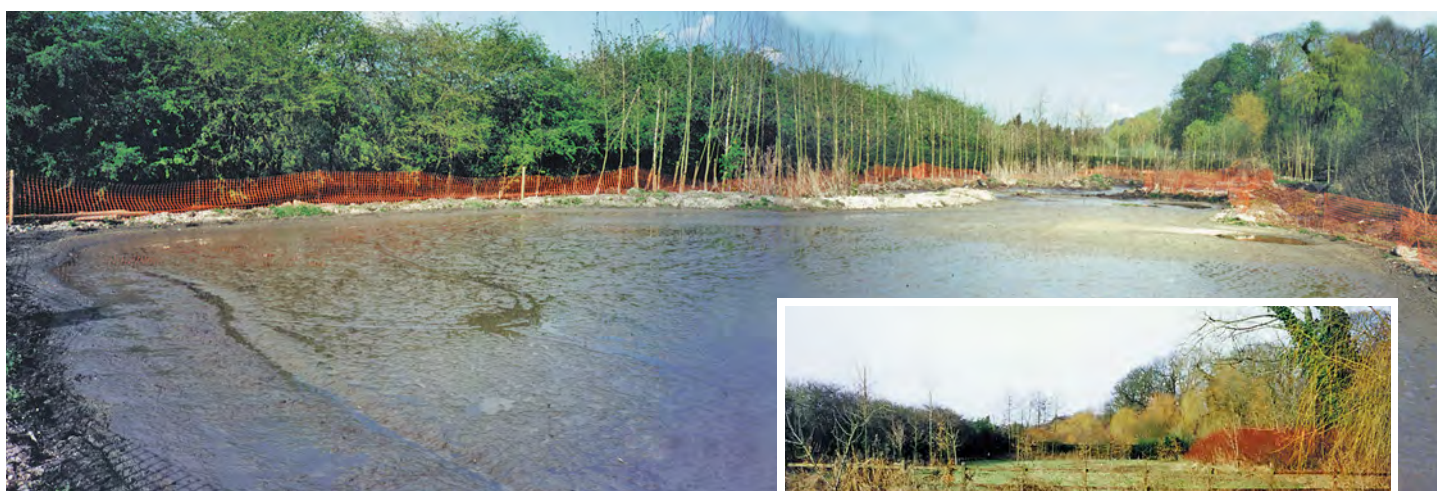
Retained silt load – April 1995

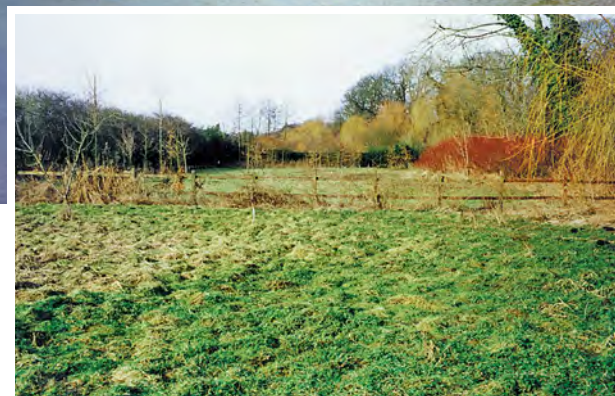
As a grass field 4 years later

Now fully grassed over, the field is not noticeably out of character. Indeed it appears to be a normal field.

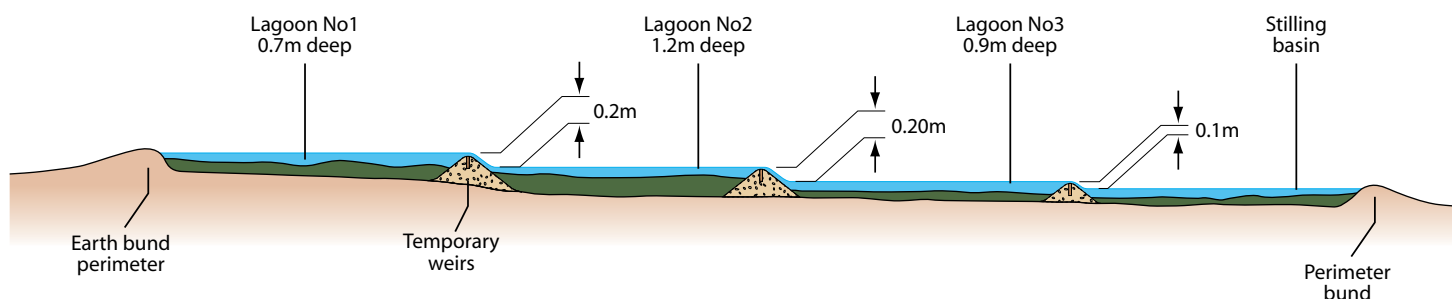
Figure 10.3.2

TYPICAL SECTION THROUGH LAGOONS

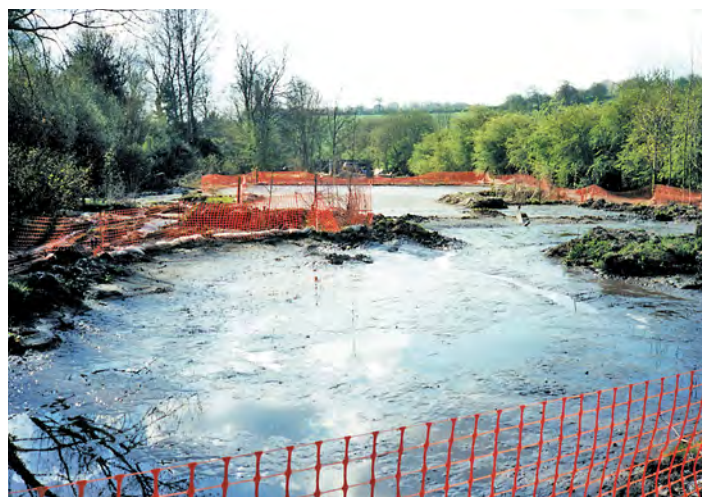
Figure 10.3.3

TYPICAL DETAIL OF TEMPORARY WEIRS

Dewatering. View from inlet channel – April 1995

The silted lagoons were allowed to de-water for 1 month and the temporary weir materials (tarpaulin and sandbags) removed. The silt and earth bunds were then flattened and graded into the field. The surface was hand raked and the whole area grass seeded with a meadow mix.

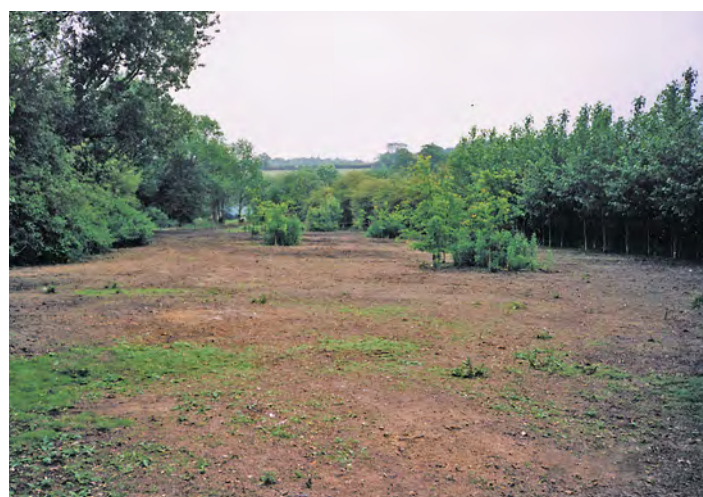
Graded, harrowed and seeded – June 1995

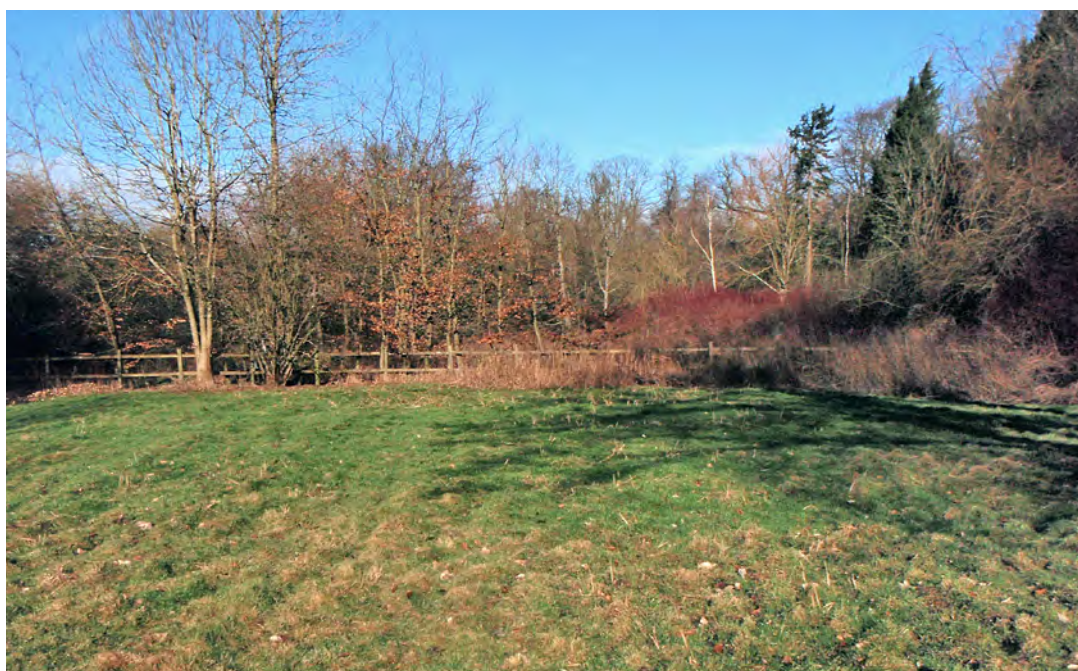
The field 18 years after works
– 2013

A RRC visit in 2013 confirmed that the site continues to function as a normal field, further demonstrating the benefits of using this technique where this is a necessary requirement. In some areas the vegetation is dominated by nettles (*Urtica spp.*), however this is not uncommon where there is a large amount of silt as nutrient levels are high.
