11.1 Diversion of a River Valley

SUGAR BROOK

LOCATION – MANCHESTER AIRPORT SJ7981

DATE OF CONSTRUCTION – 1998

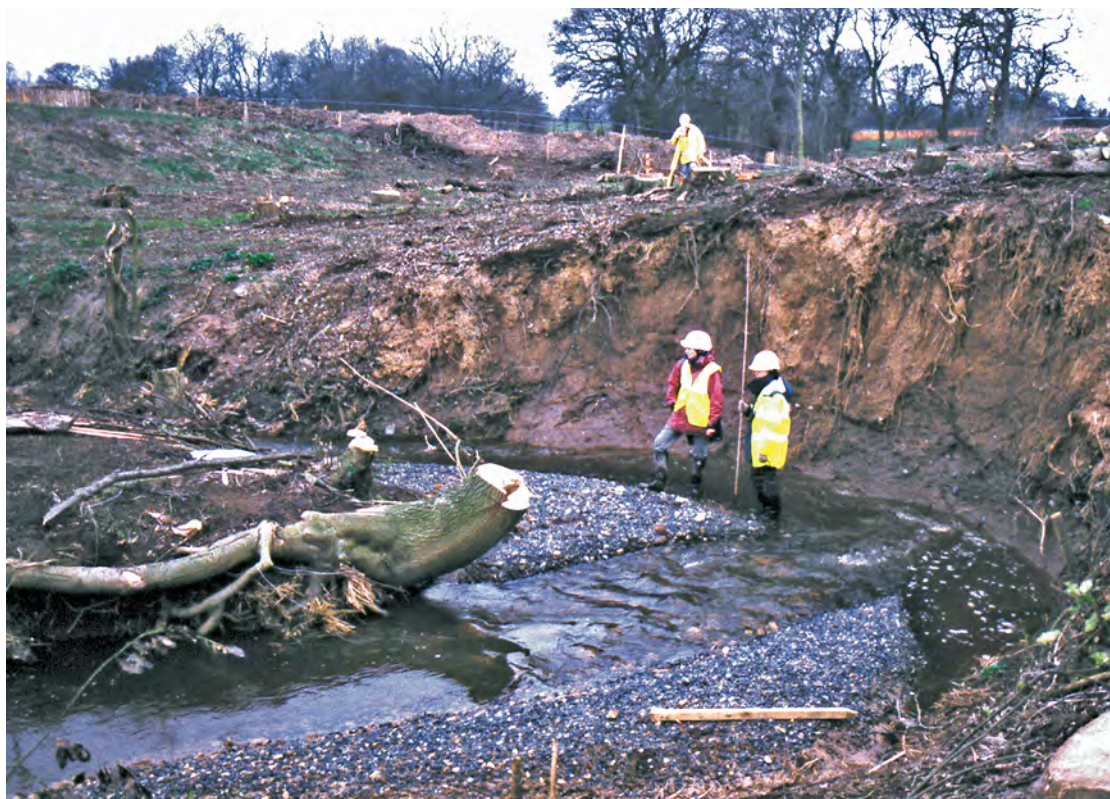
Sugar Brook before culverting, a reference site for the new channel

A new approach to design was needed which recognised that the formation of the valley within which the brook naturally flows involved different geomorphological processes than those that sustain the small watercourse that is incised within the floor of the valley. Inspection of the undisturbed reach just downstream of the airport demonstrated a narrow rounded valley formed during glacial retreat with a fairly flat bottom of more recent fluvial sediments through which the brook course meandered. Cross-sectional templates were taken from this reference reach and used to design the new valley.

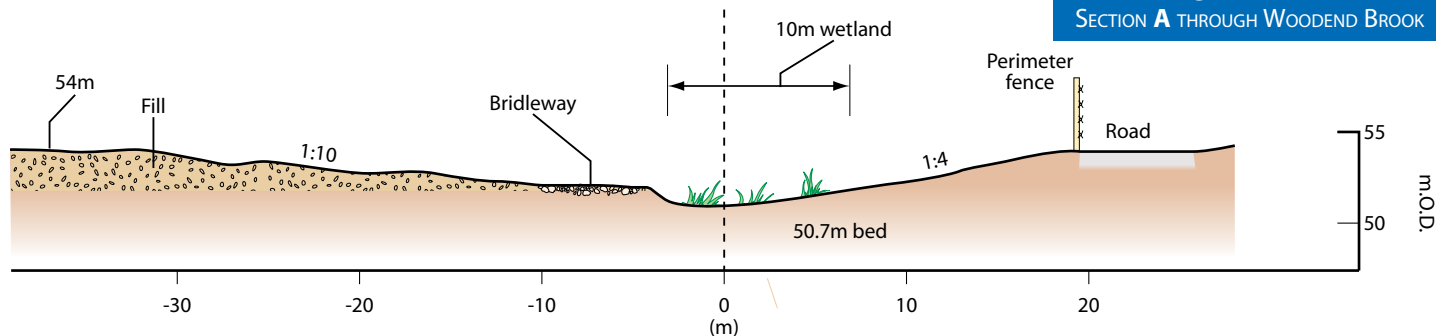
Figure 11.1.2
SECTION A THROUGH WOODEND BROOK

incised course in the new floor but has been encouraged to form a wetland across its full width of around 10m (Figures 11.1.2). Natural channel incision is expected to develop slowly.

The manner in which the new valley side slopes were shaped was carefully excavated to mimic natural profiles which vary from concave, where ancient soil slips have arisen, to convex, where they have not. The mean slope associated with concave (slipped) profiles is likely to be flatter than when convex, creating desirable variations and mild sinuosity when looking down the valleys. Compound slopes involving both concave and convex slopes were also incorporated. Three cross-sections A, B and C indicate these variations which are also apparent on the photographs.

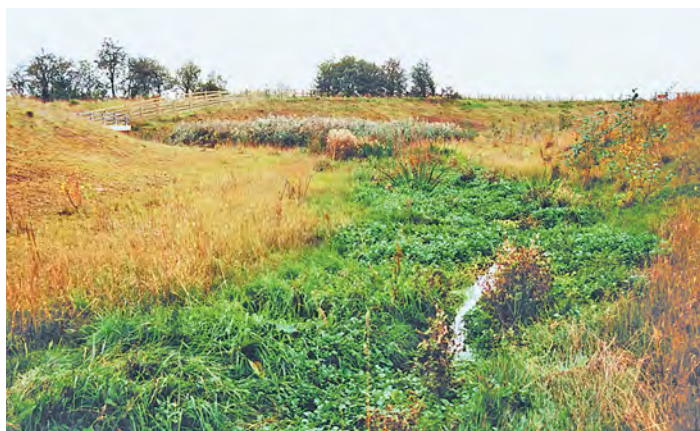
Woodend Brook

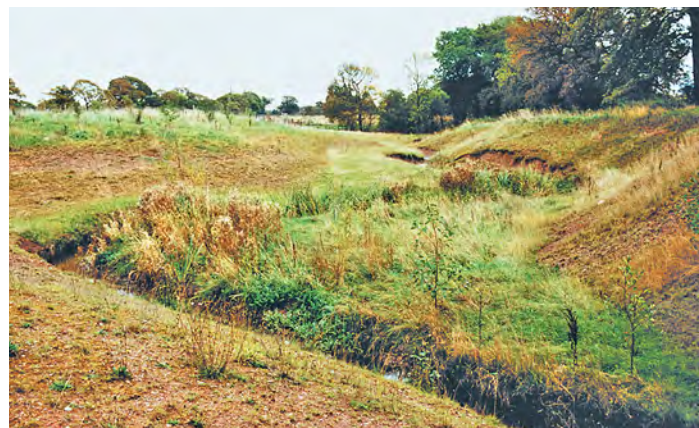
Sugar Brook looking upstream

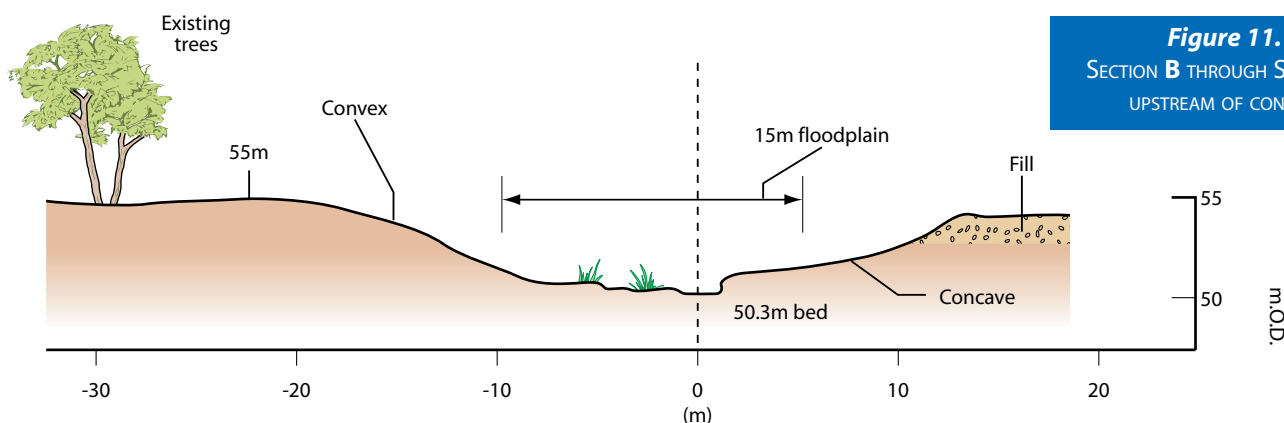
Figure 11.1.3
SECTION B THROUGH SUGAR BROOK
UPSTREAM OF CONFLUENCE

The meandering plan form of Sugar Brook, which is cut into the valley floor by up to 1m only, was strongly influenced by templates of meander patterns elsewhere on the brook (Figures 11.1.3 and 11.1.4). Woodend Brook does not feature an

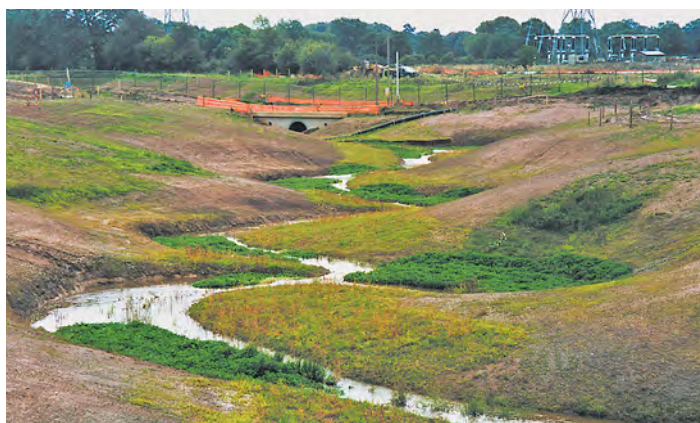
Sugar Brook Valley below confluence – September 1999.

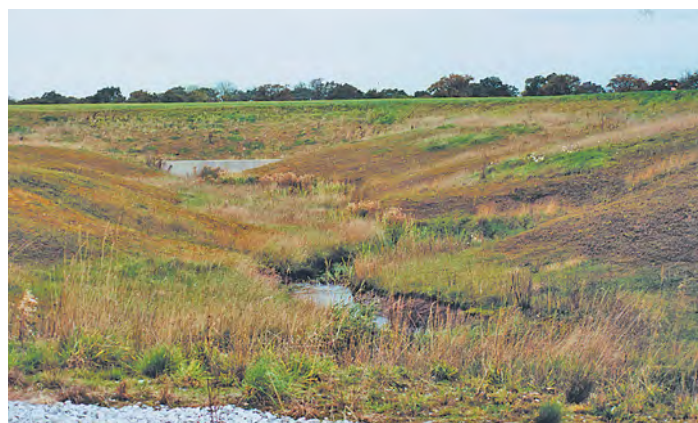
The river valley vegetation is developing well – November 2001.

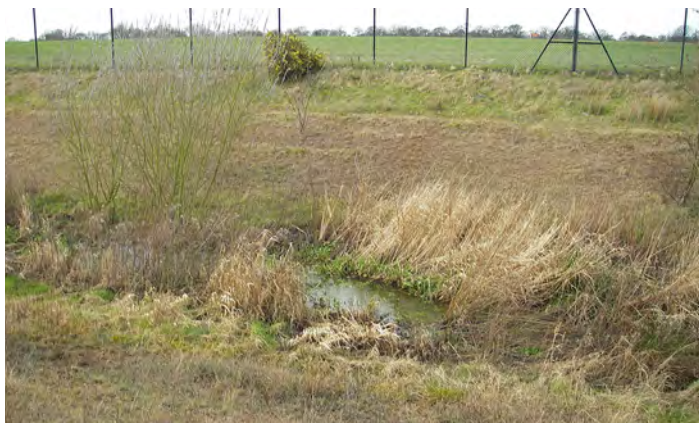
Looking upstream from the footpath bridge – July 2013

The self sown willow and alder mentioned in the 1998 – 2001 subsequent performance have now grown into a dense cover of trees. The photograph taken in 2007 shows the saplings growing along the bank and the more recent photograph taken in 2013 indicates that the channel is now completely shaded by this tree cover.

The channel would benefit from some sympathetic tree thinning to allow at least some daylight to penetrate through to the channel.

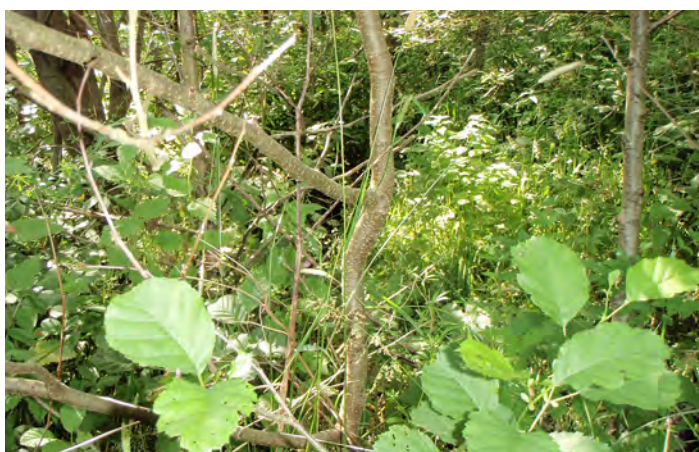
Looking upstream from the footpath bridge – March 2007

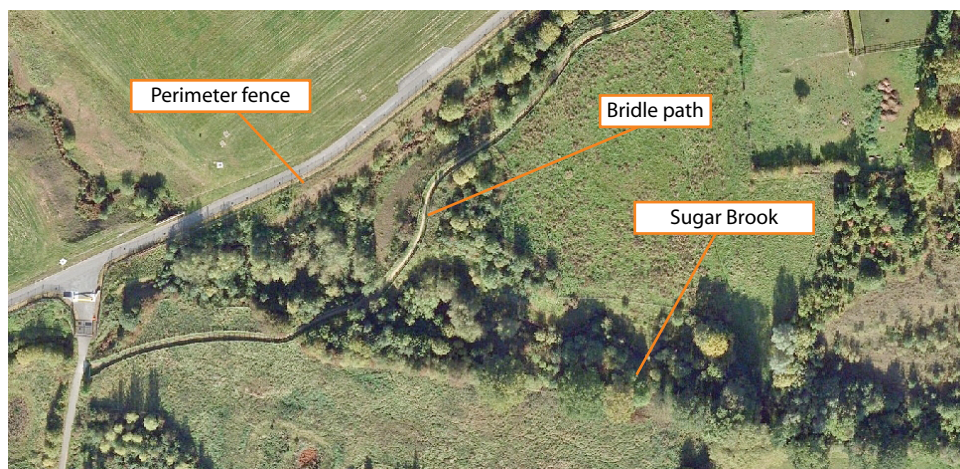
Aerial photograph of Sugar Brook showing dense tree cover
