> Stone Riffle downstream of Hutton Avenue footbridge

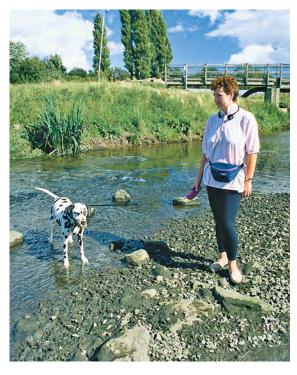
The riffle allows easy access down to the river – November 1996

Of particular note is the popularity of this spot with children who can gain safe access to the river and paddle in the shallow water, where the bed is firm and stoney.
