Enhancing Straightened River Channels

3.4 Radical re-design from uniform, straight channel to a sinuous, multi-channel river

RIVER ALT

LOCATION – KNOWSLEY, LIVERPOOL, MERSEYSIDE SJ435927

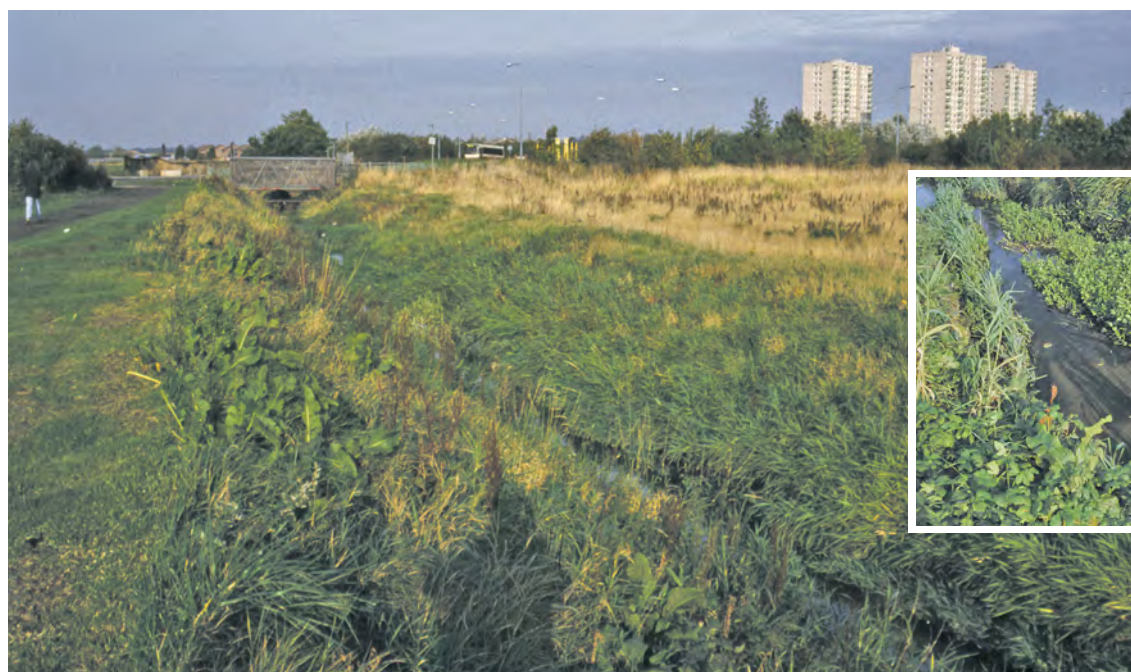
Before:
The Alt, straight
and steep sided

Bed dominated
by silt

The river flows beside a road and was constrained within a trapezoidal channel. Dense bankside growth often hid the small watercourse. An existing footpath on the left bank was set back from the river. A result of disposal of excavated material from the original construction of the course, the immediate bank was at a higher level than the surrounding land, effectively shielding the river from view.

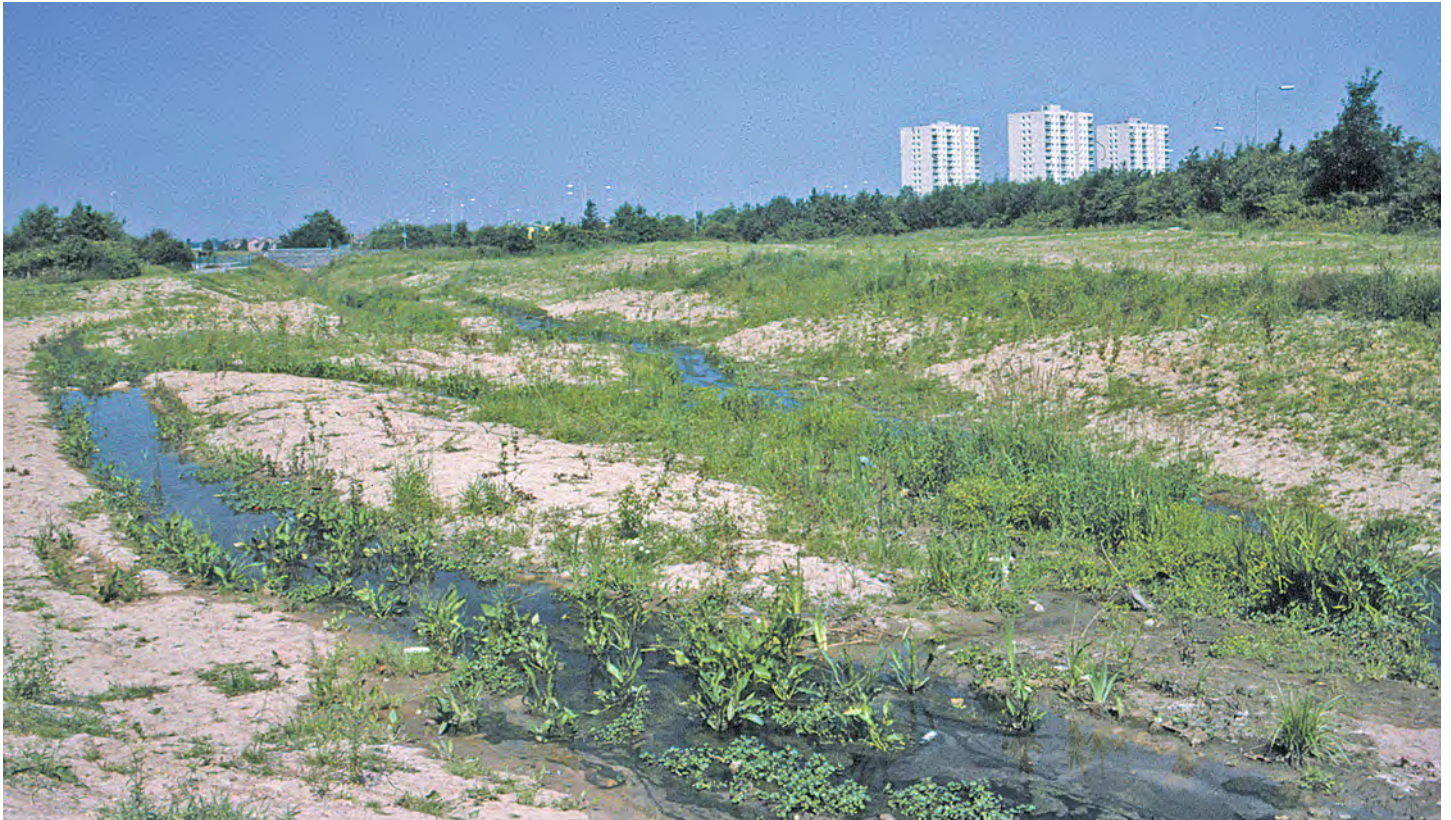
The excavated 'floodplain' area

The 1.5 metre 30 degree banks were excavated back on either side of the existing course, creating up to a 30m width of 'floodplain'. This work was carried out over 140m. The 'floodplain' comprises a 'main' channel and several braided channels separated by marginal berms. In order to achieve a matrix of channels, standing water and damp areas, interspersed by trees and shrubs, ground levels needed to vary. Due to the uncertainties of ground condition and in order to work with the natural conditions as much as possible, this was supervised on-site to avoid over-specification on the design drawings, and to allow for adjustments as necessary.

The final bank profiles were as shallow as 1:25, connecting the low lying adjacent land by removing the existing raised edge. For a length of 50m the redirected footpath now cuts across the shallow bank slope bringing the public closer to the watercourse.

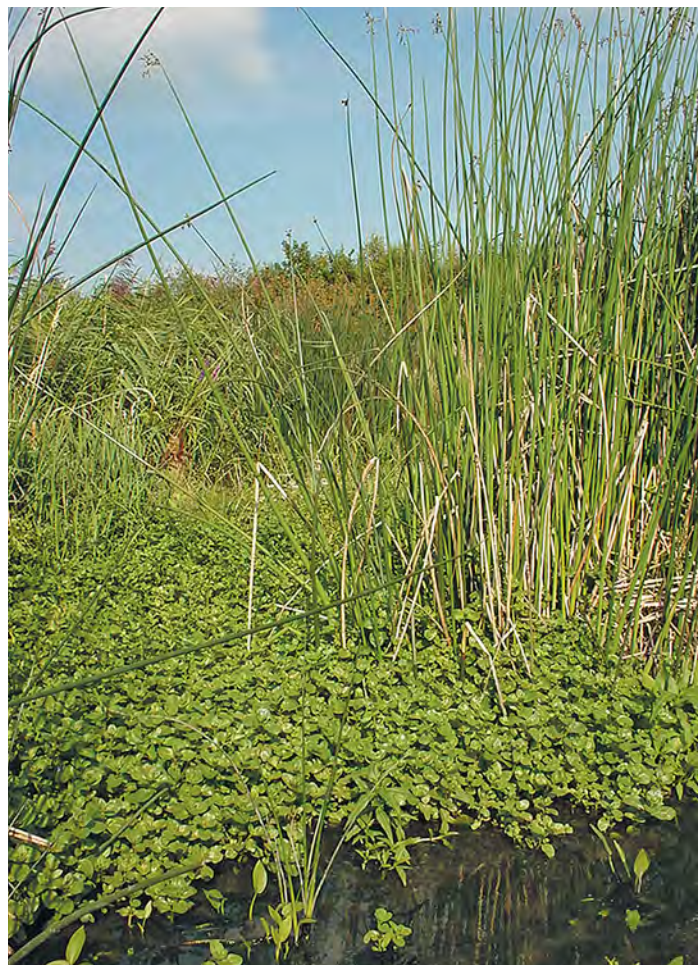
A good diverse vegetation structure has developed along and between the channel threads

The shallow berms separating the braids and main course were planted with various riparian species rather than relying on natural recolonisation, as there was little natural seed source upstream. In addition on some of the higher berms willow was planted to provide extra cover. A native grass and wildflower mix was used for the banks.

The planting has been successful, with the exception of some of the shrubs on the riverbank which were removed.

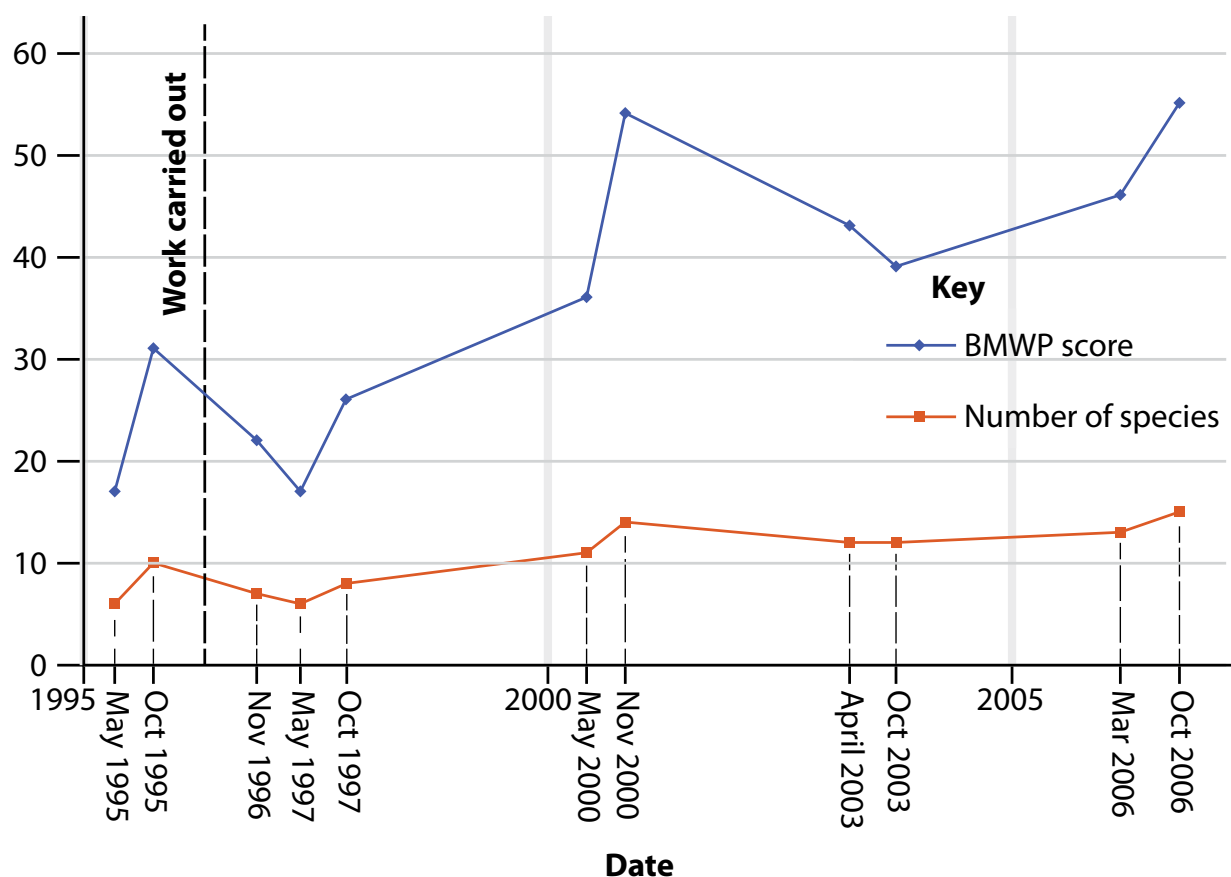
(Stock Bridge Site, SJ 43210 92717. EA data)

Changes to overall number and diversity of invertebrates at the downstream end of the site between 1995 and 2006.

Water quality and invertebrate sampling was undertaken between 1994 and 2006 and indicates that there has been an overall improvement in the number and diversity of macroinvertebrates at the site. Further to the improvements in water quality, noted in 2001, the Biological Monitoring Working Party (BMWP) scores shown below indicate that water quality downstream of the site has improved following the works. The BMWP uses invertebrates as biological indicators of water quality. A high BMWP score is indicative of cleaner water.

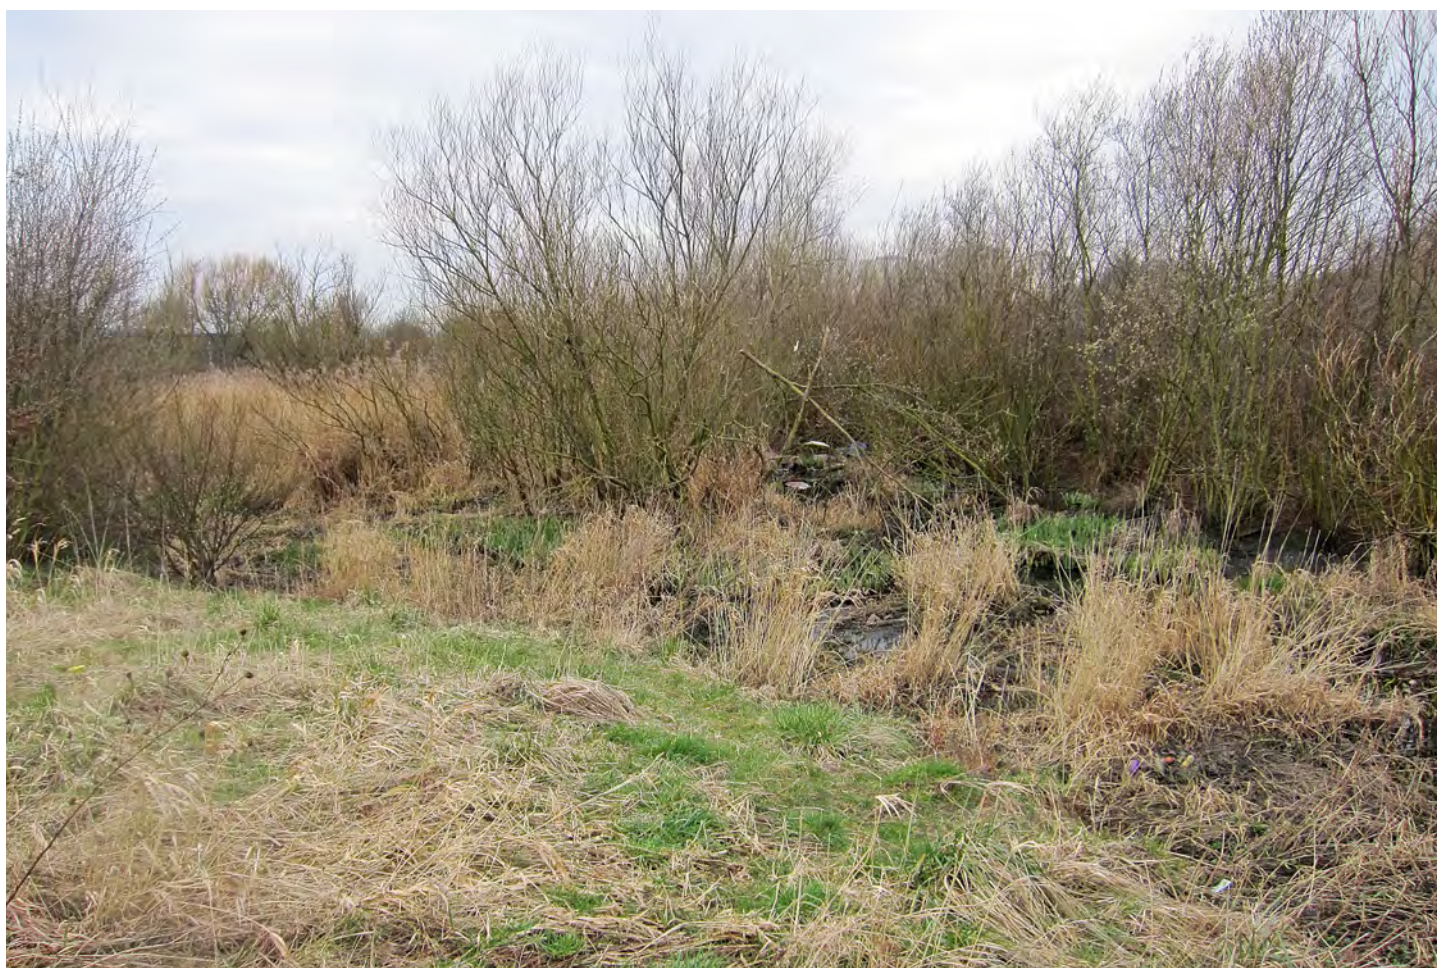
One of the choked braided side channels – March 2012

The initial earthworks have led to access and recreation improvements along this stretch of the Alt. Common reed (*Phragmites australis*) has been able to develop reinstating a locally rare habitat and increasing the biodiversity potential of the river at this location. Biodiversity within the braided section of the channel has been limited by reedbed monoculture. The encroachment of the reedbed has reduced velocities thereby increasing siltation and reducing flow variation as a result.

Minimal management has been undertaken since the project works and is limited to debris clearance at the road culvert downstream. As a result the wider area is heavily shaded by willow (*Salix spp.*) and alder (*Alnus spp.*) tree cover. Bramble (*Rubus fruticosus*) is also dominant over much of the site. In 2012 Knowsley Metropolitan Borough Council (MBC) carried out improvement works on the riparian corridor and re-opened the choked braided side channels as part of the 'Knowsley 2020' project. Tree works on the over steepened banks immediately upstream of the site were also undertaken. The council has been advised not to plant further willow and alder trees but
