# Revetting and Supporting River Banks

## 4.9 Brushwood mattress bank stabilisation on a tidal river

### RIVER ROTHER

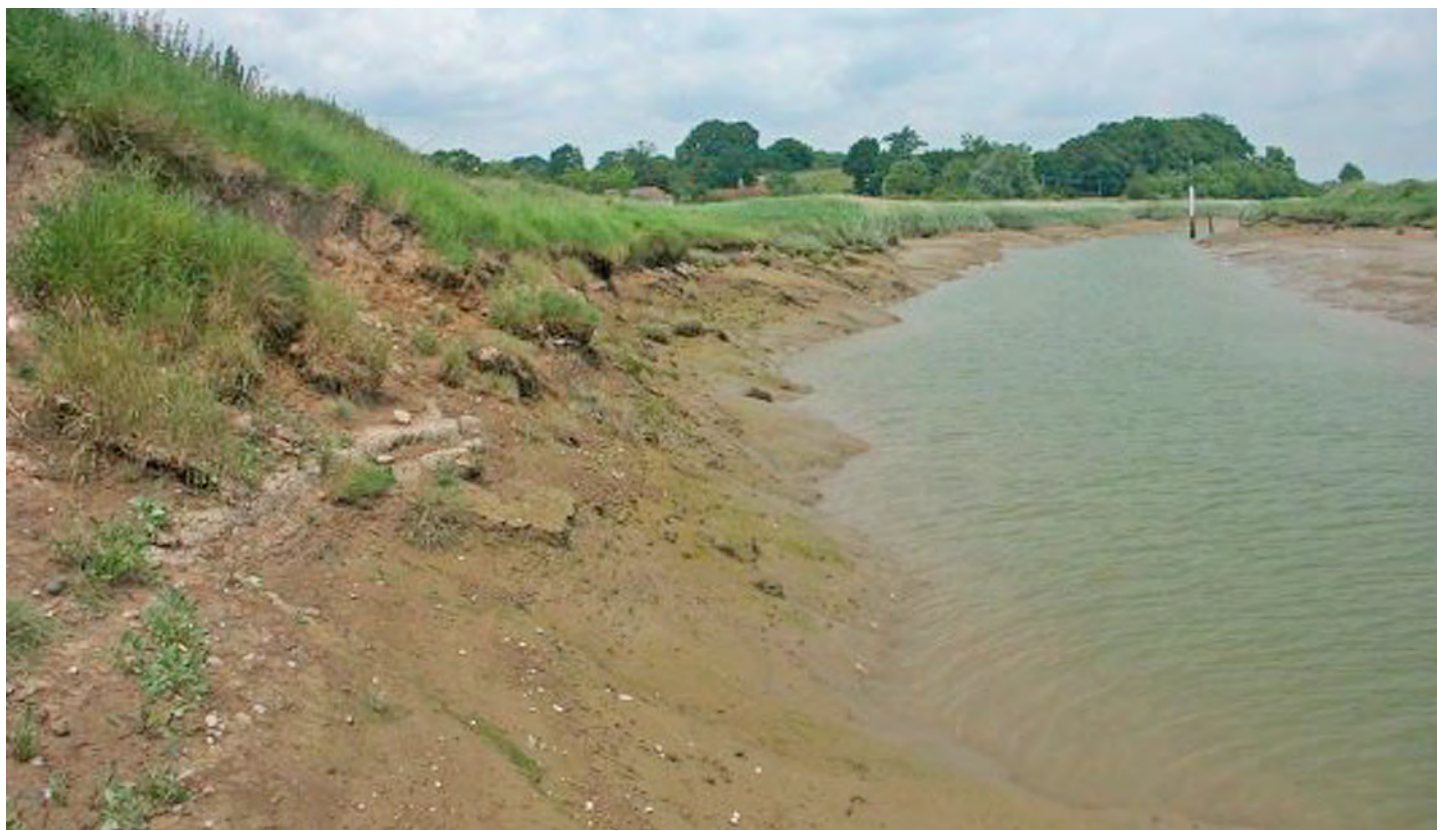
Rother embankment erosion threatening to cause a breach, prior to restoration works – 2004

This tidal section of the River Rother has undergone many centuries of river management for land drainage and navigation. The channel is characterised by long stretches of deposited littoral sediments. These preferentially deposit on the inside of meander bends with resultant erosion through rotational slips on the opposite (outer) banks. In some places breaching of the flood embankment is a concern.

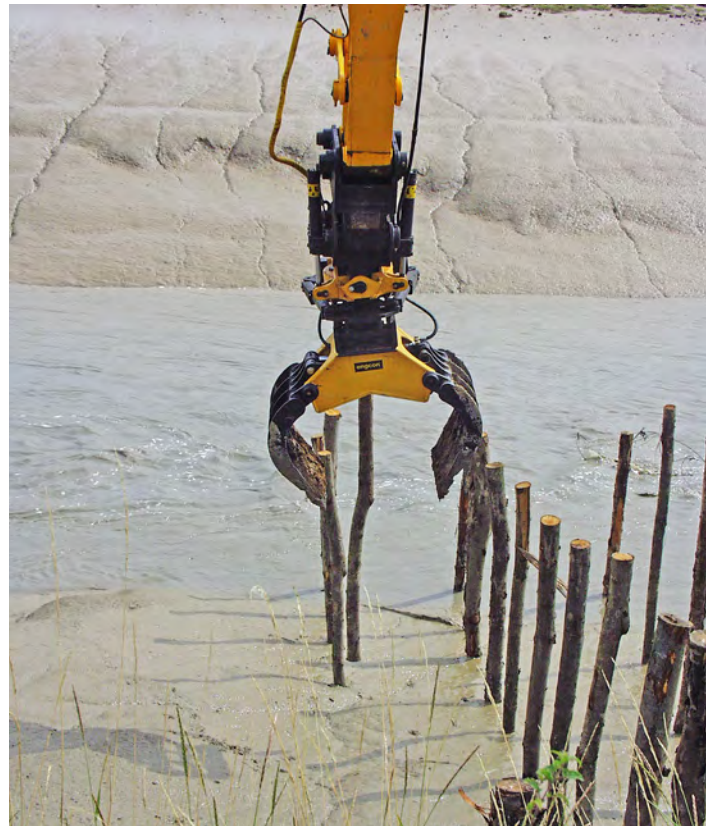
Installation of a matrix of sweet chestnut posts to secure the brushwood mattress – 2005

Hardwood sweet chestnut (*Castanea sativa*) posts were used (minimum diameter of 0.125m). These ranged from 2.1m up to 4.5m in length to allow for the variation of the eroded bank profile and to ensure that at least 1.5m of each post was driven into the bank. The posts were installed in a 1m grid along a 200m section of bank, with an average width of 11m (see Figure 4.9.1) by a long-reach excavator. A hazel (*Corylus avellana*) brushwood mattress was then laid between the posts, using 3m to 4m long brush. Brush was installed to extend slightly beyond the last posts at the toe of the structure, to encourage sedimentation in this critical area by increasing roughness.

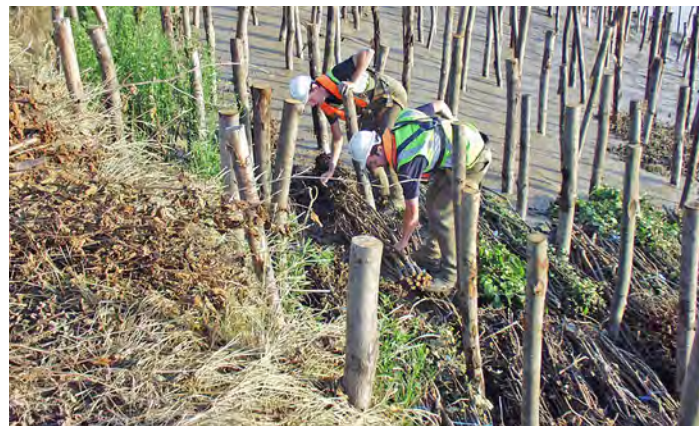
Brushwood laid between posts to form a matrix to trap suspended sediment – 2005

The brushwood created walkways and safe access across the site. Hexagonal galvanised rock netting (generally used on rock and chalk escarpments to prevent rock falls) was stapled to the posts across the whole surface of the structure to prevent any brushwood being lost whilst silt was depositing. Completing this as soon as possible was essential to minimise the risk of the structure failing during construction in the event of an extreme tidal event occurring before the whole structure was stabilised. The final slope of the repaired bank had a design angle averaging 40°.

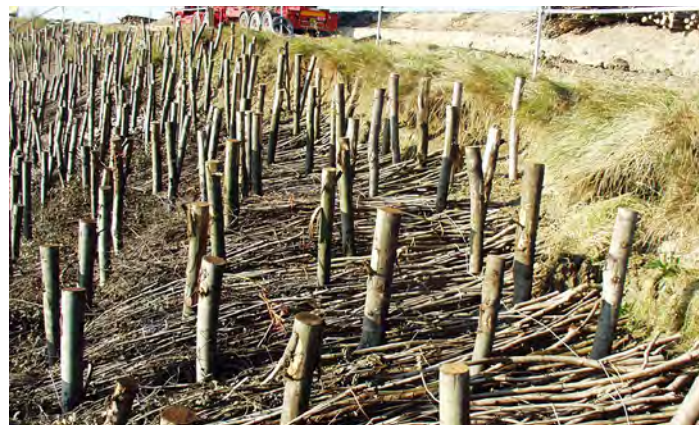
Once brushwood mattress installation is complete, rock netting is secured to the posts to prevent wash out – 2005

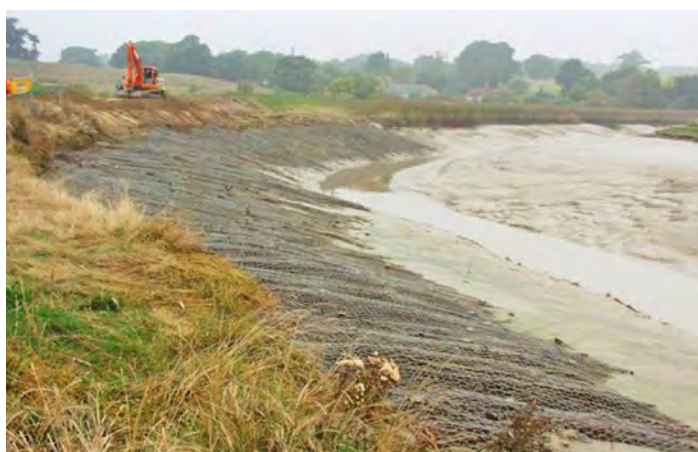
Section of bank post-restoration showing successful accretion of sediments across most of the structure, with some netting still exposed – 2005

Some of the brushwood became compressed by the weight of accreted sediment, leaving the netting standing proud above the brushwood. Cutting holes in the netting around the posts would enable it to settle with the compressed brushwood.

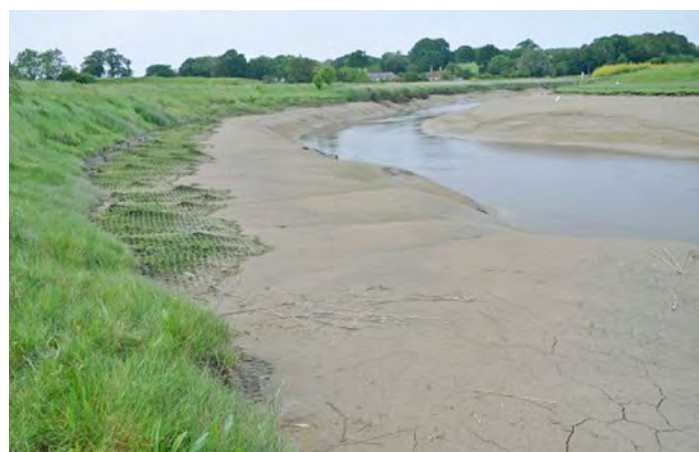
Seven years post-restoration the structure has continued to retain sediments and has been stabilised further by vegetation on the upper bank – June 2012

Fixed point photography has shown that after seven years this technique is continuing to prevent erosion, with vegetation developing well, especially at the top of the bank.
