5.5 Raising river bed levels

RIVER UPPER KENNET

LOCATION - RAMSBURY, WILTSHIRE, SU28317152

Date of construction - 2nd October - 20th October 2000

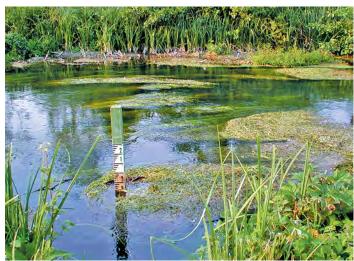
Flinty gravel used to narrow and raise the river bed

The material used to shallow the channel depth was chalky and gravel flints. Where possible it is advisable to use material from the immediate area to reflect the type of bed that would have been present under natural conditions. Here the gravel fill was excavated from the floodplain by the creation of an adjacent pond on the right bank. The suitability of the material was checked beforehand by the inspection of machine excavated trial pits. Infill material was predominantly a mixture of gravels and flints varying in size from 0.02m to 0.01m, with <5% coarse sand and minimal silt. A few larger flints were also present.

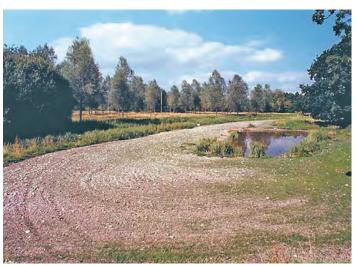
New pond with early growth, showing the gravelly nature of the floodplain material

The associated pond, from which material was won, was re-profiled to give shallow margins and bank slopes. It was planted with emergents excavated from the channel, and additional native wetland species.

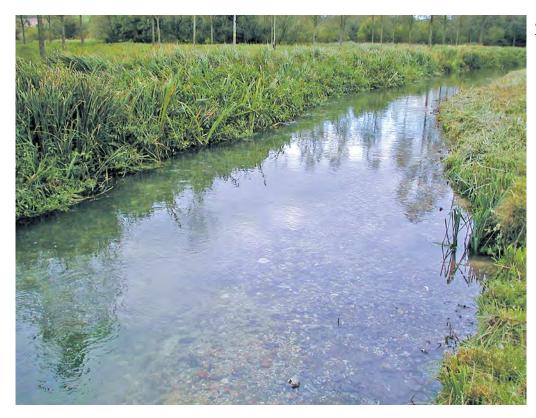
A few months after completion, the raised bed evident

Work was only completed in October 2000, prior to very high flows. Evidence after one year indicates that the reduction in channel size has not resulted in any bank erosion, and that the gravel has stayed predominantly in place. Minor local changes in gravel composition have occurred, with less fines in the low-flow channel.

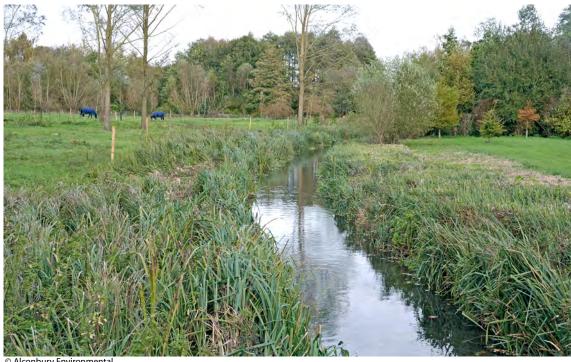
Effective narrowing of the channel and asymmetric shallowing of the bed has occurred following restoration - 2011

The river narrowing and bank stabilisation aspects of the scheme have created much more natural channel profiles. Areas of faster flowing water have developed in the main channel with local backwaters at the margins. Marginal vegetation has developed creating additional habitat.

Bed-raising has improved in-channel character and reconnection to the floodplain.
