Modifying River Bed Levels, Water Levels and Flows

5.8 Gravel reworking to restore a low flow channel

RIVER DARENT

LOCATION – HAWLEY MANOR, KENT, TQ55207213

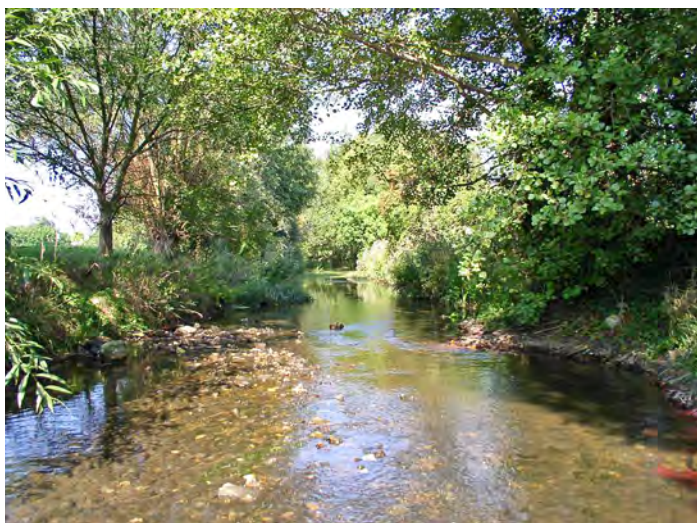
Over-widened channel prone to low flows.
Little or no marginal or submerged vegetation
– July 2005

The River Darent in the Dartford area has been heavily modified over many years, including changes to channel planform, the implementation of land drainage schemes and abstraction, leading to an over widened channel. Prior to restoration this section of river, two miles upstream of Dartford, was very uniform with a shallow gradient. The natural substrate is dominated by gravel but had become overlain by silt. Flow and habitat diversity was limited with negative impacts on fish and macroinvertebrate communities.

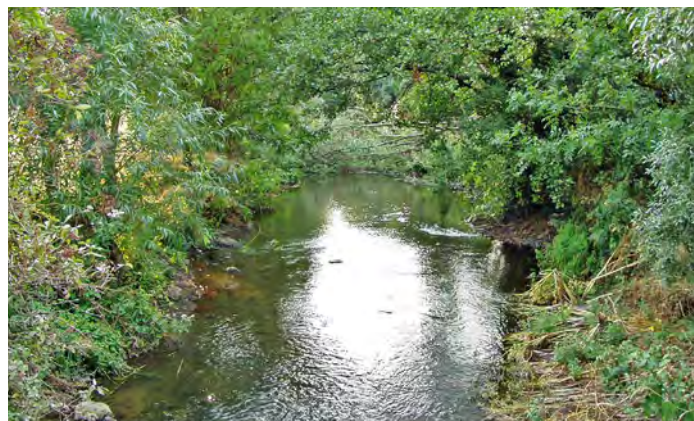
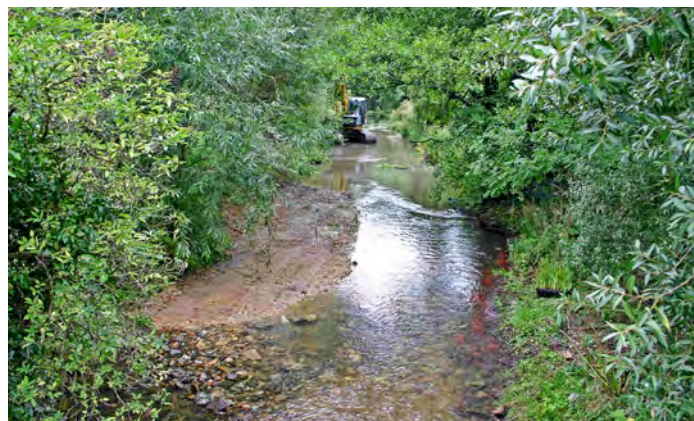
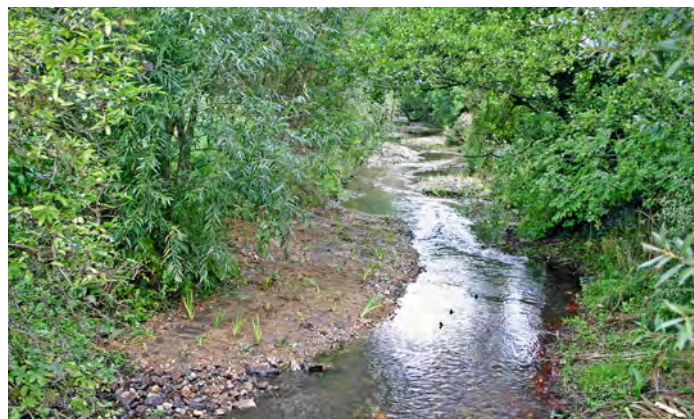
Before (top), during (middle) and immediately after (bottom).
The low-flow channel now occupies approximately 50% of the previous bed, supporting an improvement in flow depth and velocity – September 2005

All of the bed modifications were carried out from within the channel, so that the banks and trees were left untouched. The channel was re-profiled using a long reach excavator creating a sinuous channel, with pool and riffle sequences, still within the confines of the original channel.

A low flow channel was created by moving small amounts of gravel in a meandering path. Part of the bed was kept at a higher elevation to create a sequence of riffles.

In other areas more significant quantities of gravel were redistributed enabling pools to be created. Pools, spaced at approximately 20m intervals, were designed to be self-cleaning. Gravels were placed upstream of each to narrow the flow and increase velocity to induce scour in these pools.

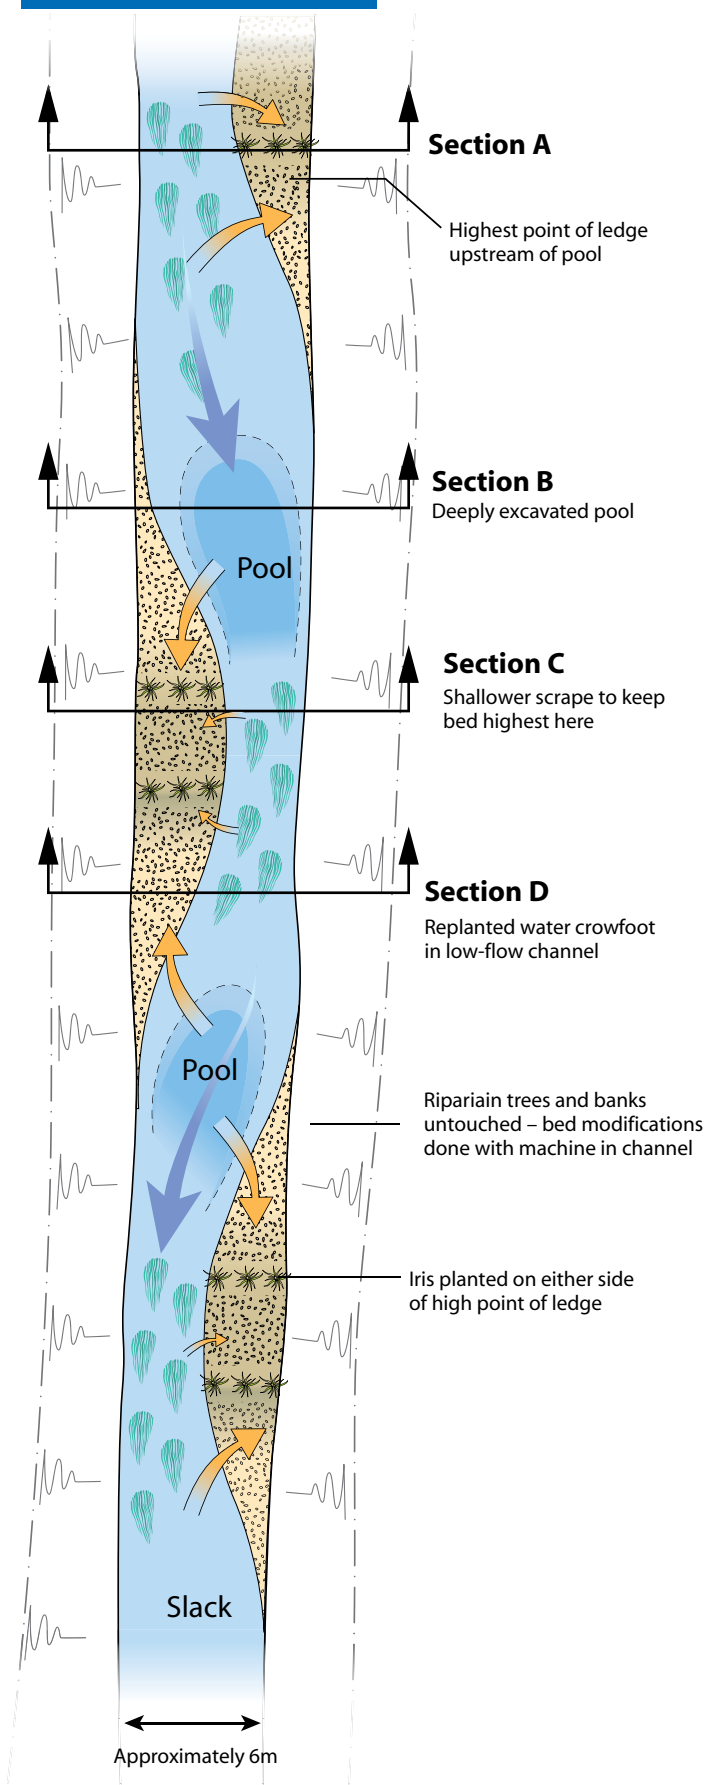
Figure 5.8.1

SEQUENCE OF GRAVEL
REDISTRIBUTION AND PLANTING

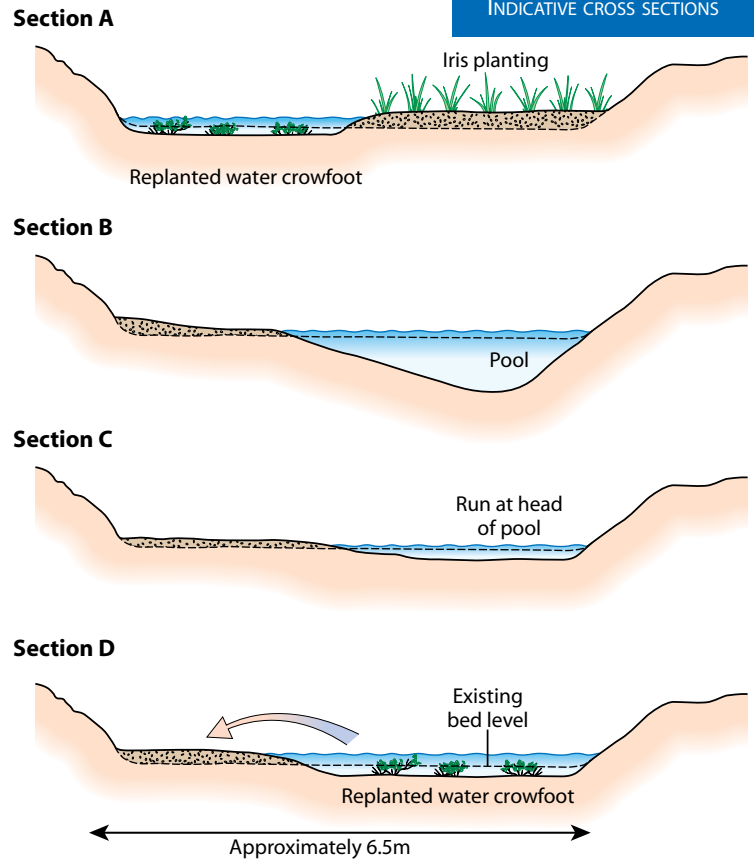
Figure 5.8.2

INDICATIVE CROSS SECTIONS

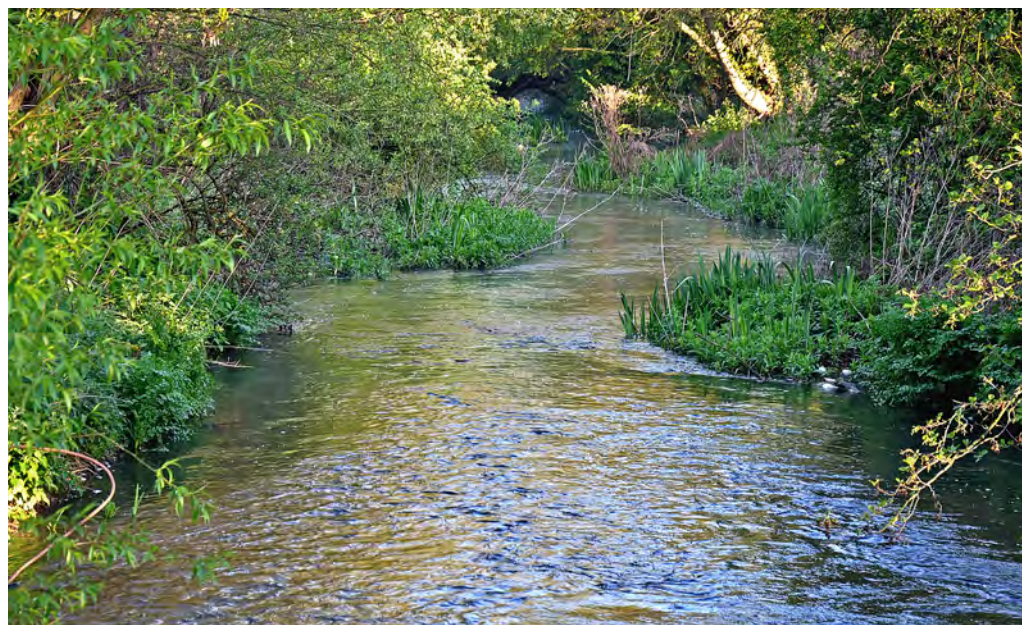
5 years on the channel is narrower and more sinuous. Vegetation, both submerged and riparian, has established well – May 2010

Photographic evidence shows that the in-channel features created as a result of the works have been maintained over the subsequent seven years and are still present. However, no detailed morphological assessment has been undertaken. Clean gravels can be seen throughout the reach and the low flow channel, pools and riffles provide improved fish habitat.

Vegetation surveys were completed pre and post-works (2004 and 2008) using the Mean Trophic Rank (MTR) method. Successful establishment of the vegetation that was planted was observed. Dense areas of reedbed (*Typha latifolia*) fringe the river and a good proportion of water crowfoot was recorded in the channel following the works. These observations were supported by an improvement in the MTR score from 35 to 42.
