### 5.9 Replacing an armoured bed with boulder step-pools

#### INCHEWAN BURN

LOCATION – BIRNAM, NEAR PERTH, SCOTLAND NO017405

DATE OF CONSTRUCTION – SEPTEMBER – NOVEMBER 2007

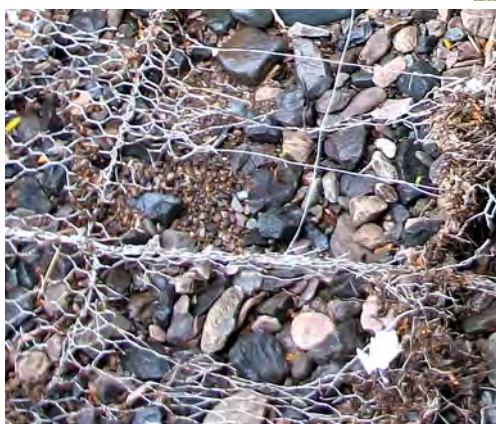
Close up of the degraded Reno Mattress base – 2007

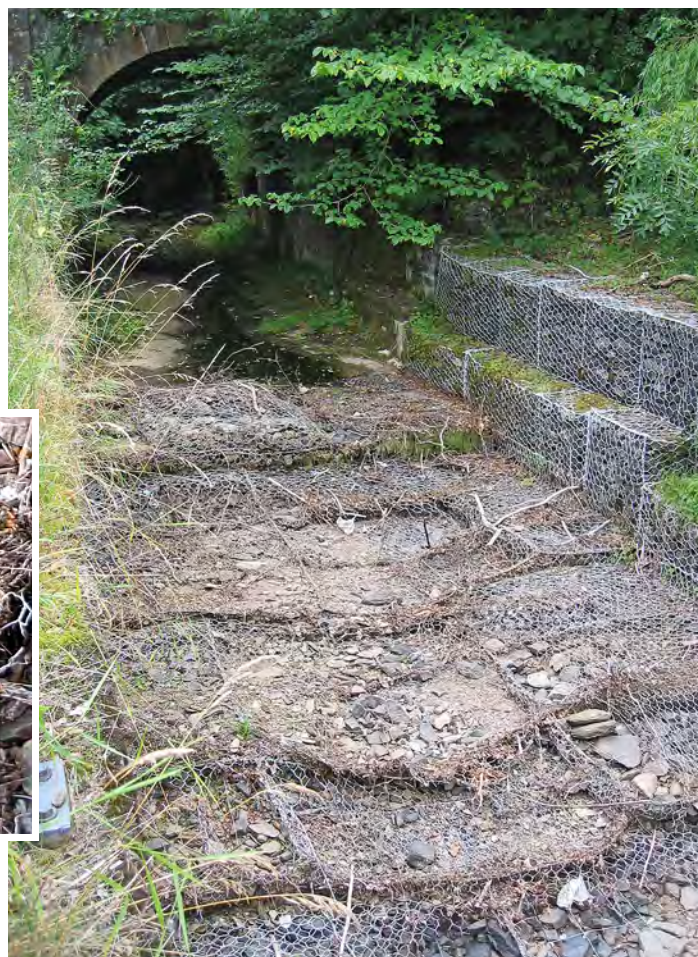
Before restoration works showing complete failure of the wire structure and no surface flow – August 2006

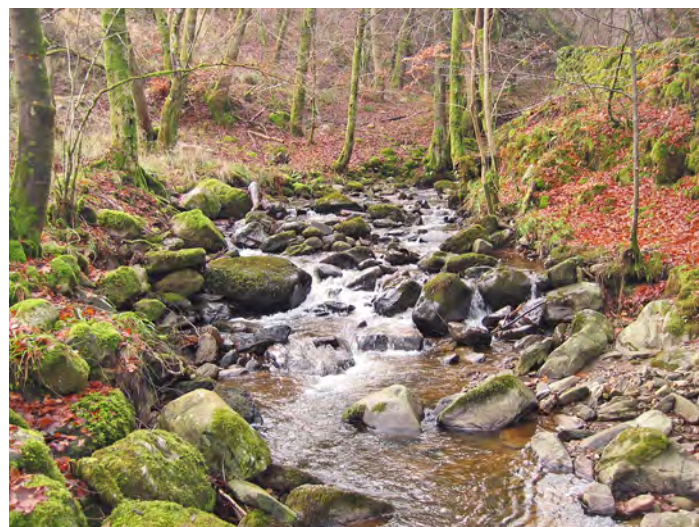
The natural channel, a few hundred metres upstream, showing the variable step-pool configuration formed by large boulders – November 2005

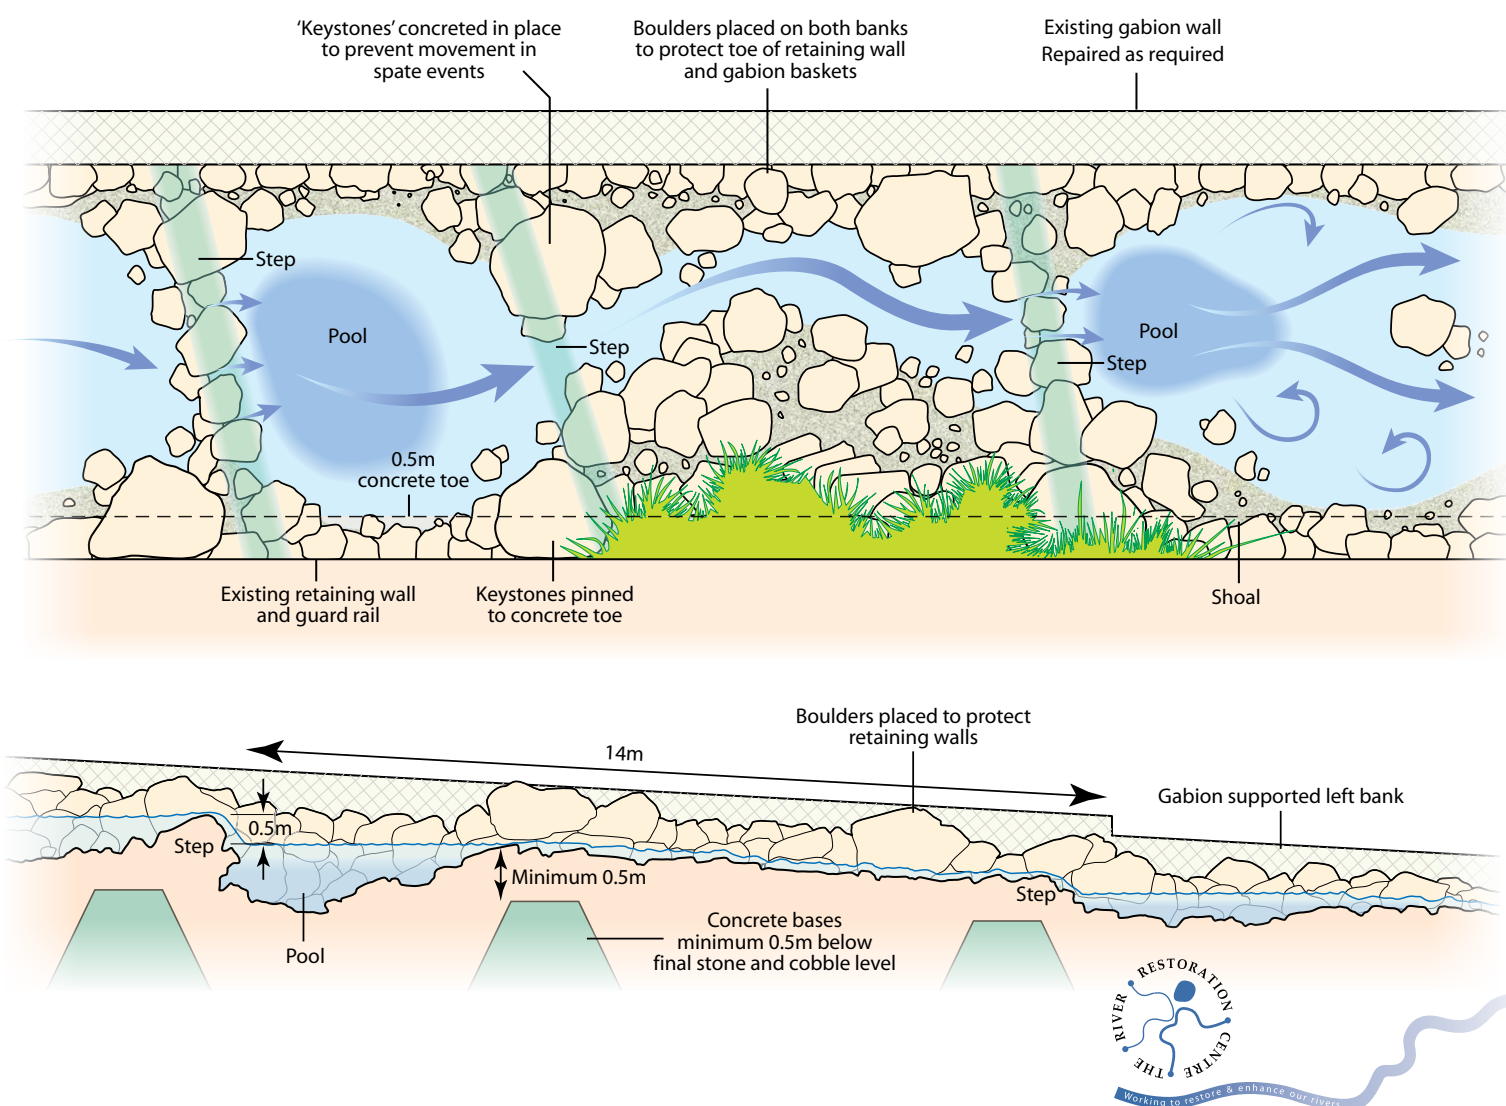
**Figure 5.9.1**

SCHEMATIC OF STEP-POOL SEQUENCES  
AND LONG PROFILE

The method statement for the works was a simple concept based on utilising the gradient of the degraded reach (1 in 14) to form a series of step-pools, replicating as closely as possible the upstream bed form (*Figure 5.9.1*).

The high gradient meant that there was a need to ensure that the keystones did not move. For this reason, a buried concrete base and steel pins were used to fix the most critical bed elements. Where concrete was to be used to bed-in the steps, it was specified to be buried at least 0.5m below the stone and cobble base to ensure that it remained unseen (*Figure 5.9.1*).

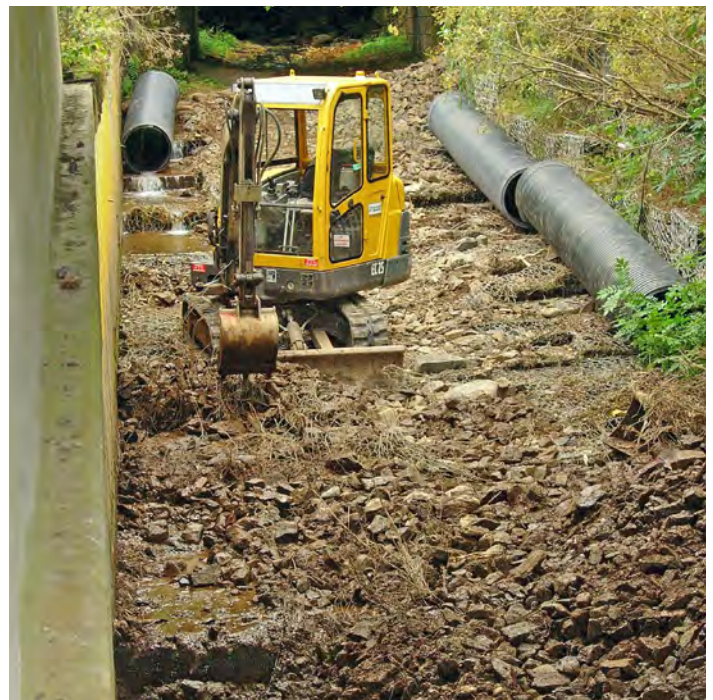
Wire from mattresses in bed removed. The stone was retained to use in the new step-pool system – 2007

First, the wire from the disintegrating mattresses was removed. The cobbles that had been transported downstream were retained for reuse. The work was carried out during a dry period, with all of the low flow in the burn routed through a 0.5m diameter pipe.

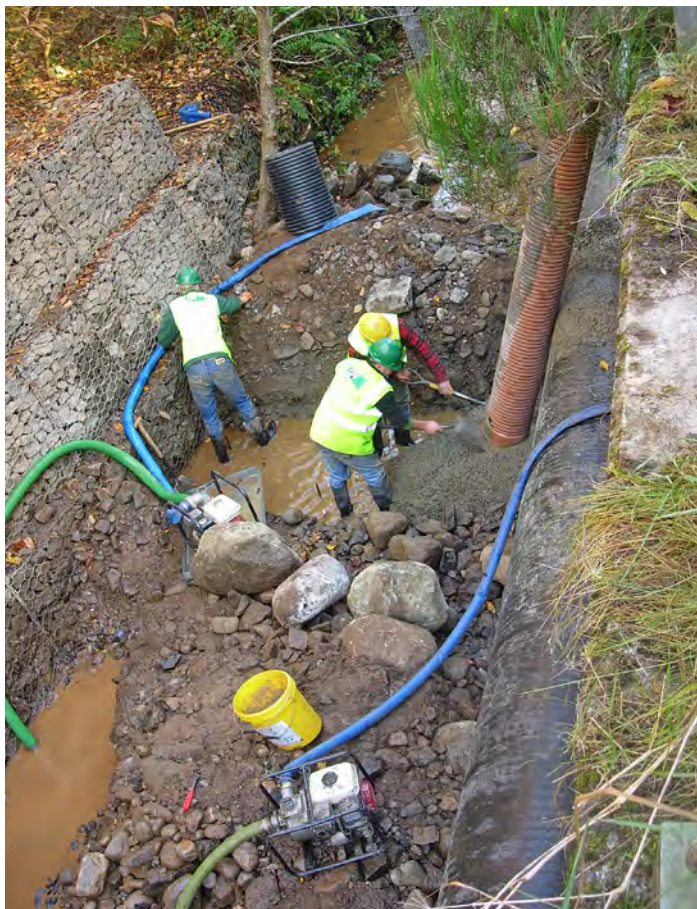
Excavating for the concrete base to bed the larger boulders – October 2007

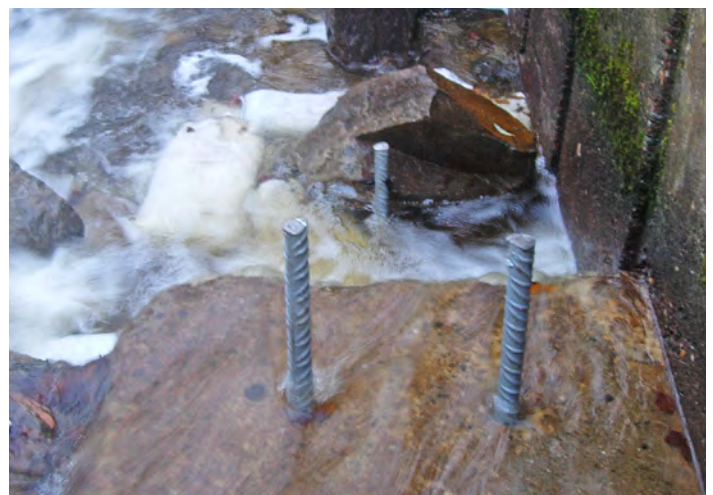
Steel pins in the concrete retaining wall toe awaiting boulder placement – 2007

The vertical concrete right bank (i.e. the road bridge footing) was constructed with a 0.5m wide toe which had previously been hidden beneath the wire mesh bed. This stepped ledge needed to be hidden by the new works (for aesthetic reasons and to prevent undercutting) and therefore provided a secure foundation for locating a number of the keystones. The boulders and concrete ledge were both drilled and the boulders then fixed in place with resin and steel pins.

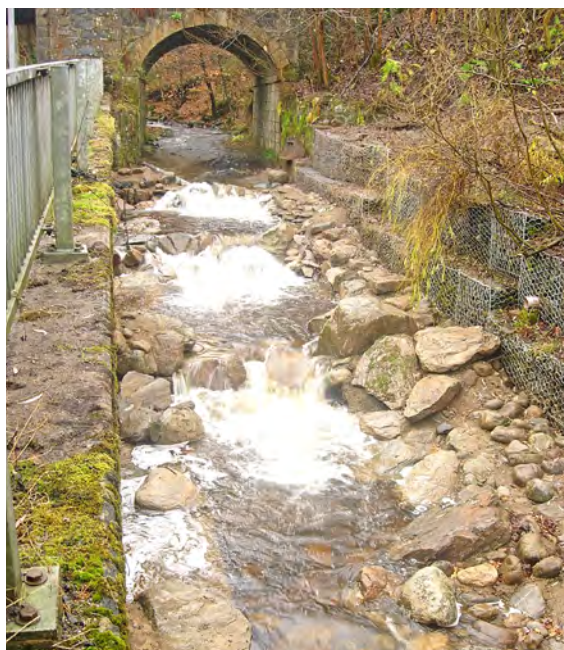
Immediately after  
completion  
– December 2007

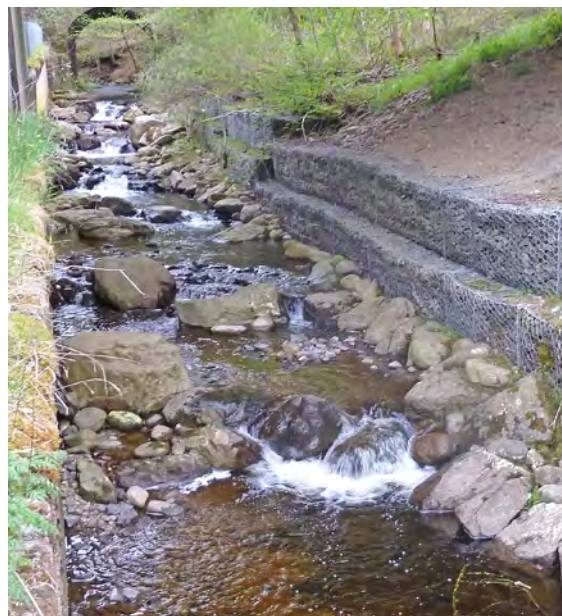
Beneath the A9,  
five years after  
– May 2012

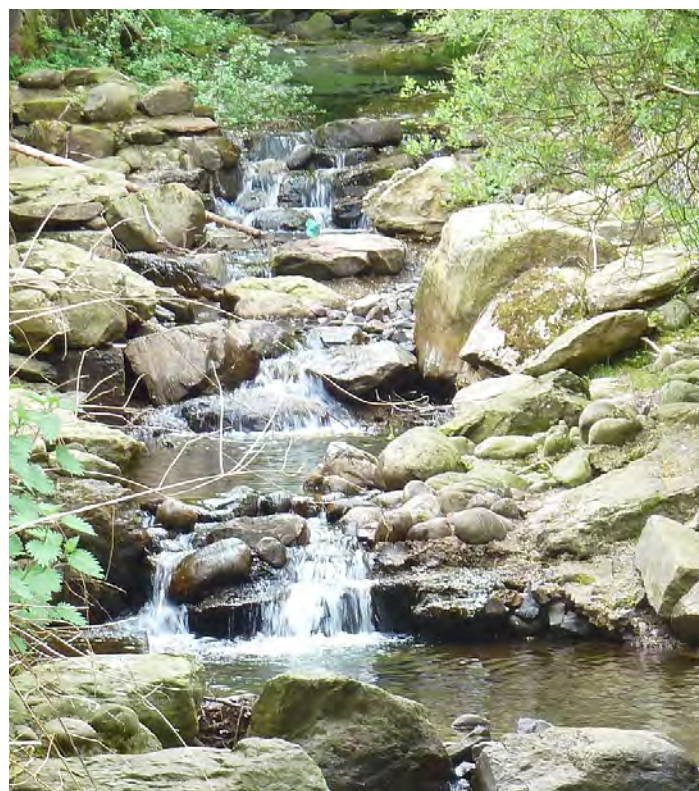
The restored reach mimicking the step pool configuration  
of the upstream reach– May 2011
