# Providing Public, Private and Livestock Access

## 8.2 Watercourse crossings

River Cole Location - Coleshill, Oxon/Wilts Border, SU234935 Date of construction – Autumn 1995 Costs – concrete culvert £8,700 – steel culvert £3,000

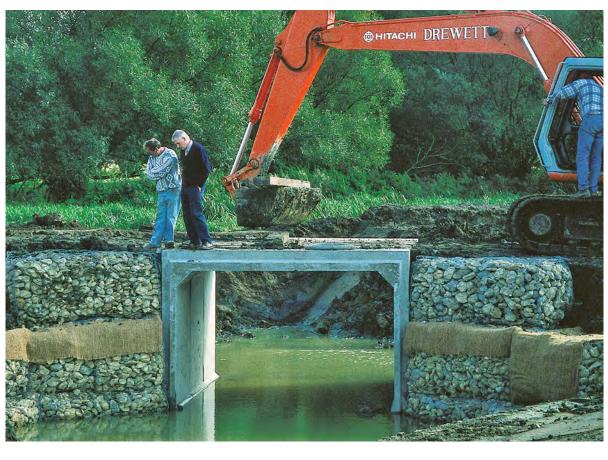
New concrete culvert crossing under construction

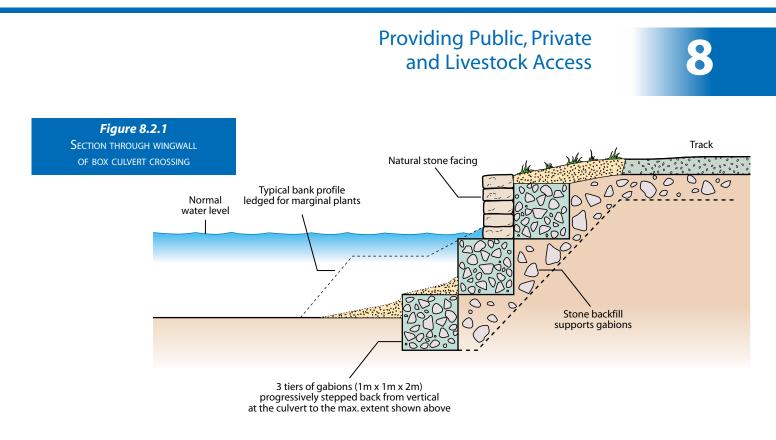
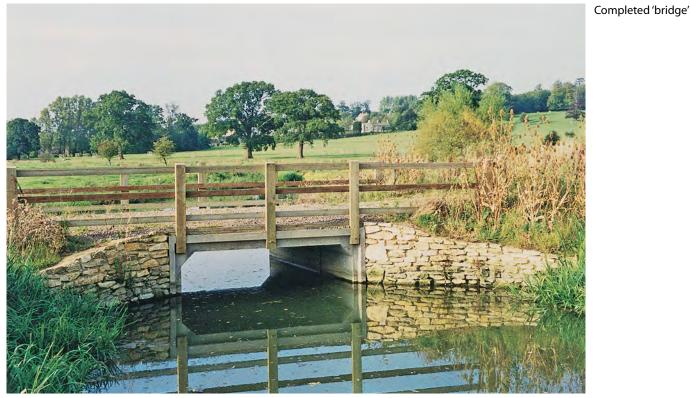
#### Mill leat crossing (Figure 8.2.1)

The structural elements comprise a pre-cast concrete box culvert 3m wide and 2.1m high that is flanked at each corner with stone filled box gabion wing walls. This arrangement is functionally satisfactory but is most unsightly so great care was taken to detail the wing walls such that visual amenity and habitat potential were improved.

Three tiers of gabions were needed to achieve the full wingwall height from invert to track level. The lower two were set just below the retained water level in the mill leat where they are permanently out of sight. These two layers were set out in plan to follow a 90 degree curve creating a wider river cross-section than the culvert. They were progressively stepped back from the vertical to create a ledge at the top of the first tier.

The upper tier followed a similar curve but was continuously stepped back sufficient to allow a stone wall to be built around the front face - this wall is the only visible element and it is decorative rather than structural. By stepping back the gabions the sloping river banks adjacent could be brought smoothly into line with the gabions and also accommodate an underwater ledge for aquatic marginal plants. The combination of marginal plants and stone walling are intended to draw the eye away from the concrete box which is a relatively minor feature of the overall visual aspect evident in the photo.

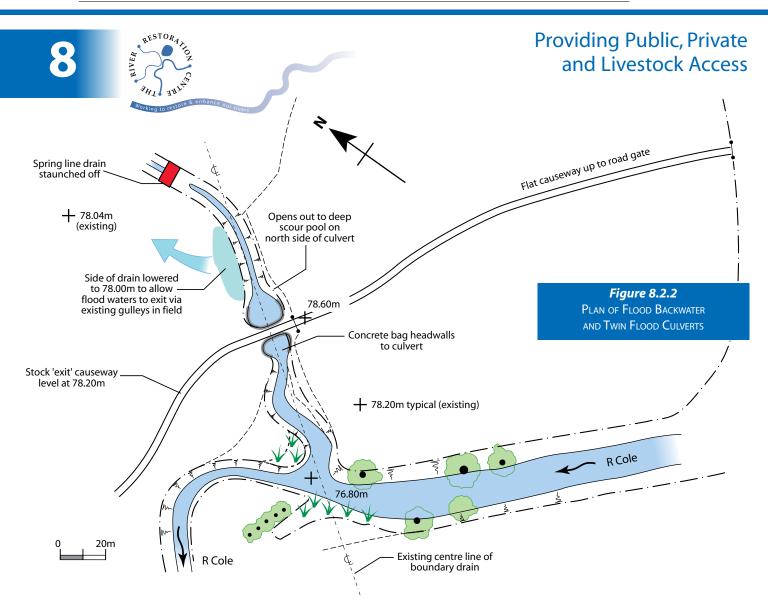
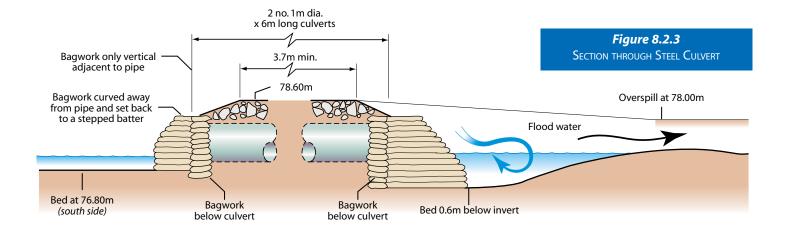
Flood drain crossing (Figure 8.2.2)

The flood drain is only 1m deep and two pipes of this diameter were needed to provide sufficient area to pass floodwater. Corrugated galvanised steel pipes were selected by the contractor; they are readily available and easy to install. When laid side-by-side they measure about 2.5m across, which is wider that the drain. The design of the headwalls at both ends, therefore, needed to form a smooth transition between the 'over-wide' pipes and the relatively narrow trapezoidal channel.

Concrete filled hessian sandbags were used to achieve this complex geometry. Another consideration was that the pressure of floodwaters passing through the pipes might produce high velocities and turbulence

The bagwork is built vertically across the face of the pipes and then curved gently outwards through 90 degrees or more with a slowly increasing batter until it merges smoothly into the sloping banks of the drain. The slopes are achieved by stepping the bagwork rather than laying it flat on the banks; the ledges thus formed attract silt and plant growth. The height of bagwork was curtailed close to the level of the pipe soffits.

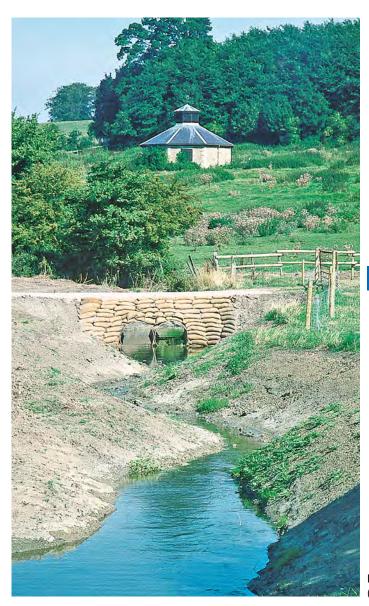
Flood drain crossing seen from bank of R. Cole. (bagwork wing walls incomplete)

Concrete bagwork is a versatile method of achieving complex shapes and it can rapidly take on a reasonably aesthetic appearance. This is because the concrete is invariably less dense than pre-cast or poured concrete alternatives and therefore provides a suitable surface for a variety of vegetation. The hessian rots away in a year or two, but in the short term it attracts silts which help to establish vegetation, particularly if the hessian is not impregnated with preservatives.
