## Bioengineered designs

### Case Study 1: River Severn, Longney, Gloucestershire (completed 1997)

# Estuary Edges: Ecological Design Guidance

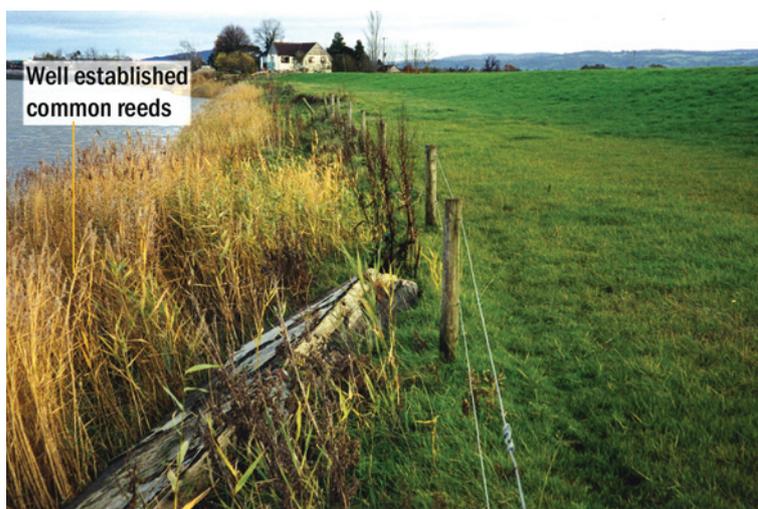
River Severn, Longney: Successful restoration

- Common Reed established well, continuing to stabilise the substrate after the decomposition of the coir matting.
- Design considered highly successful, cost-effective and appropriate to location.

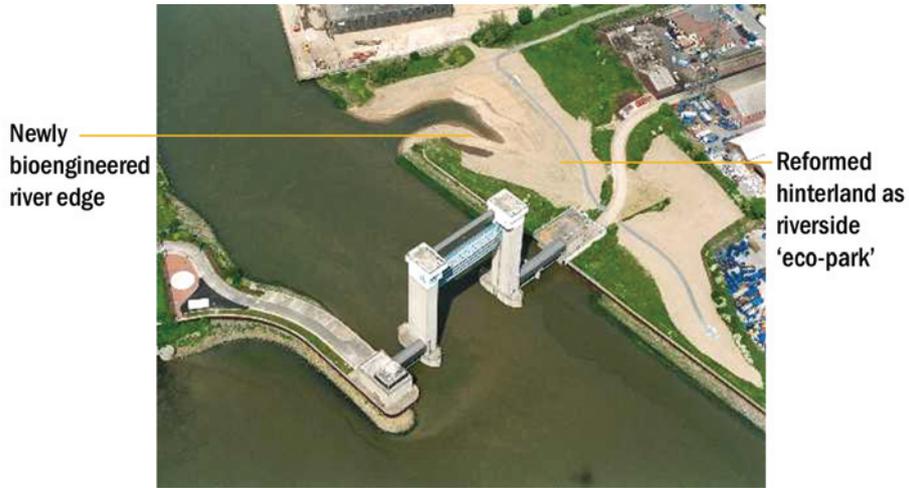
Barking Creek at Barking Barrier: After creation of intertidal embayment

- Existing land profile excavated away to slopes less than 1:7 and clay capped.
- Sweet Chestnut posts installed and brushwood bundles delivered.
- 'Brushpacking' (500mm brushwood fascines packed over whole mud surface) installed between 2500mm long Sweet Chestnut posts (installed at 600mm centres) retained by biodegradable tensioned coir twine on slopes up to Mean High Water Neaps. Fascine diameter graded down to 200mm at low tide mark.

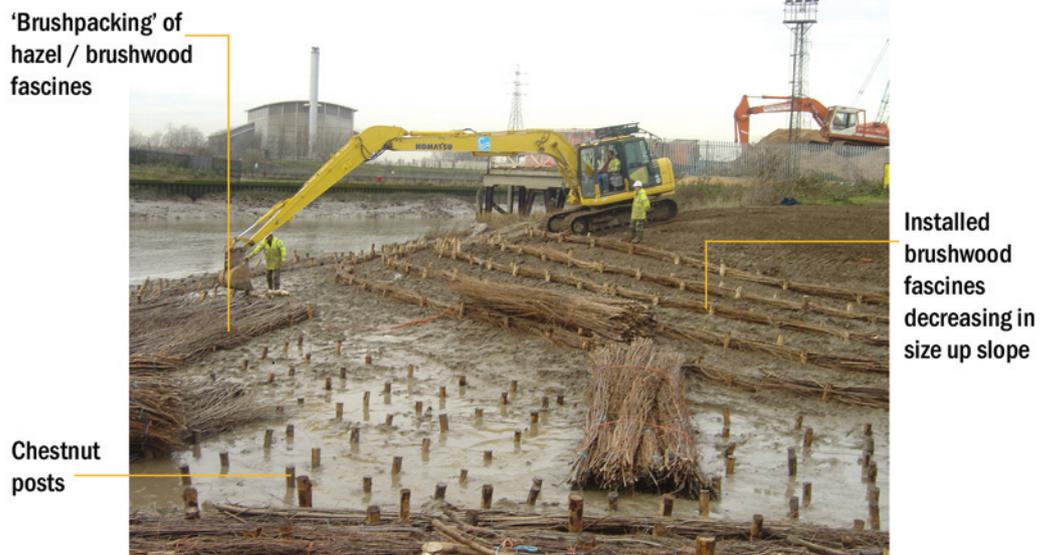
Barking Creek at Barking Barrier: Delivery of brushwood bundles

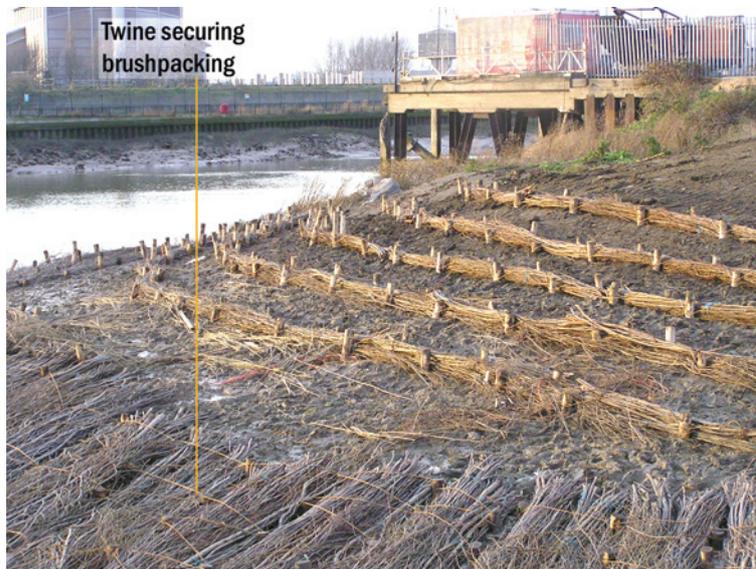
Barking Creek at Barking Barrier: Fixing detail of brushpacking

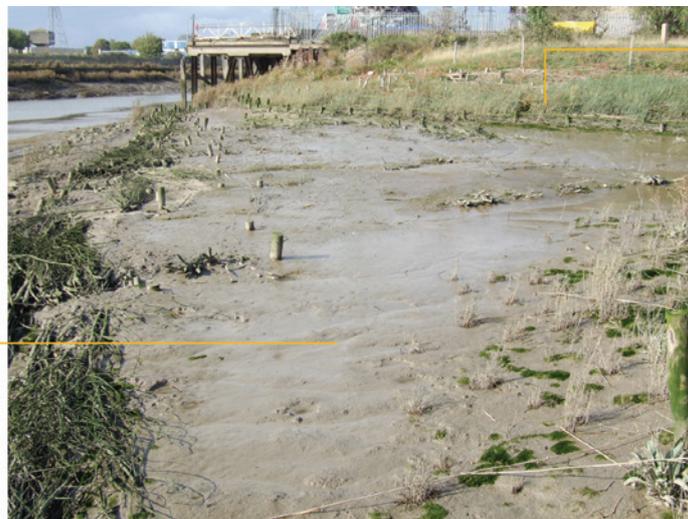
Cell-grown Common Reed smothered by sediment over the first six months

Lower slopes of Barking Creek bank at Barking Barrier showing 40cm of sediment accretion on six months

- Clumps of locally sourced cell-grown Common Reeds introduced on lower slopes smothered with some 40cm of sediment in just six months.
- Steeper upper slopes retained by brushwood bundles installed as fascines between Sweet Chestnut posts on alternate sides at 600mm centres. Diameter of faggot bundles used increasing from 200mm to 500mm down the slope. Retained by biodegradable tensioned coir twine.

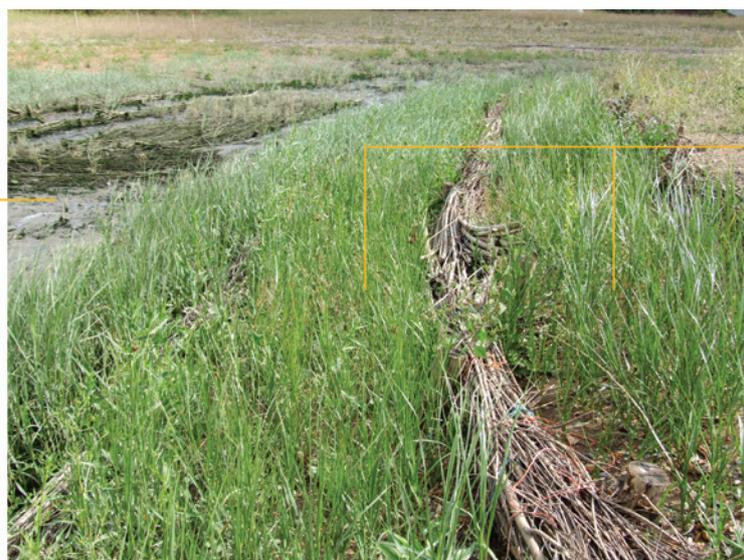
Patchy growth of saltmarsh plants at lowest level but substrate accreting

Excellent natural colonisation of Sea Club-rush

Upper slopes of Barking Creek at Barking Barrier showing rapid establishment of Sea Club-rush

- Natural colonisation of Sea Club-rush extensive on the upper slopes, stabilising the substrate but overwhelming the planting.
- After 16 months, a wide variety of plants present, with abundant self-sown Sea Aster and strongly spreading Common Reed at higher tidal levels.
- Plentiful supply of fine sediment and net accretion/erosion balance achieved at lower tidal levels.
- Stable vegetation establishment anticipated in the long term, the lowest fringe being colonised by Sea Club-rush.
- Extensive use of the embayment by juvenile fish, especially Sea Bass.
- Considered highly successful and beneficial in ecological, social and economic terms.

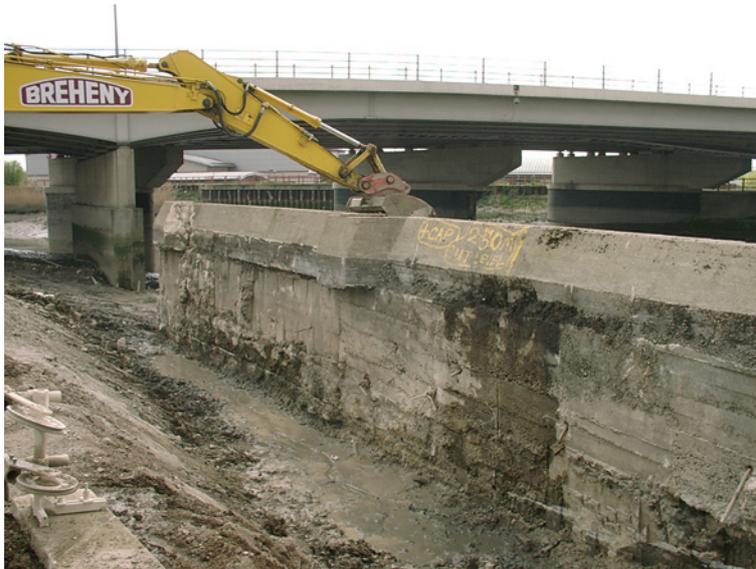
Barking Creek at A13: Demolition of river wall

- Existing wall broken out and/or truncated and capped with concrete.
- Slopes re-graded and clay capped and fascine revetment installed.
- Coir erosion control blanket installed over upper slope to prevent sediment loss for up to two years during plant establishment – covered with ‘blinding layer’ of soil and seeded with wildflower mix. Additional saltmarsh seed added in zone between mean high Neap and Spring Tides.
- Biodegradable Hazel/brushwood fascines placed in rows 1m apart to promote sedimentation at low- to mid-tidal levels.
- New rock rolls in trenches to anchor fascine rows at each end but revetment still essentially bioengineered.
- Kingfisher burrows installed in the truncated concrete river wall.

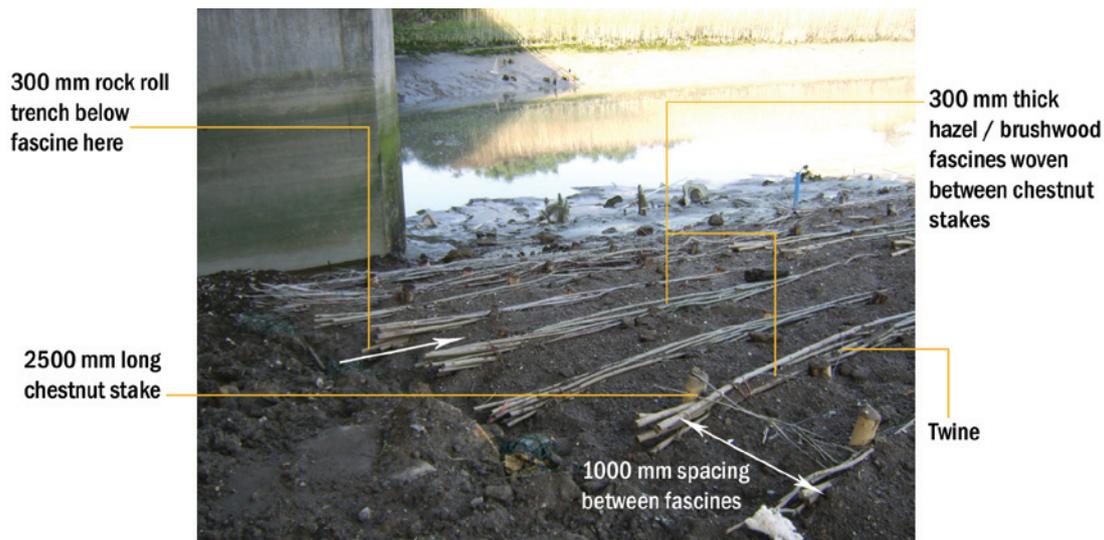
Barking Creek at A13: Details of fascine installation near bridge

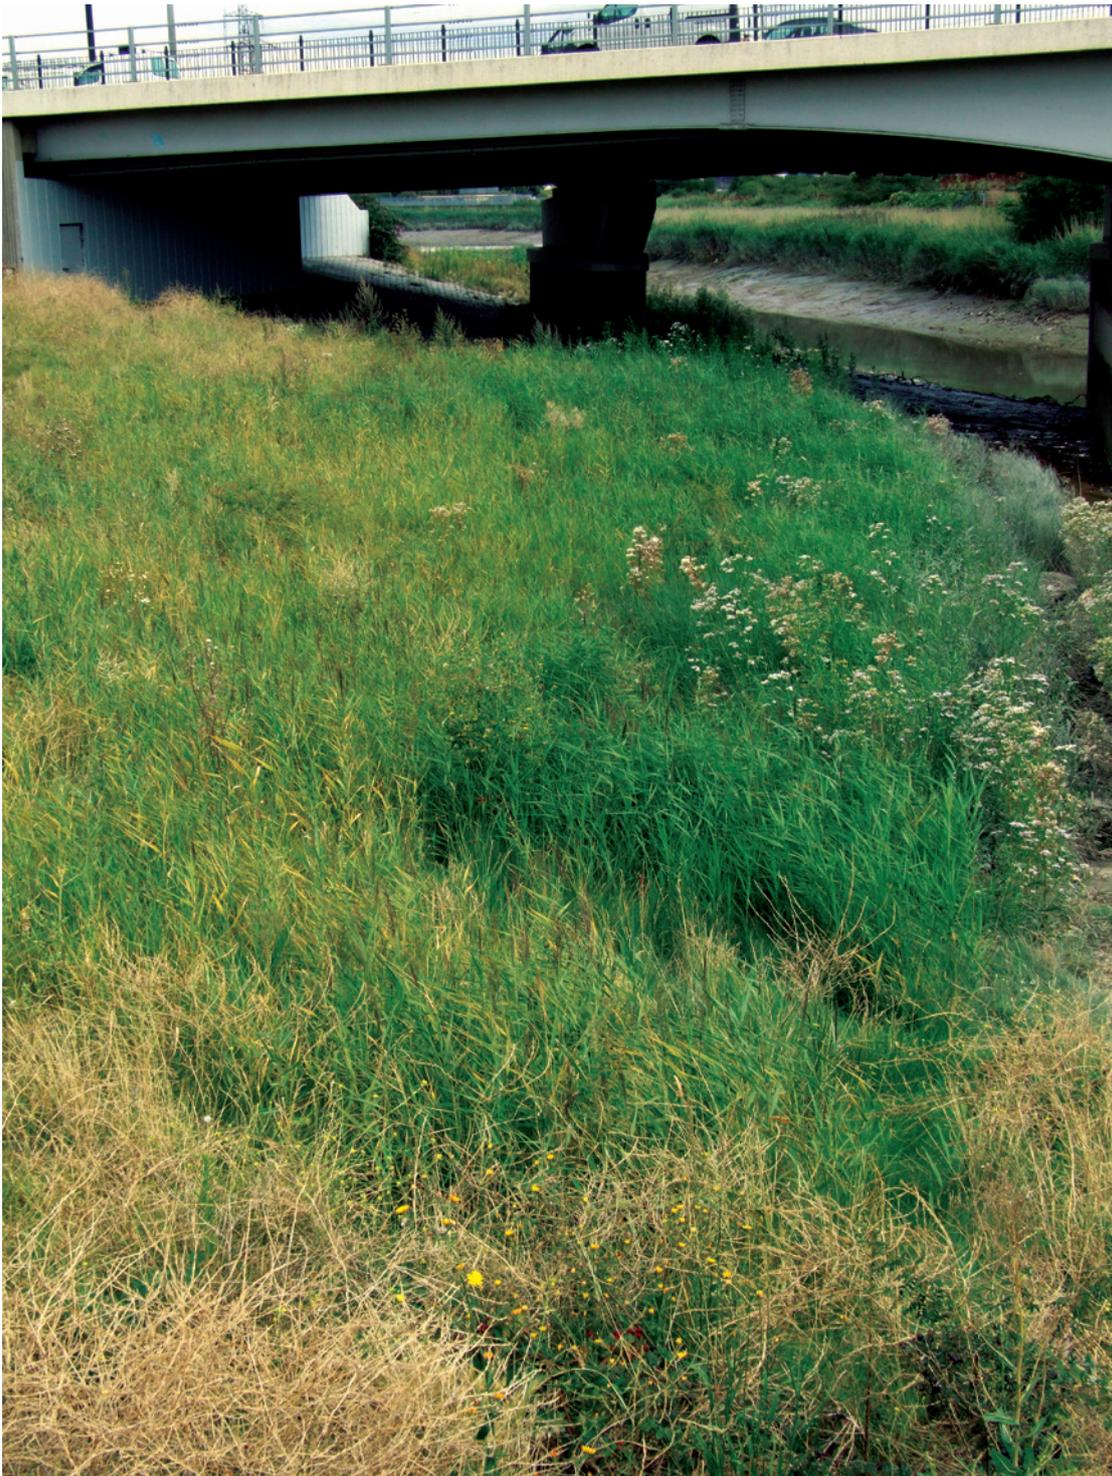
Barking Creek at A13: Vegetation establishment after 14 months

- In the first 12 months no erosion occurred on the slope and the coir matting and brushwood fascines had not been damaged.
- Cell-grown Common Reed planted on the lower slope largely unsuccessful but subsequently started to colonise naturally.
- Grassland vegetation establishment from seeding the upper slopes successful despite limited sedimentation.
- Introduced growing medium on the upper slopes considered to have helped establishment.
- Close proximity of a bridge did not prevent a bioengineered design.
- Greatly improved local visual amenity, with far better relationship to nearby semi-natural habitats.
- Considered very successful in ecological, social and economic terms.
