# Dove Weir Removal, Dovedale

Techniques: Weir removal, Re-wilding techniques using large wood and trees

**Project location:** Dovedale, near Thorpe and Ashbourne

**River:** Dove

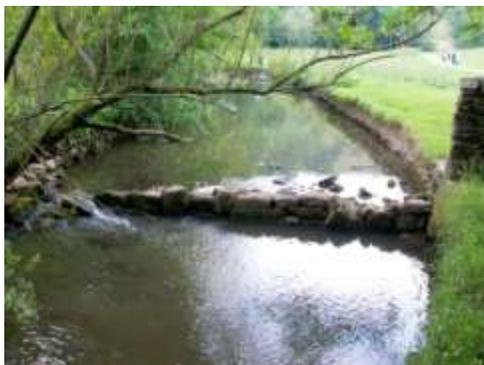
*In the reach adjacent to the LDFFA, a series of weirs at frequent intervals are constraints, preventing connectivity of the Dove upstream.*

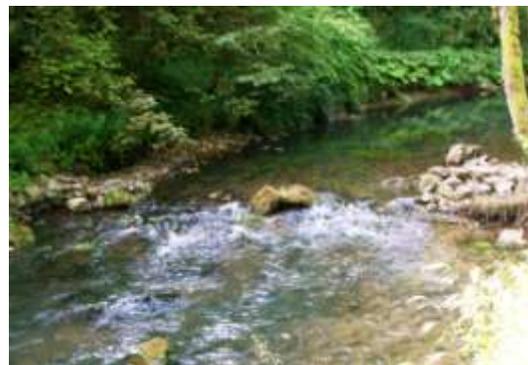
*Following removal of the weir, turbidity of the flow reduced significantly and in-stream gravels and vegetation established very soon after works.*

1) **Weir:** The works involved the removal of one weir along the stretch of the river. Following deconstruction, care was taken to leave the removal looking 'complete' to avoid public attempts to rebuild the weir - an interesting point to take away!

1) **Weir:** Twenty metres upstream of the weir, there has been a significant drop in water level and pool and riffle sequences have established naturally as a result of increased sediment transportation, creating a range of flow conditions in-stream. New plant species have begun to establish at the start of the riparian zone. Water clarity has visibly improved both up and downstream.

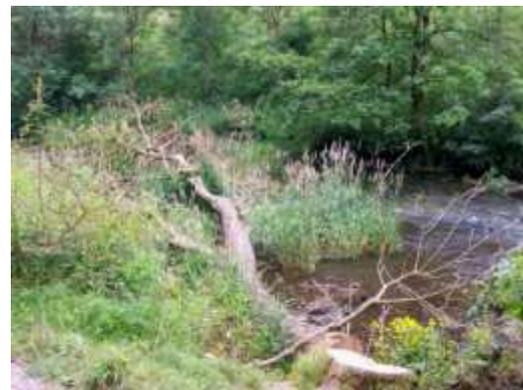
*A 60ft tree felled as part of the Dove's 're-wilding'. The photo demonstrates the extent of the vegetation development in only 6-12 months following the works.*

2) **'Re-wilding':** Trees were felled and wood wired into place in-stream to allow material accumulation and to create a diversity of depths, flow patterns and substrates. New habitats (aquatic and riparian) have formed and river sinuosity has increased. Remaining woody debris was intentionally placed in piles on the bankside along with a sign explaining its ecological purpose. It was hoped that this would make the public think twice about removing it. The tree drops were up to 60ft, but small wood arranged around it has enabled the creation of a range of features.

2) **'Re-wilding':** A year on from felling, the trees have created a range of structures in the river that have increased plant establishment and created a variety of flow conditions.
