the River Restoration Project

River

COLE

restored 1995/6

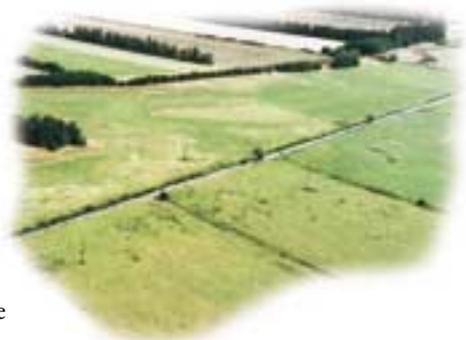
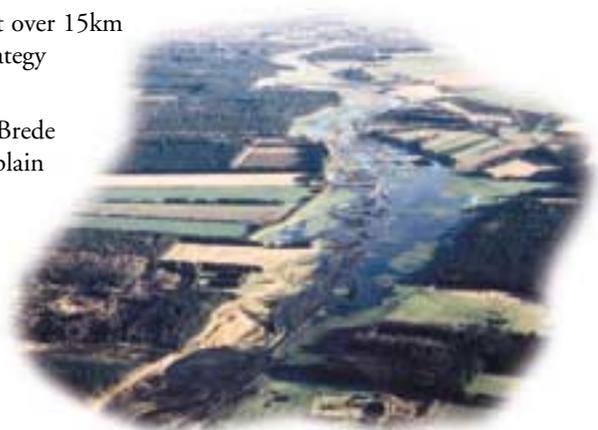
Photos: Sønderjyllands Amt

A 5km reach was re-meandered under the EU-LIFE project, but over 15km of the Brede have now been restored as part of a nationwide strategy to improve the environmental management of river valleys.

The scale of re-meandering is much greater than in the UK; the Brede once again sweeps from side to side along the 500m wide floodplain and seasonal flooding has been restored to the whole valley.

The natural regeneration of the meandering river has been rapid and the sea trout are taking advantage of this.

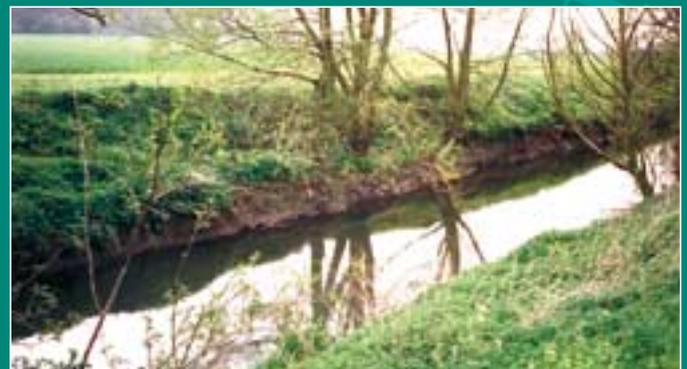
The Cole prior to restoration – trees stranded well above water level by previous deepening (photo: M Janes)

Downstream of the mill, mature trees were perched well above the bed of the old channel, due to a dredging scheme carried about 25 years ago which removed 1m of clay from the river bed. This general bed lowering also served to reduce the water table in the adjacent floodplain fields.

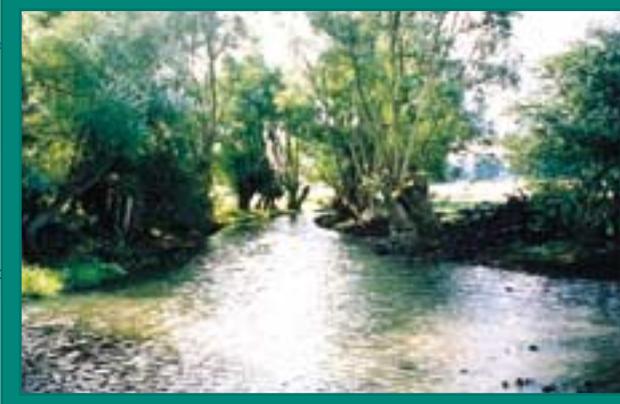
The mill leat has been retained as a linear pond with a small 'sweetening' flow, in the expectation that the mill wheel will in the future be restored. A large willow lined meander (cut off soon after 1770) has been restored for its historical value. Water levels in the leat have been raised and drainage ditches dammed to help dampen the surrounding flood meadows.

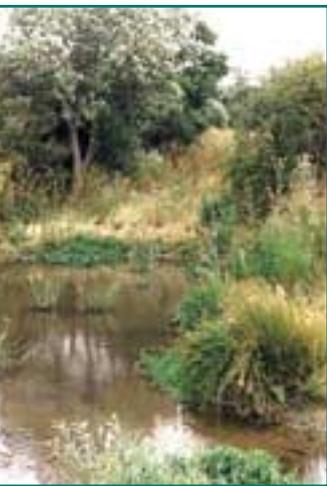
Backwaters and habitats

Whilst much of the old river Cole was infilled, some parts were kept as backwaters to provide a different habitat to the fast flowing, newly restored course.

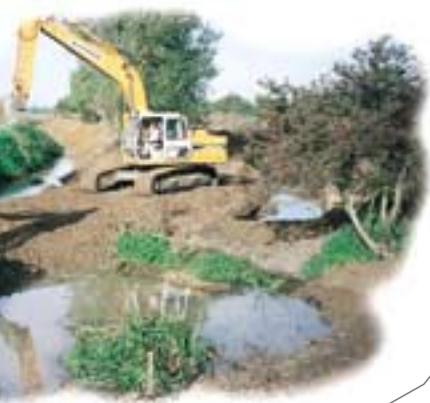
A small linear reedbed has been constructed and planted on a wide berm adjacent to the new course.

The reedbed is fed by an agricultural field ditch with a high nutrient content.

Although this feature has been designed as a habitat reedbed, it also offers some 'buffering' of the ditch water before it enters the river.

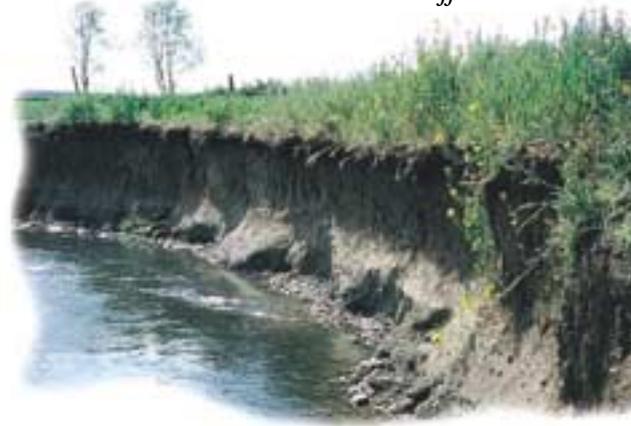
Channel adjustment

In creating a different course for the River Cole some natural adjustment was allowed for.

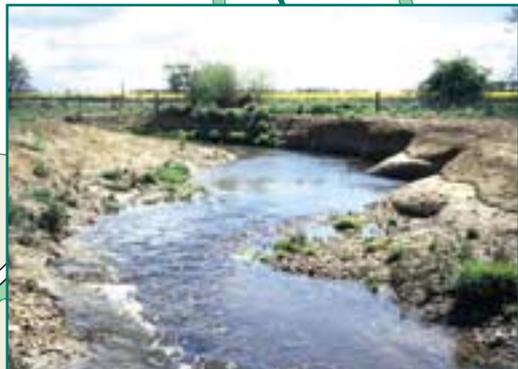
This gives the river the chance to form the small irregularities present in all rivers, as well as the more regular pool and riffles, vertical riverbank cliffs and gravel beaches.

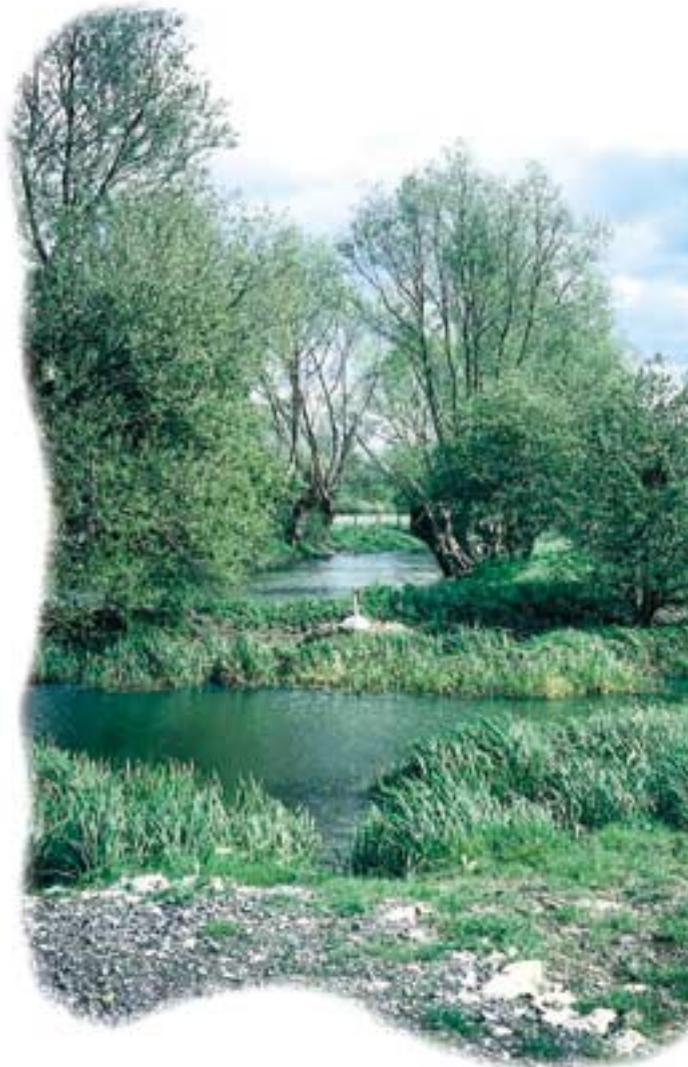
Swans nesting at restored meander in mill leat (photo: M Janes)

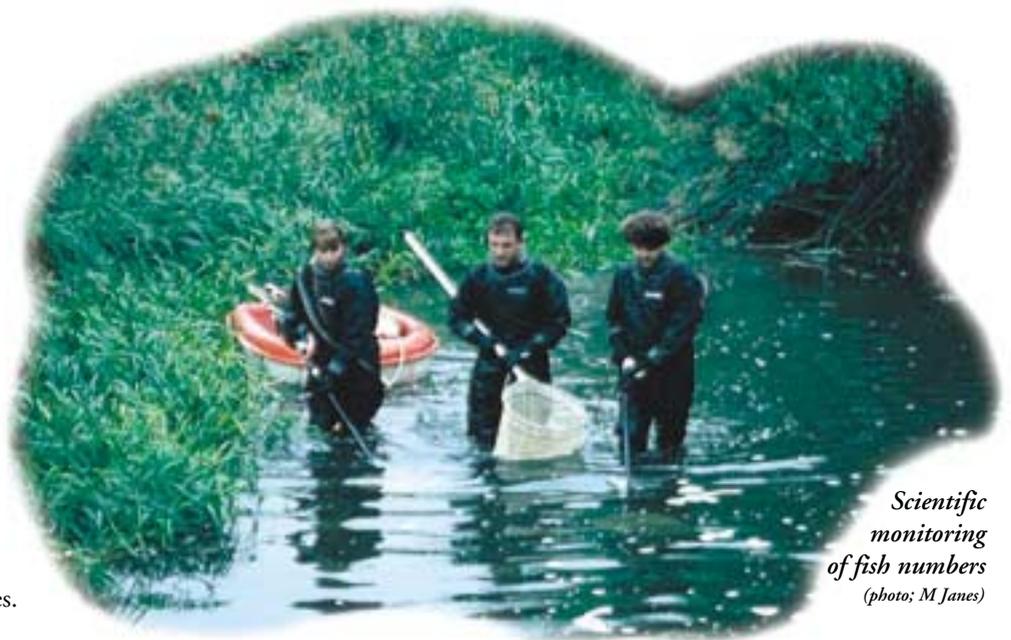
Scientific monitoring of fish numbers (photo: M Janes)

A comprehensive monitoring programme has been running since the start of the project and will be extended to cover at least four years post-project.
