# ENHANCING STRAIGHTENED RIVER CHANNELS

## 3.5 Narrowing of an over-widened channel using low cost groynes

### RIVER AVON

LOCATION - Stratford-Sub-Castle, Salisbury, Wiltshire

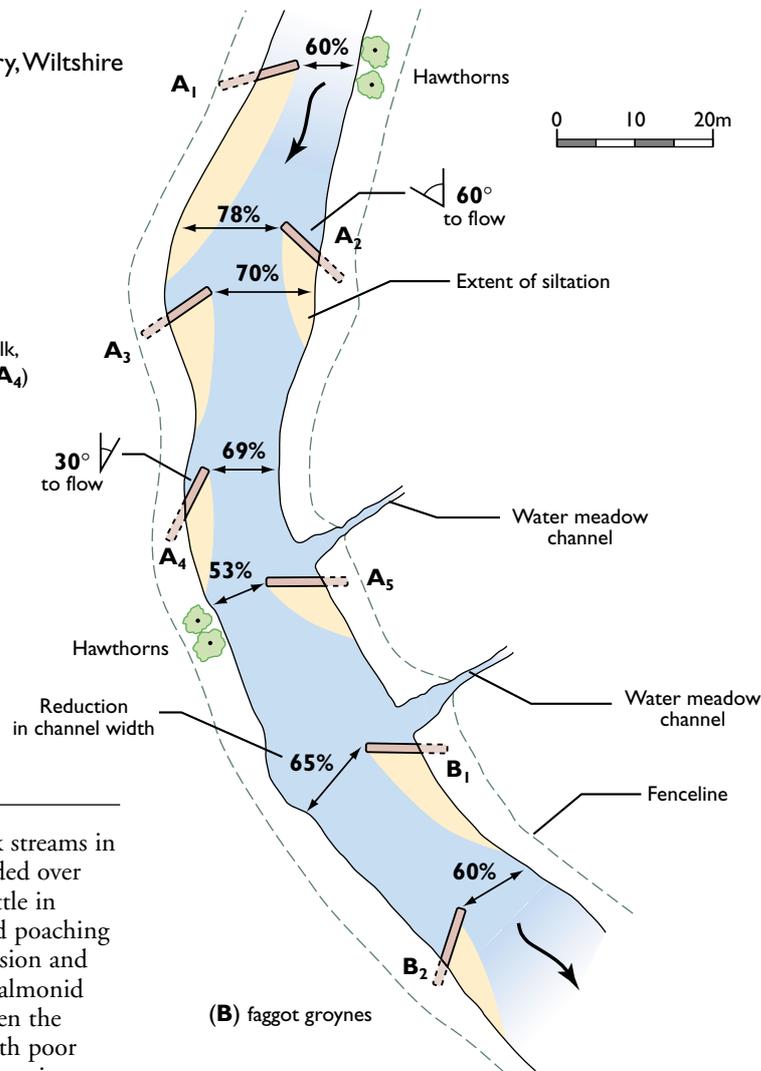
**Figure 3.5.1**  
PLAN OF NARROWING WORKS

(A) groynes comprising chalk, all 60° (except A<sub>4</sub>)

The design concept incorporated the need to diversify the flow characteristics along the length of the river by installing upstream facing groynes at specific sites on the right and left bank. These were placed according to the on-site observations and an understanding of the flow dynamics of the river.

Construction of the first of the 7 groynes in the 125m stretch commenced at the upstream limit of the site. The angle of groyne at the bank was decided by ascertaining the direction of flow (using a floating

rope) and constructing at either 60° or 30° to this. The same method was used to construct each of the groynes. Final placement of the groynes was decided on site.

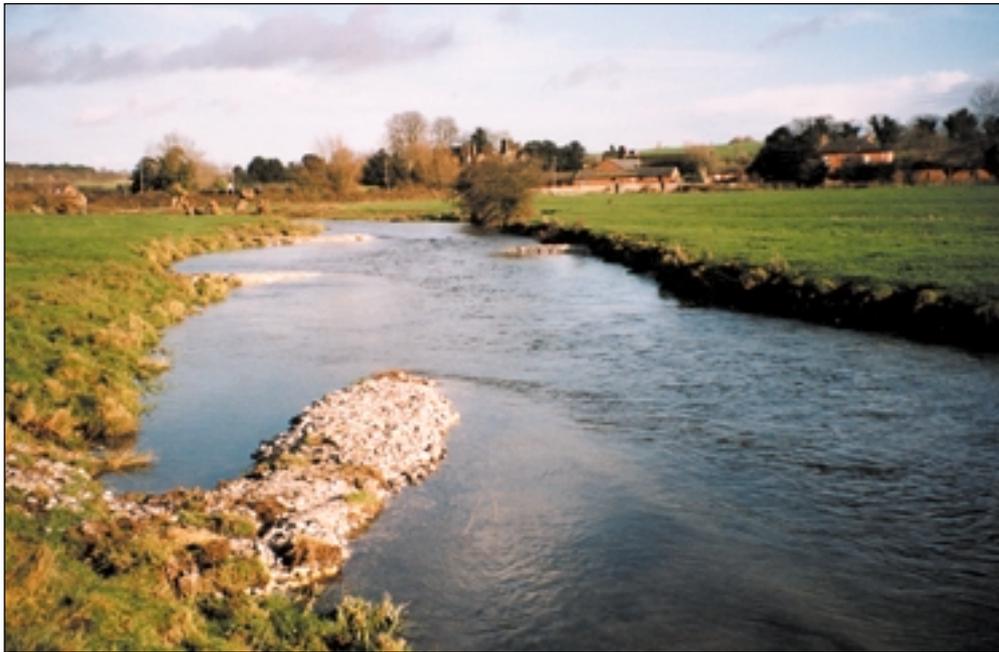
Completed chalk groynes

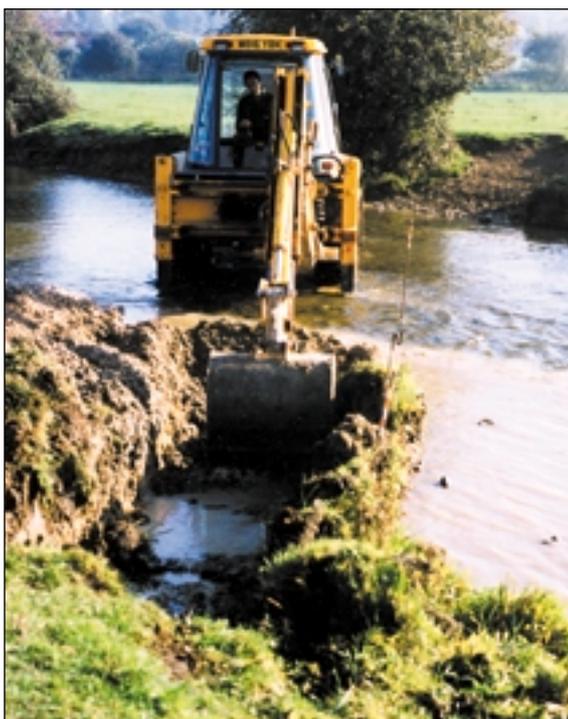
Digging the groyne trench

After marking out the area with pegs a JCB dug a trench 0.5m deep and 1-2m wide, with the excavated bed and bank material placed to one side. The trench was cut into the existing bank to anchor the completed groyne. The trench was then filled with either chalk or faggot bundles to provide reinforcement and stability and the excavated material from the original trench replaced on top.

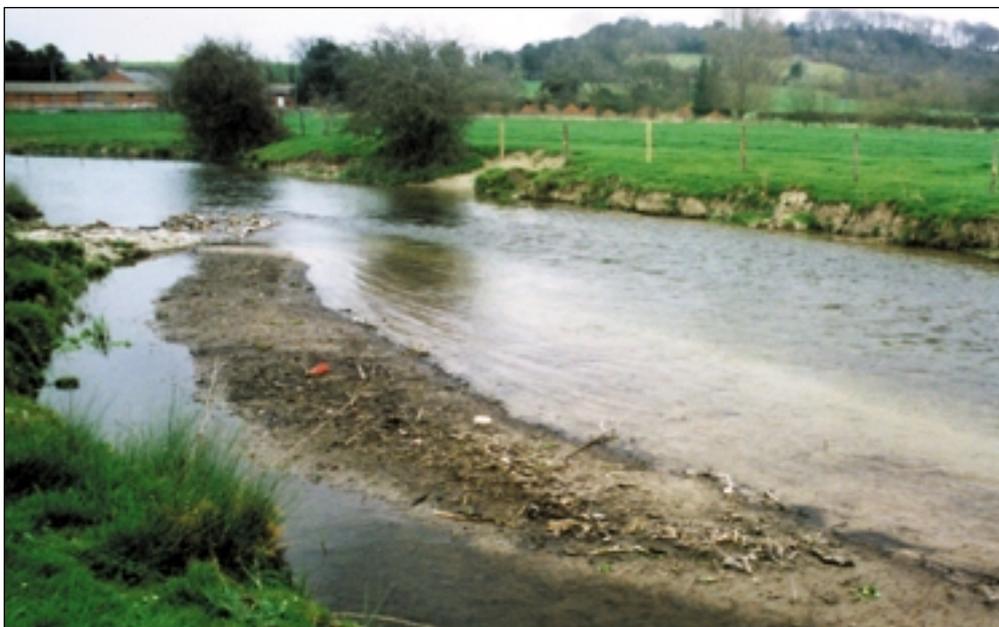
Six months of siltation

The desired accretion of material up and downstream of the groynes began soon after installation was completed. Particle sizes indicate a good mix of fine silt and organic material to coarse sand and gravel. This habitat has been colonised by a variety of submerged and emergent vegetation and is providing excellent habitat for lamprey and cyprinid fish fry.

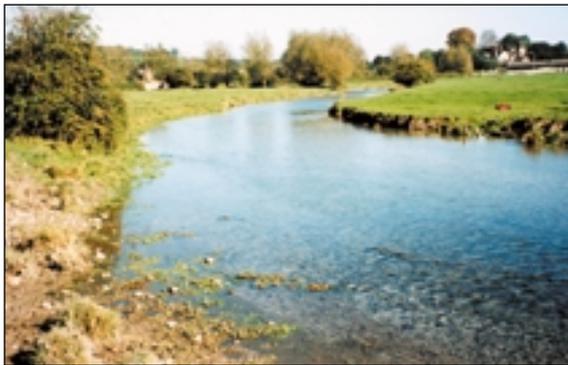
Cattle poached, wide and shallow

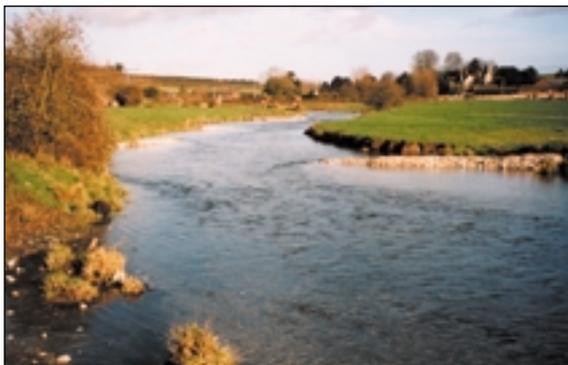
Groynes in place already increasing flow diversity

In narrowing the channel to approximately 60% the groynes have effectively increased velocities. Several structures have had some of the gravel surface eroded by winter flow, the material being deposited immediately downstream of the groyne forming shallow gravel riffles. The ends of the structures are areas of relatively high velocity: these areas have been utilised to great effect by both salmon and trout for spawning.

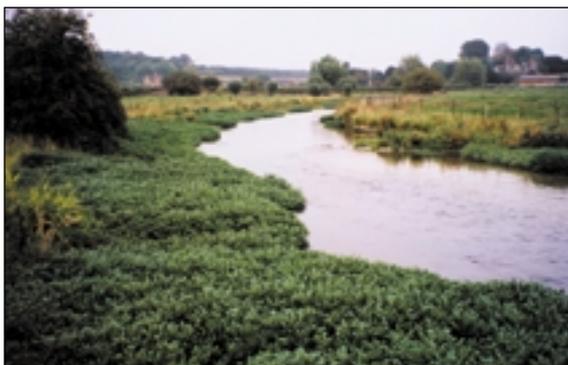
Silt deposits were quickly colonised and the river narrowed

An initial concern, visual intrusion of the groynes, has been negated by the rapid siltation and colonisation by marginal plants naturalising the structures and stabilising the banks. There was no significant difference in the performance and stability of the chalk filled groyne compared with the faggot filled structures: the chalk groynes were however 37% cheaper to construct.
