Icklingham Sluice, River Lark

Options assessment for Icklingham Mill Sluice

Type: Structural options appraisal,
flood risk management

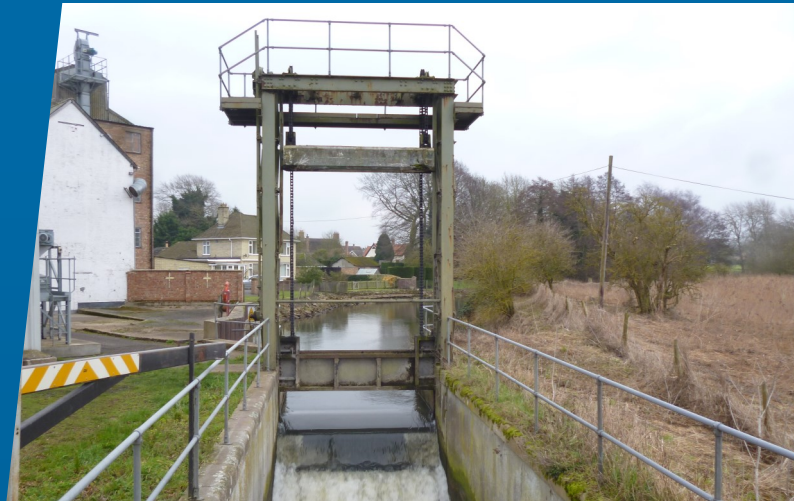
The Environment Agency commissioned RRC to carry out an options appraisal of the Icklingham Mill Sluice on the River Lark, Suffolk, and identify cost effective options for flood risk management. The structure is at risk of failure if it is not repaired or maintained, as well as acting as a barrier to migratory fish. Furthermore the remnant navigation channel is over-deep, over-wide and disconnected from the floodplain.

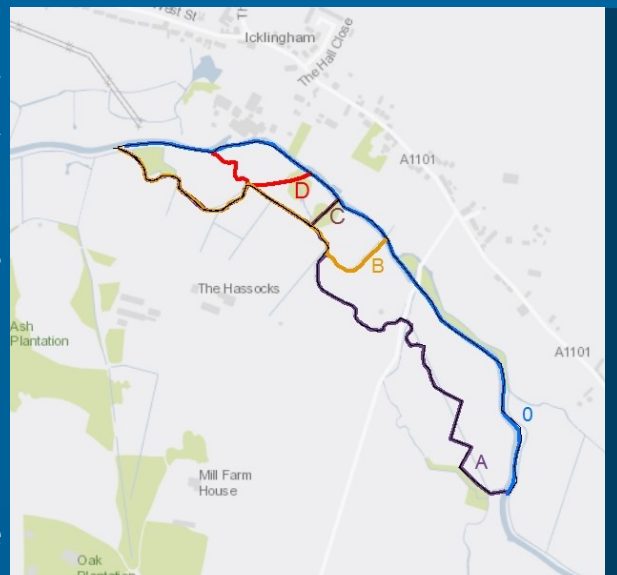
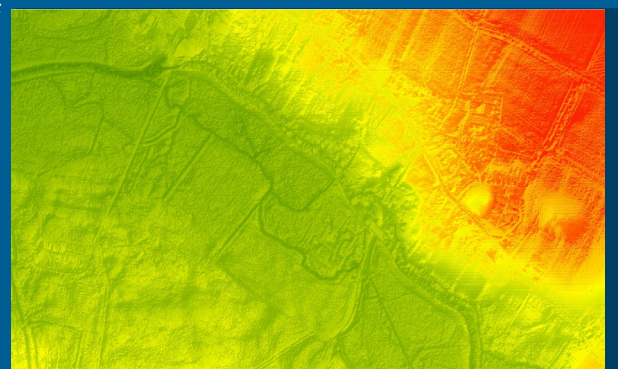
The RRC assessment included a field visit to meet the owners of the mill, and identify issues with the sluice; and a desktop study to review possible options for fish passage and geomorphological enhancement. Historical maps and aerial photographs were used to identify palaeo-channels in the landscape, which were used alongside LiDAR data to develop potential bypass channel pathways (see images). A series of options were suggested including:
