# the River Restoration Centre

## Technical Advice

### Thrift Farm, Buckinghamshire

*Identification of opportunities at Thrift Farm, Buckinghamshire to reduce flooding and bank erosion*

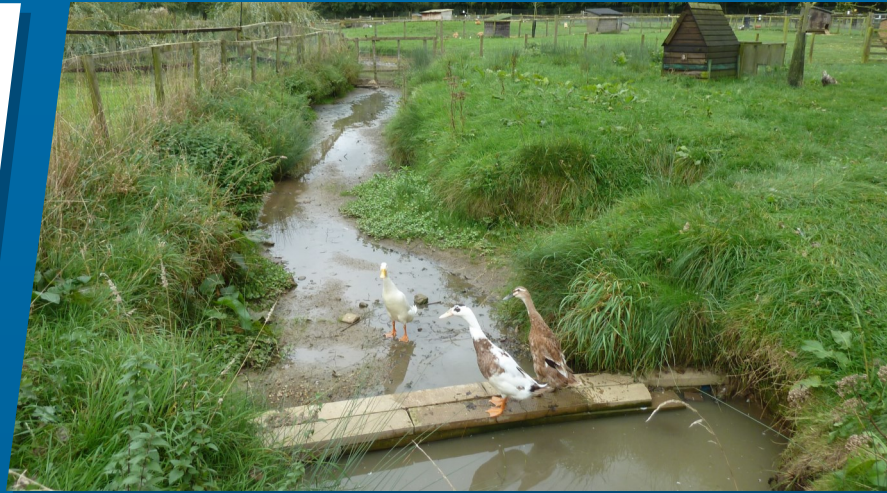
The channel was in poor physical condition because animals use it as a water source. RRC suggested solutions which would stabilise the banks whilst continuing to allow access for the animals (which the farm requires) with the use of coir rolls, gravel and ramps down to the water.

Suggestions have also been made on how Thrift Farm can reduce the impact of sudden high flows generated by overland flow in the immediate catchment, by installing bunds to intercept and slow this overland flow in adjacent fields.
