Thrift Farm, Buckinghamshire

Identification of opportunities at Thrift Farm, Buckinghamshire to reduce flooding and bank erosion

Type: Opportunity assessment

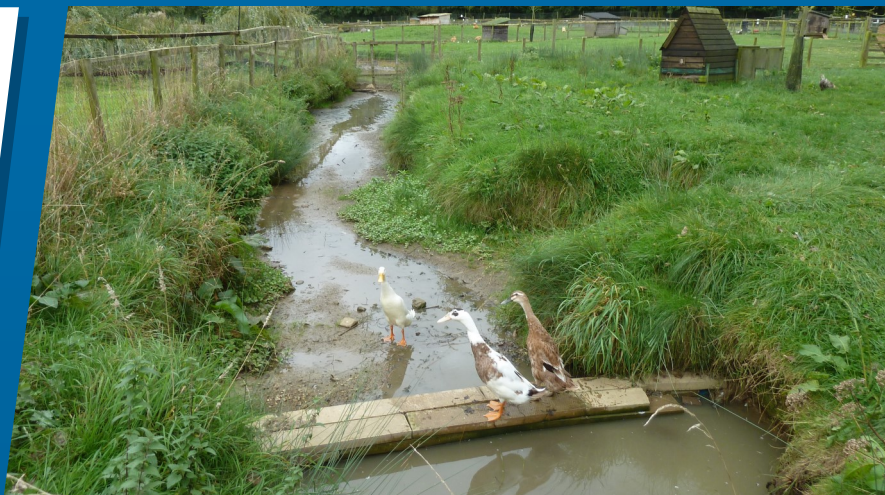
The channel was in poor physical condition because animals use it as a water source. RRC suggested solutions which would stabilise the banks whilst continuing to allow access for the animals (which the farm requires) with the use of coir rolls, gravel and ramps down to the water.

Suggestions have also been made on how Thrift Farm can reduce the impact of sudden high flows generated by overland flow in the immediate catchment, by installing bunds to intercept and slow this overland flow in adjacent fields.
