Improving Fish Passage at Gotter Water Weir

Mark Donoghue (Senior Engineer, Royal HaskoningDHV), Carina Agnew (Principal Environmental Consultant, Royal HaskoningDHV),

Rob Mitchell (Restoration Specialist, SEPA)

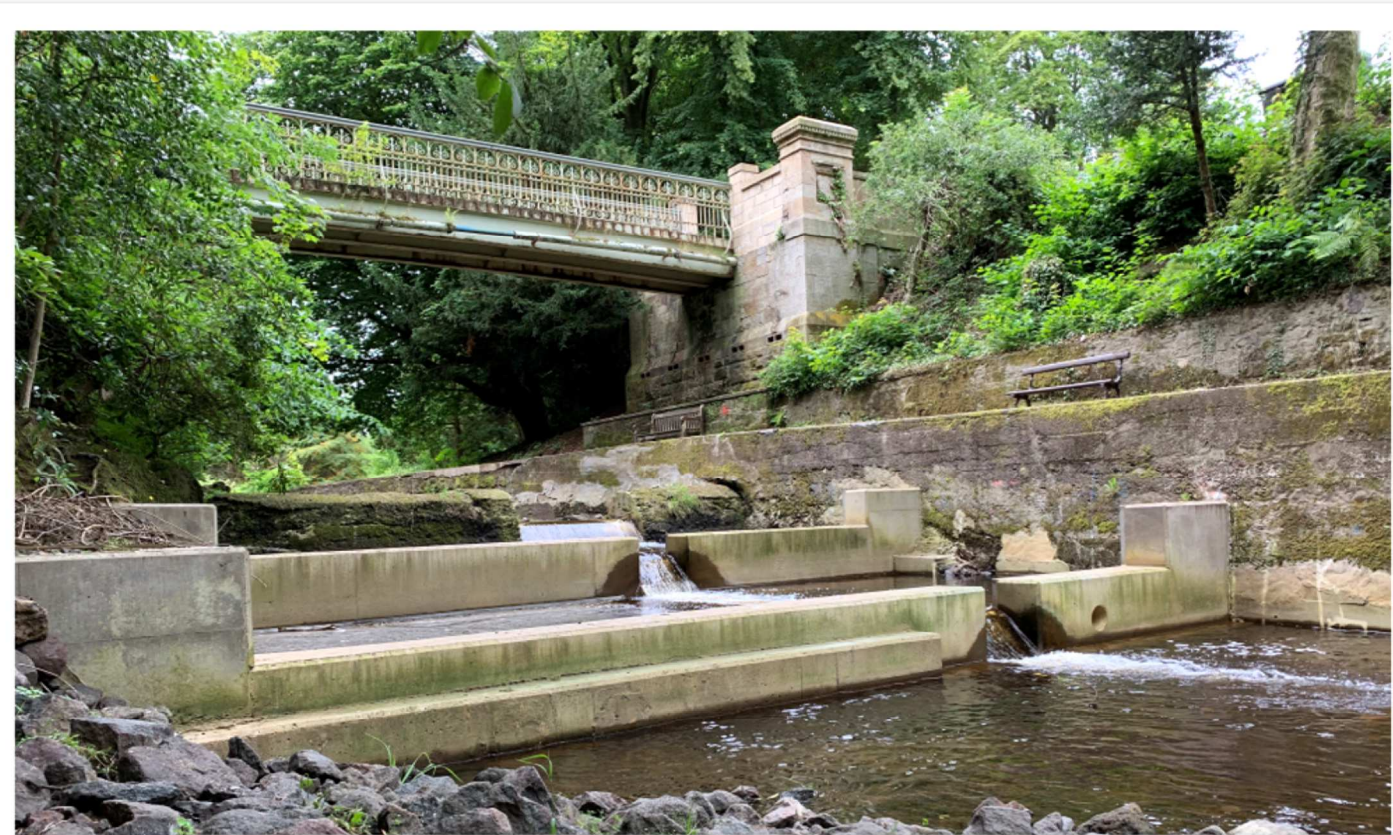
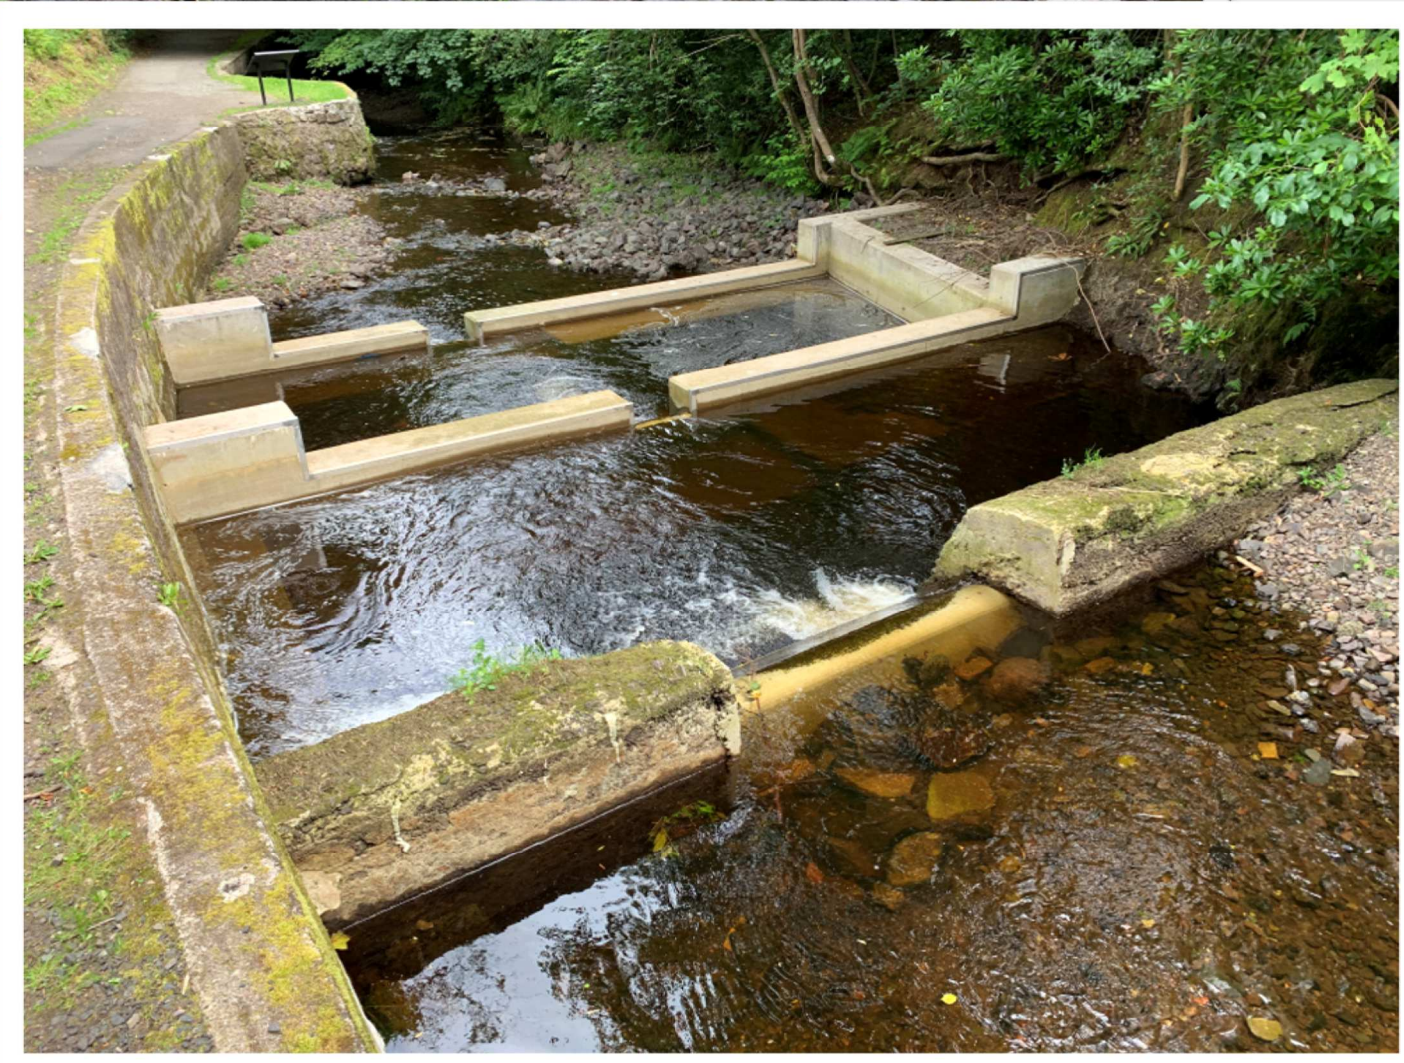
The scheme, comprising of the notching the existing 2m high weir crest and the construction of two reinforced concrete pre-barrage structures across the full width of the channel, opens up access to up to nine kilometres of high-quality upstream habitat for the first time in over 120 years. Construction was completed in December 2019 by George Leslie Ltd and salmon were observed using the pass within hours of completion. Electro-fishing by Clyde River Foundation in July 2020 identified salmon fry upstream of the weir and in three feeder streams of the Gotter Water indicating approximately 2km of habitat colonised in the six months since completion. Funding for the project has been provided through the Scottish Government's Water Environment Fund. The project was directly commissioned by SEPA, and Royal HaskoningDHV has been involved from the outset, leading feasibility and design phases and the supervision of construction works.
