Churchill Gardens, Salisbury City Centre

Technique: Enhancing concrete floodwalls

Project location: Salisbury
River: Avon
County: Wiltshire
Project start date: October 2004
Project end date: October 2004
Length: 0.1km
Cost: £2,230
Upstream grid reference: SU 150 293

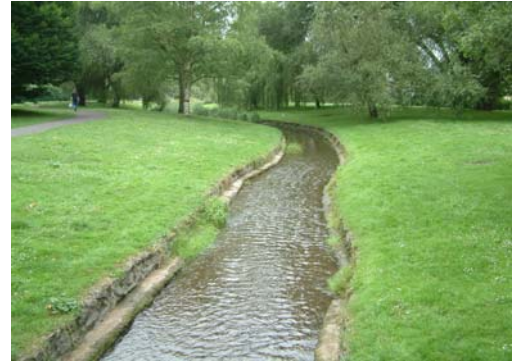
Original channel, upstream
of the enhancement works.
(Photo: M. de Retuerto)

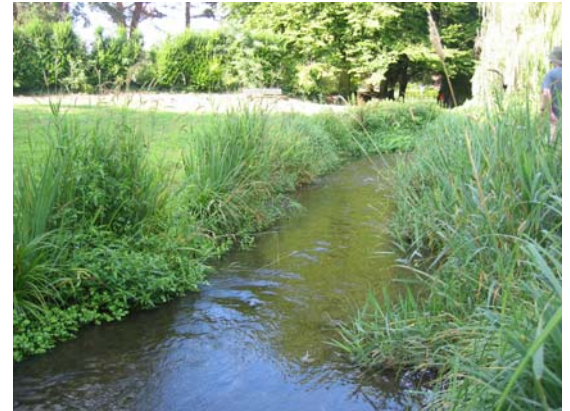
Well established plants within coir rolls totally hiding the hard edge. (Photo: M. Janes)

The vegetation within pre-planted coir rolls have quickly covered the unsightly bank. To the casual eye, there is little to suggest that there is a formal hard edge between the bank and the reedy fringe. The test over the next few years will be the ability of the vegetation to bind into the gravel bed and the silt depositing within the vegetation mass. If this is not successful, the plants may lack a solid base to anchor themselves once the coir rots away. In the unshaded sections (photo above) the root mass achieved may be sufficient, however where tree shading is restricting growth, this may be a problem. A solution might be to loosen/remove stones from the low wall to allow marginal roots to bind into the terrestrial edge.

- Pre-planted coir rolls used to soften the edges of the block-stone walls, providing marginal habitat for wildlife and improved aesthetic value of the channel. Once the flora has established these will provide vastly improved cover for fish and invertebrates, as well as improving the connectivity of the channel as a wildlife corridor. Coir rolls were secured in place using chestnut stakes and wire.
- Works were undertaken by volunteers living within the Salisbury area.
