# Channel Widening at Croxall Lakes

**Techniques:** Bank re-grading & removal; creation of shallows in adjacent lakes

**Project location:** Croxall Lakes Nature Reserve

### *the River Restoration Centre Case Study Series*

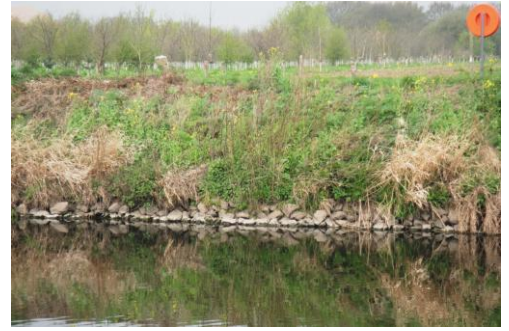
Typical condition of banks pre-restoration.  
© 2011 The River Restoration Centre

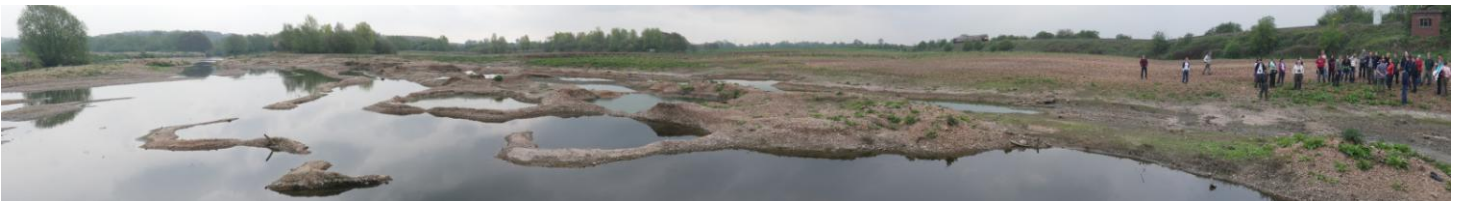
View of some of the complex micro-topography created in the widest part of the works. © 2011 The River Restoration Centre

Soil was removed from the right bank area over which the river was to be widened, to expose the extensive coarse gravels. The soil was deposited in the margins of the nearby lake to create shallows and areas of bare mud. Exposed gravels were moved around locally using excavators, bulldozers and dump-trucks to create bars, lagoons, spits and islands. One large island was created around some existing willows, and a live willow tree was also deposited and secured into the channel upstream. Extensive baseline geomorphology and wildlife surveys have been undertaken in order to evaluate the changes due to the works.
