Godinton Park Channel Enhancements

Technique: Revetment of eroded banks and channel narrowing, stock watering point and wet margin creation

the River Restoration Centre Case Study Series

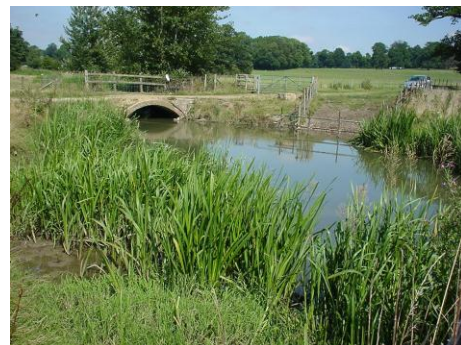
View of site 18 months after completion - wet margin well established in foreground

The channel was narrowed to its pre-erosion width using coir rolls staked to the river bed and back-filled with existing river silt. Volunteers from the Kent Stour Countryside Project then transplanted local marginal vegetation. Restored banks were fenced off from cattle. A stock watering point was created with design advice taken from the RRC Manual of River Restoration Techniques (Contact RRC for further details). A shallow slope was cut down to the water's edge using a digger and the bottom was reinforced with compacted, graded stone.

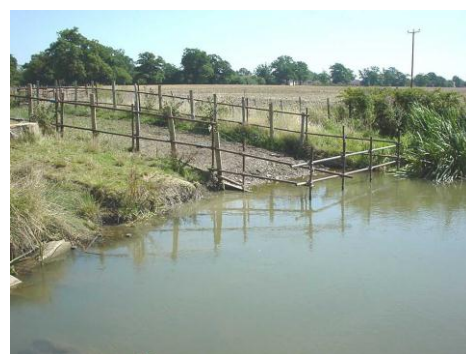
Cattle watering point designed to protect revetted banks from cattle poaching and direct cattle to one area

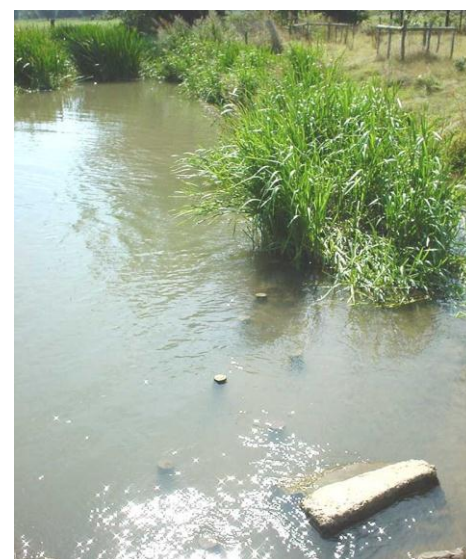
The coir rolls have overall successfully narrowed the width of the channel, although in 2 small sections on either side of the bridge the coir has been washed away. The transplanting of vegetation ideally should have been carried out earlier in the growing season (instead of July) but this was impossible due to high river levels with many of the taller species being washed away by the river. However, since then transplanted watercress has established well and it is expected that natural colonisation will occur.

View of one of the sections where the coir rolls have been washed away, leaving the stakes behind
