# Great Ryburgh Common Meander Loop Re-connection

## Techniques: Rural river restoration – channel re-meandering and narrowing

**Project location:** Fakenham

**River:** River Wensum

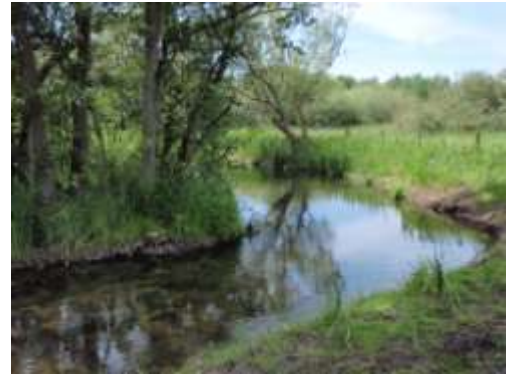
The old meander channel has been re-connected to the main river.

The old meander was carefully excavated leaving the riverbed gravels intact where they already existed. In addition new gravels were added to create shallow glides. Deeper pools were dug to provide refuge areas for fish and other aquatic species. The existing straightened channel was plugged such that in normal flow conditions, the river flows around the re-connected meander. The straightened channel therefore acts as a flood relief channel at times of high flow and as a quiet backwater during normal flow. In addition, channel narrowing was achieved by creating a bund along the line of the new bank, and this was covered with coir matting and was planted up with live plants.

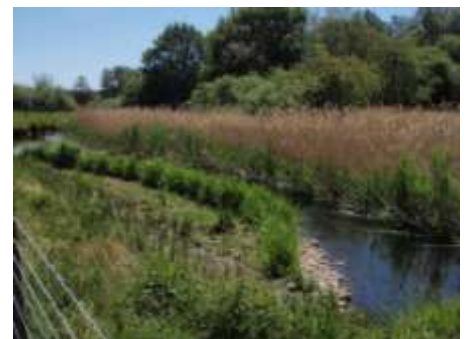
Post works – fully vegetated and functioning well as intended.

Eighteen months on, the site is fully vegetated and functioning well as a re-connected meander. The original gravel bed was exposed during excavation and the use of adaptive management allowed these original features to be incorporated into the on-the-ground works. The Environment Agency OPS team was used to do the works as they had experience of doing similar work (at Bintree further down the catchment). Prior to re-meandering, the channel was straightened and over-wide. The project has recreated the natural chalk stream habitat, with pool and riffle sequences. The substrate now has macrophytes growing along much of its length. By allowing high flows to pass down the old straightened channel the flood capacity has been increased, and during normal flows the old straightened channel acts as a backwater habitat.
