River Rhee, Cambridgeshire

Techniques: Narrowing, re-profiling, backwater creation

Project location: Wendy
River: Rhee
County: Cambridgeshire
Project start date: 2001
Project end date: 2002
Length: 2000m
Cost: £15,000
Upstream grid reference: TL 321 477

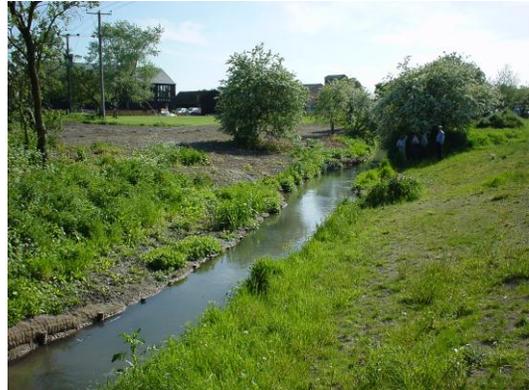
Narrowed section of the river

narrow and re-meander 200m of the river and improve the flow, creating a self-cleaning channel and reducing maintenance needs. Three existing bends were re-profiled to create an eroding cliff on

The bank has been levelled by machinery to create a more natural cross-section profile gradient. Biodegradable rolls have been used to good effect to narrow the channel and reduce the sluggishness of the flow, preventing siltation. A wildflower grass mix was spread onto the bare banks, and this has helped to recolonise the re-profiled bank. Typical marginal vegetation was used to backfill the coir logs, helping to further narrow the channel and provide cover for fish and invertebrates.

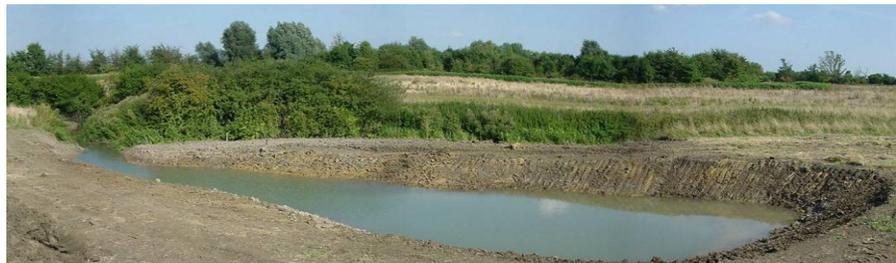
River Rhee backwater shortly after construction (August 2001)

the outside and a shallow wetted area on the inside. The bends will provide nesting areas for kingfishers and encourage a greater diversity of bankside vegetation. Finally a backwater was created to provide fish with a refuge during high flows, and habitat for fish fry and invertebrates.

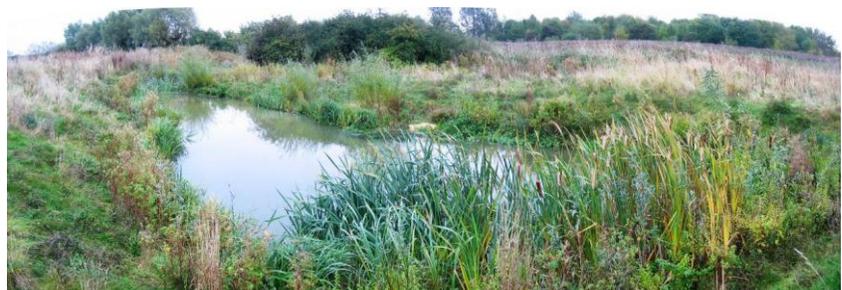
River Rhee backwater 3 years after construction (November 2004)
