River Roding at Ray Lodge Park

Techniques: Backwater & pond creation, bank re-profiling

Project location: Redbridge, North East London

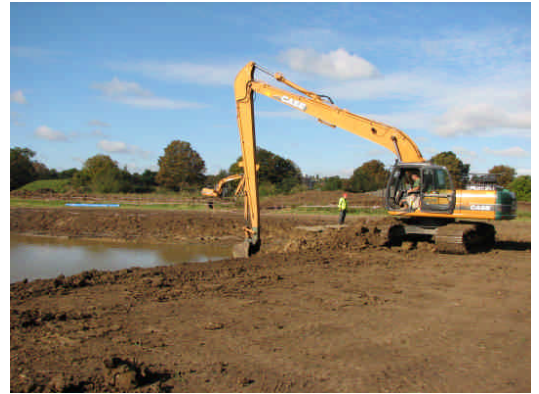
Work in progress to achieve new habitat features

Following the receipt of £140,000 of Office of the Deputy Prime Minister (ODPM) funding, earthworks took place between August and October 2007 at a number of locations. The banks of the river were re-profiled to a gentler gradient. Upstream of the footbridge the flood bund was realigned and raised and a backwater excavated to provide shelter for species such as chubb, roach and eel during periods of high flow. A pond was also dug behind the flood banks, with excavated gravel used to strengthen footpaths and improve access for the public. In May 2008, with help from the local volunteers and environment agency officers, the pond, backwater and a section of the river bank were planted up with numerous native riverside plants.

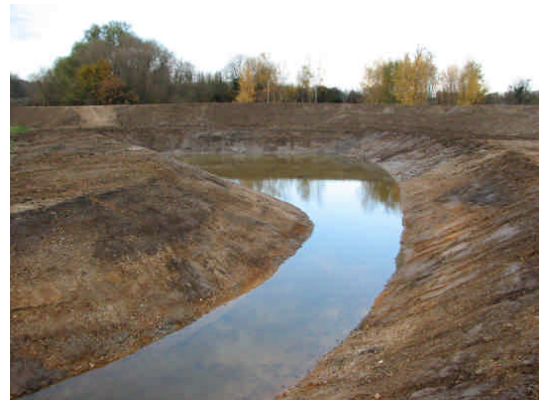
Backwater shortly after excavation

The excavation of a new backwater and floodplain appears to have provided a diversity of wildlife habitats able to support a range of species. The project is an excellent example of involving the local community especially through planting schemes and pre-project discussion both of which were important aspects in achieving a valuable and successful restoration scheme. Access to nature has been enhanced via new footpaths and a public recreational facility enhanced.

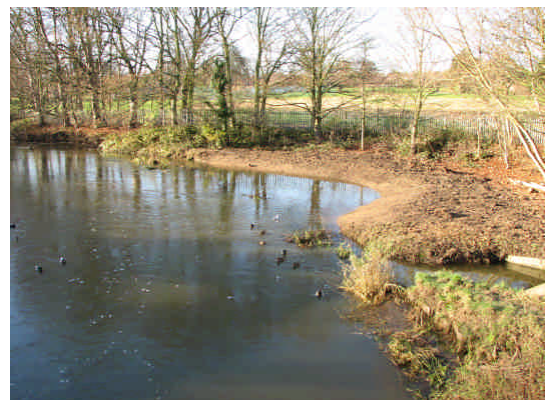
Re-profiled banks downstream of footbridge
