Boot Lane Enhancement Project - Gravel riffles (1)

the River Restoration Centre Case Study Series

Boot Lane Enhancement Project - Meander restoration (2)

Boot Lane Enhancement Project - Channel narrowing (3)

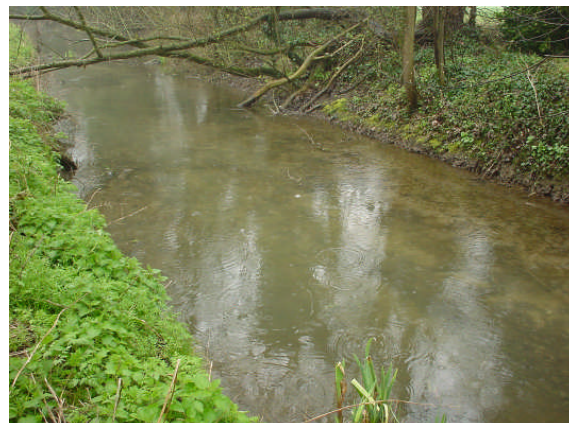
Stretch of the river Shep lacking clean gravels and spawning habitat

A topographical survey undertaken by 'the friends of the river Shep' (prior to the work) identified areas in which it was deemed suitable to import gravel. Subsequent work took place in November 2007 with the assistance of the local volunteer group 'the Barrington conservation trust'.

- Gravel, provided free of charge by the local Amstey Quarry, was tipped into the river channel at two locations; downstream of a meander, and immediately upstream of a footbridge.
- Volunteers from the local conservation group manually moved the 10 tonnes of gravel with wheelbarrows, tipping the gravel into the river in a controlled manner. Rather than creating a uniform riffle, a varied and undulating profile was created to create a pool/riffle sequence in the channel. Any existing water crowfoot (*Ranunculus fluitans*) was left in place and allowed to grow through the gravel.
- Vegetation was cut back by the local community group to allow light to enter the channel. Willow spiling bank revetments were installed prior to the gravel works to provide bank protection.

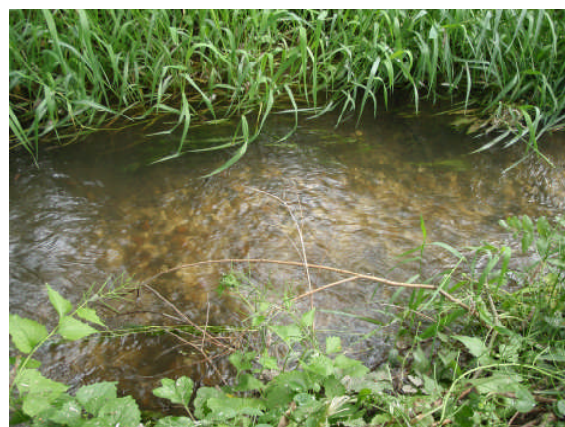
Gravel riffle, providing a spawning habitat for roach and chubb.

Since the work took place, fish have been observed spawning on the newly created gravel riffles. In-channel vegetation growth has increased, with starwort (*Callitriche stagnalis*) and water crowfoot (*Ranunculus fluitans*) being observed. This project is an excellent example of what can be achieved by working with the community and with little funding available.

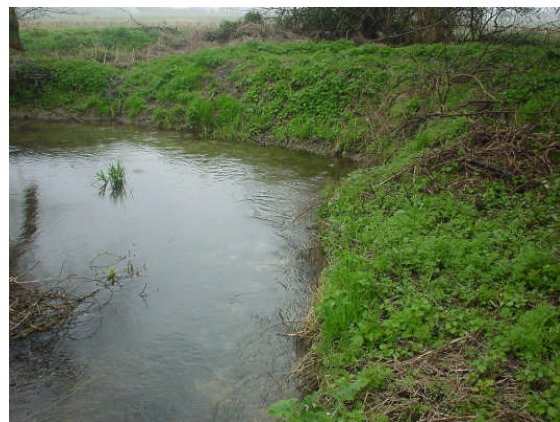
Eroding outside bend of meander as a result of the horse drink.

The River Shep is a chalk stream, much of which is heavily degraded and has suffered from a combination of historical management, especially dredging and hence removal of any gravels, and water abstraction. The meander bend located downstream of the footbridge has previously been dug out and re-graded by the landowner to form a horse drink (which is no longer in use). Horses have subsequently eroded the banks, and the river has become over-wide and incorrectly aligned. As the river has been trying to find a more 'natural' profile, siltation has occurred on the inside of the bend, and the outside of the meander has subsequently suffered from erosion. Following a site inspection by the River Restoration Centre, a series of recommendations to enhance the river were made in March 2005.

- Brushwood and faggot bundles were installed on the outside of the meander bend, which were staked and tied to the river bed and bank, encouraging siltation by slowing the flow through the structure and reducing levels of bank erosion.
- Willow and reed canary grass were planted in order to stabilise the bank further.
- Vegetation has been maintained in recent months by hand cutting, in order to maintain the summer low flow channel.

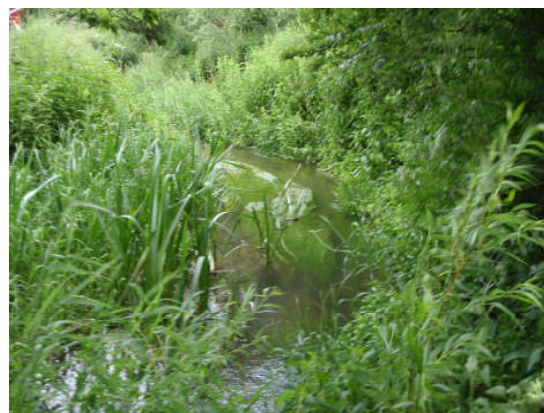
Recovered meander showing increased in-channel and marginal vegetation growth

Since the works took place, vegetation has established rapidly on the bank as well as on the berm on the inside of the meander. Whilst vegetation has established well on the berm, consideration may need to be given to further cutting the meander in order to prevent scouring of the berm.

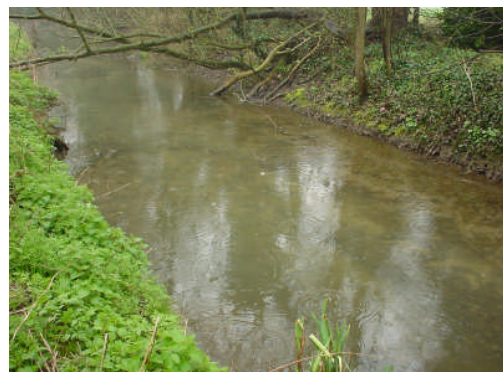
The River Shep is a chalk stream, much of which is heavily degraded and has suffered from a combination of historical management, especially dredging and hence removal of any gravels, and water abstraction. The river at this section was over-wide and too large to support average summer low flows. The reach was also heavily shaded, with very little light able to penetrate the extensive vegetation cover in order for in-channel vegetation growth to occur. Subsequently, there were very few of the features expected to be seen in the context of a chalk stream environment. Following a site inspection by the River Restoration Centre, a series of recommendations to enhance the river were made in March 2005.

A heavily degraded stretch of the River Shep, with little flow variation and no in channel vegetation.

- On the straight section upstream of the footbridge, 100m of channel was narrowed to 50% of its original width. This was achieved by installing faggot bundles supported by posts driven into the bank, creating a habitat ledge for vegetation growth to occur. The ledge was partly planted with marginal vegetation (reed canary grass and sedge) to bind deposited silt together.
- Cambridge conservation volunteers undertook tree management along the reach to reduce shading and allow light to penetrate through the vegetation.

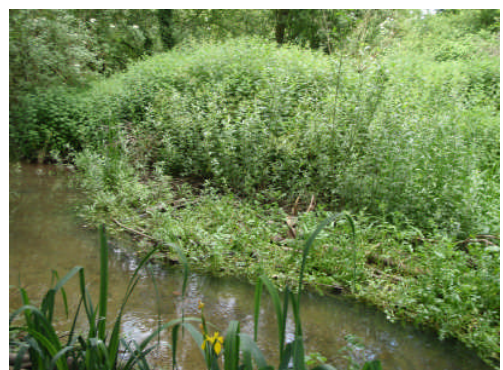
Narrowed section of the Shep using faggot bundles.

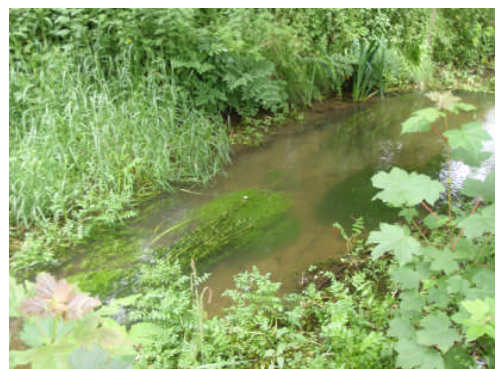
Establishment of in-channel vegetation following channel narrowing.

Since the work took place, vegetation has naturally begun colonising the habitat ledges. With increased light entering the channel, growth of in-channel vegetation including water crowfoot (*ranunculus fluitans*) and starwort (*callitriche stagnalis*) has increased. The Environment Agency have since been undertaking electro-fishing surveys to monitor brook lamprey, bullhead, brown trout and dace populations. Populations of trout have been observed.
