Stoke Brook Floodplain Restoration, Stoney Middleton

Techniques: Floodplain restoration

the River Restoration Centre Case Study Series

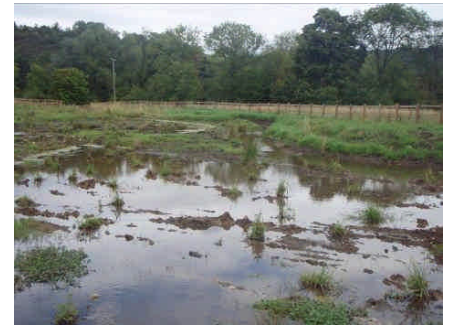
Creation of floodplain habitat to act as further environmental buffer to the receiving water course

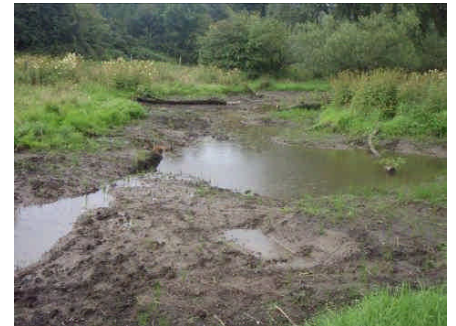
Floodplain dug out and reprofiled to create wetland habitat

- Previous work in which a tributary stream to Stoke Brook was confined to a concrete channel was modified. This involved removing the stream from its concrete channel and creating a series of shallow channels across a lowered and widened floodplain;
- An existing pond was reconnected to the river by constructing a back-channel, whilst the original connecting pipe was blocked up and coir rolls placed on the banks;
- Offline ponds were dug out of the floodplain at varying levels, fed by a water meadow further upstream.

In conjunction with the works to remove the sediment within Stoke Brook and Derwent, valuable wetland habitat has been created at a number of locations on the floodplain of Stoke Brook. By not over-designing, the work was completed quickly and efficiently, providing good quality habitat with high conservation value to a range of species, including dragonflies and damselflies. The specialised machinery was vital to the work, enabling varying levels in the wetland to be dug out.
