# River Brent at Tokyngton Park

Techniques: Re-meandering, backwater creation, de-culverting

**the River Restoration Centre Case Study Series**

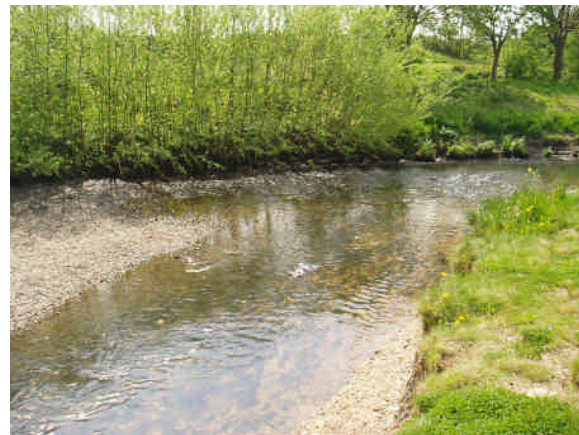
*Bank stabilisation with crushed concrete (hidden) and live willow poles providing good marginal habitat*

The partnership developed a masterplan for the whole park following a community consultation through a Planning for Real ® exercise. The river provided a focal point in this process with the aspiration to provide a better environment for wildlife and people. The concrete river banks were removed and the watercourse re-meandered. Some banks needed stabilisation which was achieved using live willow poles on the bank and re-cycled crushed concrete from the site at the toe; other less vulnerable banks were left to naturalise. Pool and riffle sequences were initiated within the design by varying the bed levels and introducing natural river gravels. A backwater was created and planted with reeds to provide an additional habitat feature and refuge in times of flood or pollution events.

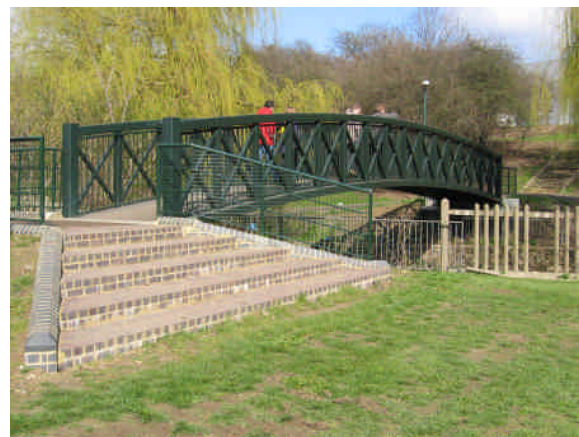
*New footbridge constructed across river*
