River Wensum Rehabilitation Project

Technique: Restoring a defunct meander

Project location: Billingford
River: Wensum
County: Norfolk
Project start date: April 2000 (5 days)
Project end date: April 2000
Length: 30m section
Cost: £3500
Upstream grid reference: TG 006 200

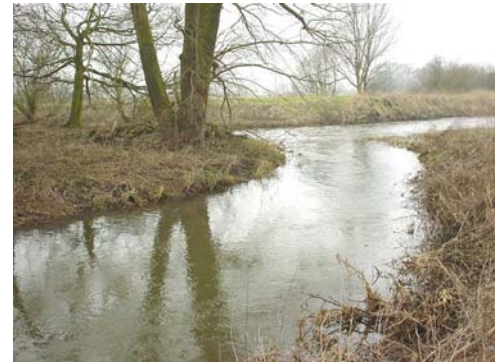
Restored meander on the Wensum, Billingford. View looking upstream to in-flow of meander.

Water now circulates freely around the restored meander loop. Protruding tree roots on the opposite bank of the main river act as a natural deflector to send flow around the backwater. The in-flow at the upstream end of the meander is quite narrow which may restrict flow and cause sediment to begin silting up requiring further maintenance (dredging). Widening of the in-flow could help to maintain a constant flow at all times of the year and prevent excessive silt build up.

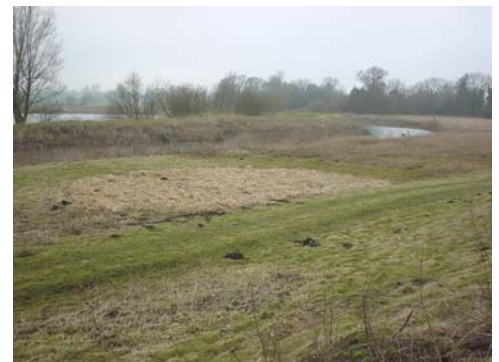
Dredged material deposited on floodplain. View of restored meander in the background.

- The sheet piling was removed from the upstream and downstream ends of the meander loop. Material was dredged out of the loop and deposited on the floodplain nearby.
- The new backwater was fenced off to protect the banks from poaching by livestock.
- A deflector was constructed at the upstream end of the old meander loop to divert flow into the new backwater. An otter holt is also planned for construction.

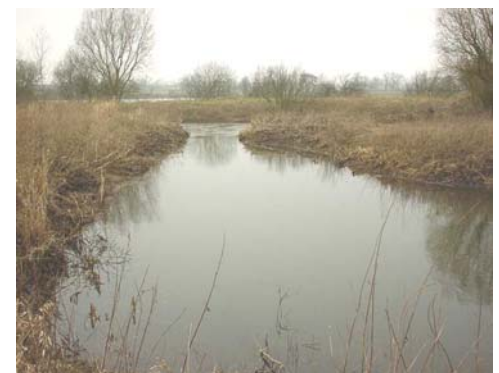
Out-flow of restored meander into main river Wensum. Water-filled gravel pits in background.
