# River Wensum Rehabilitation Project

## Technique: Bank revetment using bio-engineering methods

**Project location:** Fakenham  
**River:** Wensum  
**County:** Norfolk  
**Project start date:** December 2000  
**Project end date:** February 2001  
**Length:** 130m section  
**Cost:** £20,000  
**Upstream grid reference:** TF 917 293

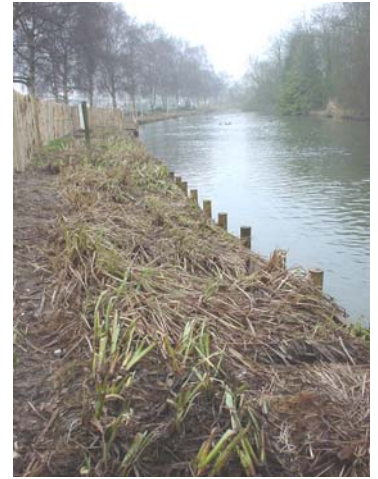
Coir mattress bank revetment on the Wensum, Fakenham.  
Temporary fencing erected to allow structure to stabilise

- Coir mattresses were laid side by side extending back 1.5 to 2m from the water's edge.
- A double layer of coir rolls were staked in at the foot of the bank.
- Sediment dredged from the river was used to fill the gap below the mattresses.
- A degradable membrane between the mattress and dredged sediment was used to retain silt.
- The tops of the coir rolls were planted with *Juncus* sp. (rush).
- Timber railing (20 year life) was staked into the base of the river bank to hold the structure together.
- 6 angling platforms were constructed out of timber boards allowing access to the river at selected access points.

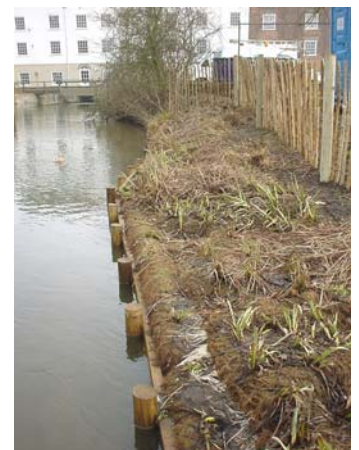
View of coir rolls with coir mattresses behind  
and timber railing at the toe.

As the bank revetment was only completed in February 2001, vegetation has not yet become fully established. However, 'live' coir rolls and mattresses do provide instant protection against further bank erosion. An alternative approach to the design of the revetment which may have reduced costs could be one layer of coir roll with the mattress covering the top of the roll. By doing this the timber railing which currently shows above water level could be replaced with wooden stakes below water level.
