Woody debris in rivers (England and Wales) – supplementary case studies

Quick guide 139_13

Issued 11/03/2013

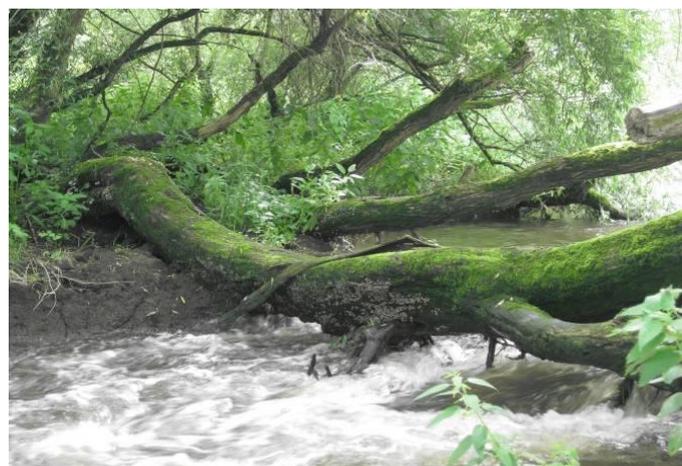
In 2011 a bypass channel was constructed to enable fish passage and to help achieve WFD objectives. A live willow crossed the route of the new bypass channel, rather than removing this tree it was retained as a feature.

The willow has helped restore river-floodplain connectivity creating upstream flood storage. It has also created physical diversity within the channel providing habitat for invertebrates, fish and plants.

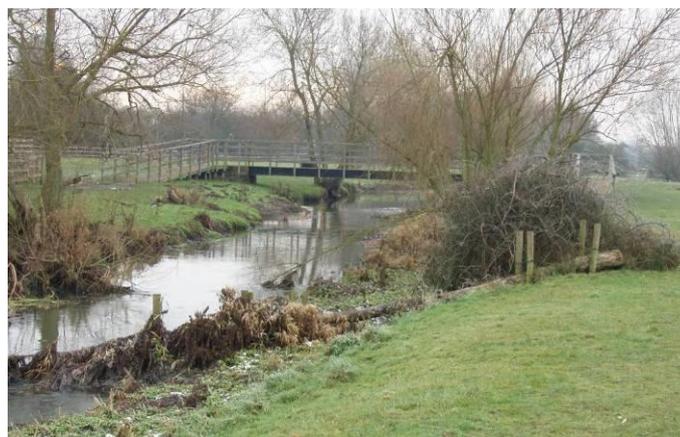
The fish population surveys show the dramatic effect that the woody debris has had. From 2007 to 2008 the total biomass of fish caught more than doubled, with the number of Roach in particular increasing. However, in 2010, after the removal of some of the woody debris, the fish biomass fell sharply to a little more than it's 2007 level.

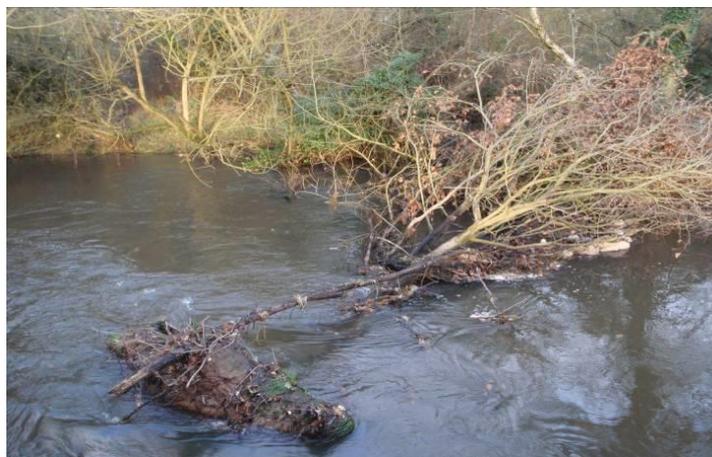
A small oak tree has recently fallen into the River Blackwater towards the south of Shepherd Meadows. Because of the position and size of the tree it doesn't present any flood risk, it was therefore retained to improve the river for wildlife.

The tree is inspected 6 monthly to ensure that it is stable and to monitor the development of the river channel. Litter is removed from around the tree annually.

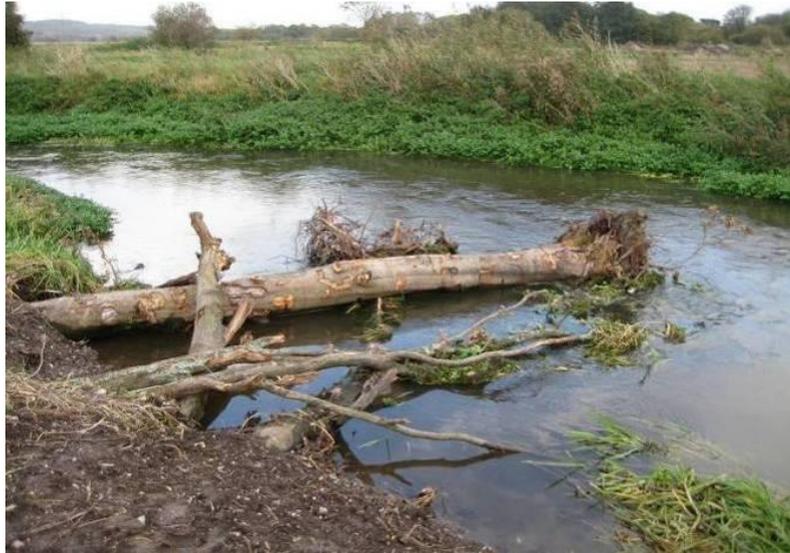
Buried limbs (third) in banks

In 2009, a 1.5km reach of the River Frome SSSI was rehabilitated as part of the River Frome Rehabilitation Plan. This historically dredged channel had bed and bank reprofiling carried out to introduce flow and habitat diversity. Woody debris was installed along the reach using a range of different techniques including buried limbs, tree hinging and tree kickers

Deep pools are created below the woody debris structure and often sands or gravels are distributed downstream. Faster velocities will be created at the structure's edge keeping spawning gravels clear of silts. A range of habitats are created supporting a wider variety of plants, fish and invertebrates.

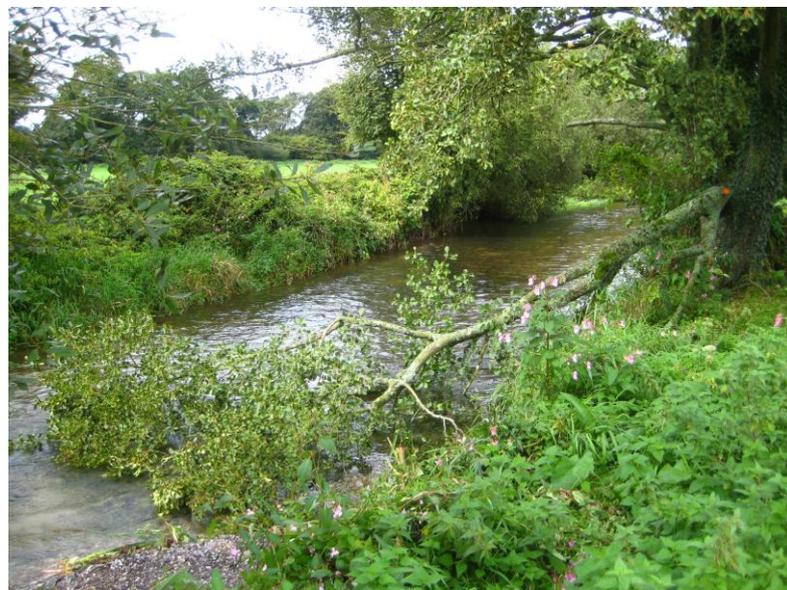
Tree hinging (live limbs)

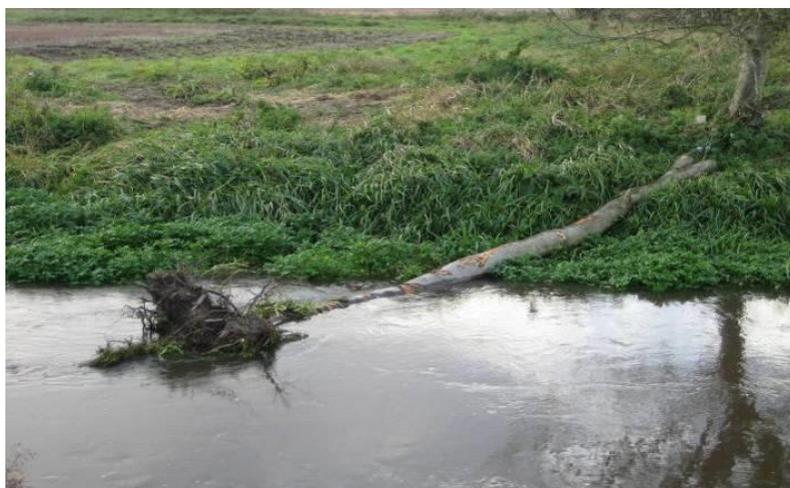
Small Tree Kicker (attached to existing tree)

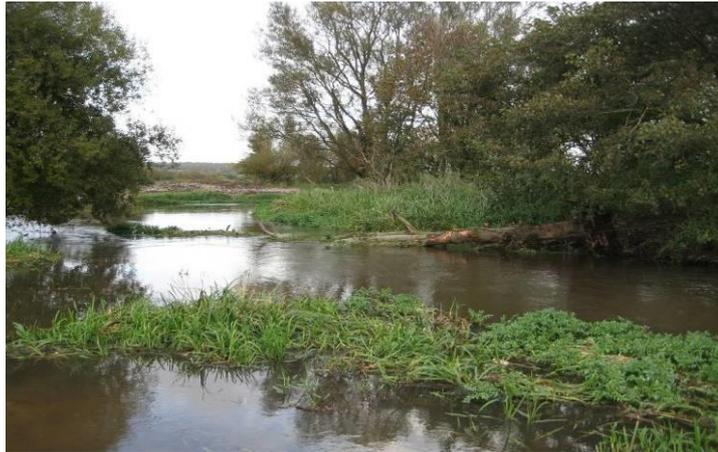
Large Tree Kicker

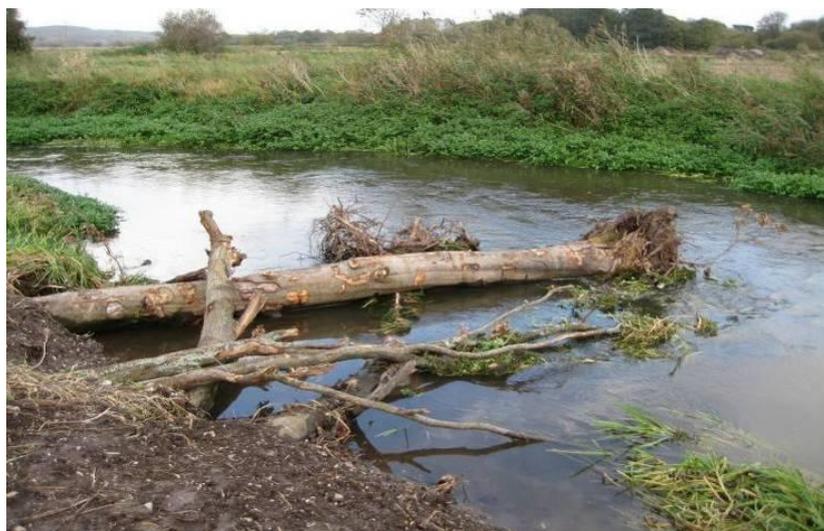
Tree hinged and buried in bank to create back water for fish

The hinged trees have helped create a marginal zone in the channel where they were installed. They have created refuge areas for fish fry and help trap sediment. Each structure creates a variety of flow patterns, faster velocities help keep spawning gravels clear of silts. A range of habitats are created supporting a wider variety of plant, fish and invertebrate species.

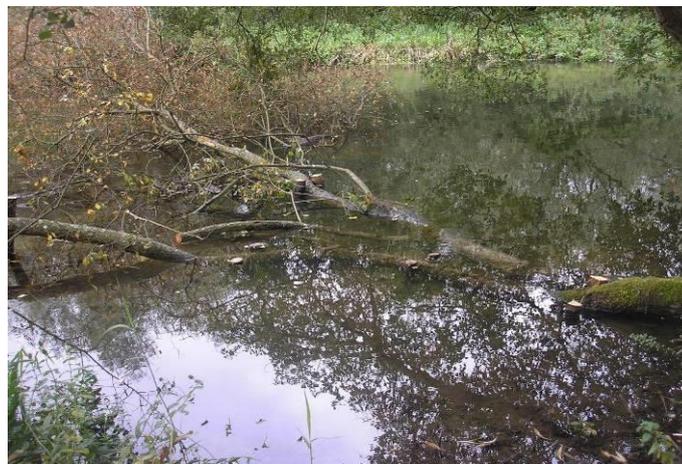
In 2011, a reach of the River Avon SSSI / SAC at Amesbury (downstream of Ham Hatches) was rehabilitated in partnership with Salisbury and District Angling Club (SADAC) as part of the River Avon Restoration Project. Woody debris was installed along the reach to provide improved marginal habitat. These structures were created using felling and pinning (chestnut stakes and wire) the limbs to the bed and bank.

The staked limbs have helped form a marginal zone in the channel where they were installed, creating refuge areas for fish fry and helping trap sediment. Faster velocities on the outer edge of the structure keeps spawning gravels clear of silts. A range of habitats are created supporting a wider variety of plant, fish and invertebrate species.

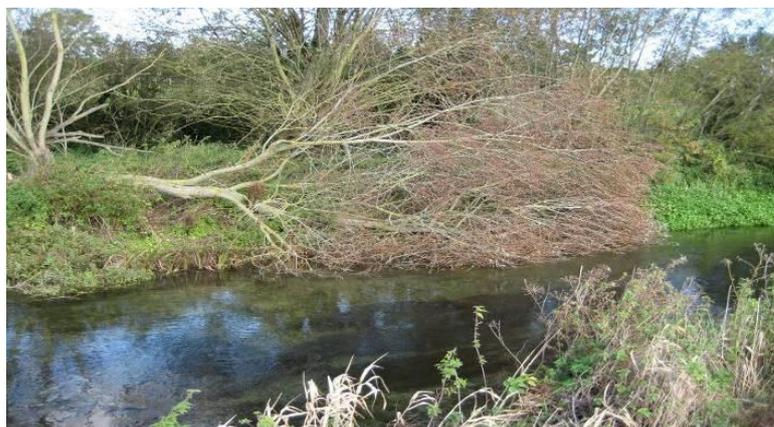
In 2009, a reach of the River Avon SSSI / SAC at Langford Lakes was rehabilitated as part of the River Avon Restoration Project. Woody debris was installed along the reach to provide improved marginal habitat. These structures were all created using felled and pinned trees that are pinned to the bed and bank.

The staked limbs and / or trees have helped create a marginal zone in the channel where they were installed. They have created refuge areas for fish fry and help trap sediment. Faster velocities on the outer edge of the structure helps keep spawning gravels clear of silts. A range of habitats are created supporting a wider variety of plant, fish and invertebrate species.

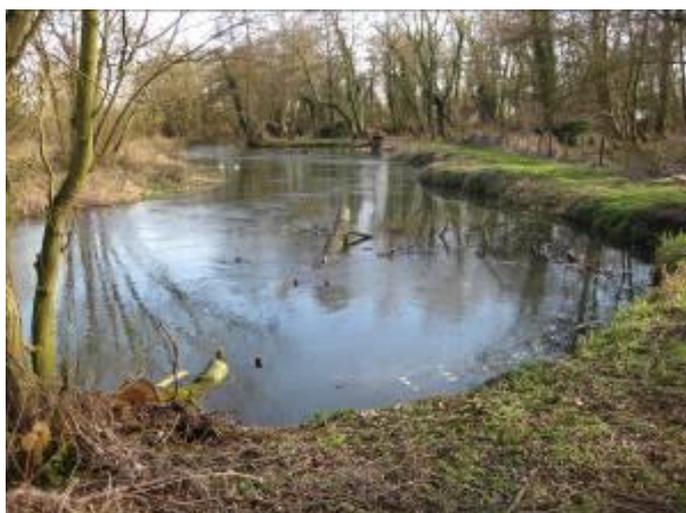
Excavated back water

The project installed over 20 pieces of woody debris over a 2km stretch of the SSSI. The aim was to create in-stream habitat and improve flow diversity to help increase fish populations. In addition to woody debris, three back waters were excavated to provide refuges for fish during high flows and habitat for juvenile fish.

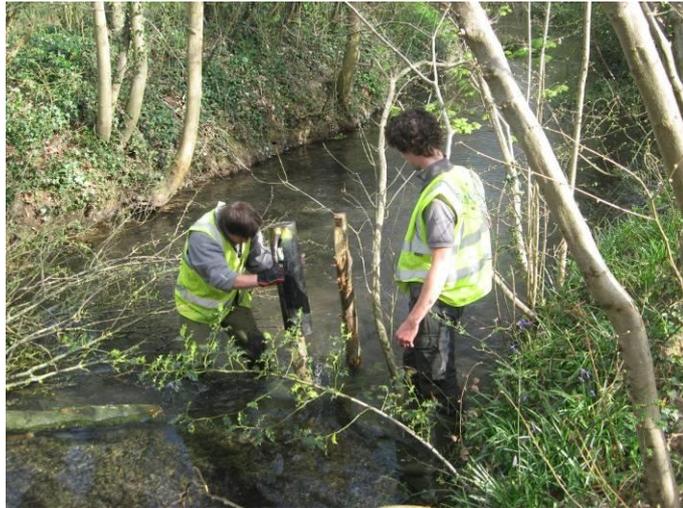
Photo of contractors installing woody debris

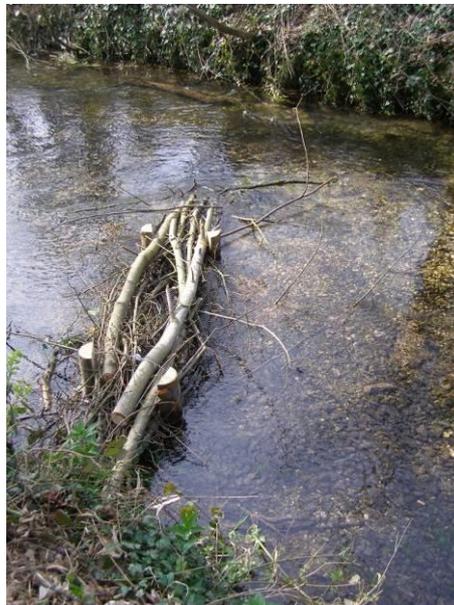
Woody debris in place

We improved the River Loddon, to the East of Basingstoke, through the installation of woody debris in a section of channel which was previously over-shaded and over-wide.
