## Enhancing Straightened River Channels

### 3.11 Sinuous low-flow course in an over-wide urban channel

#### RIVER WANDLE

LOCATION - CARSHALTON, SUTTON, SOUTH LONDON TQ 28166504

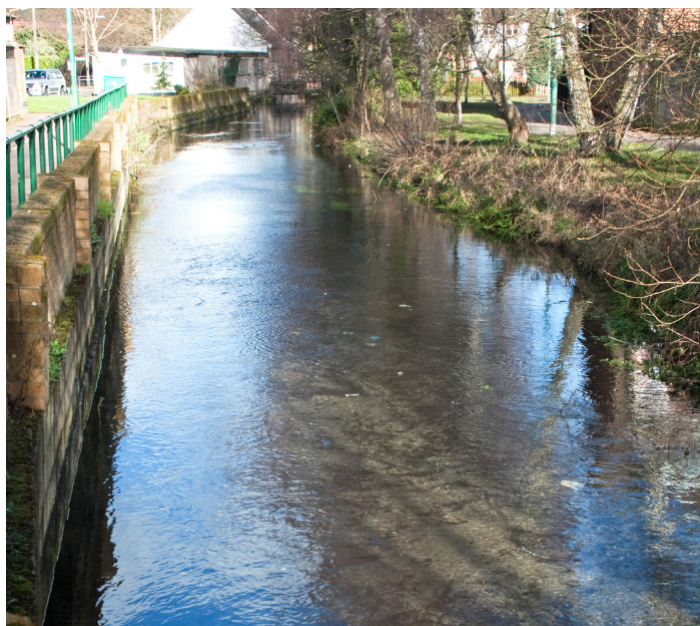
Fine sediment fills the impounded river - Feb 2013

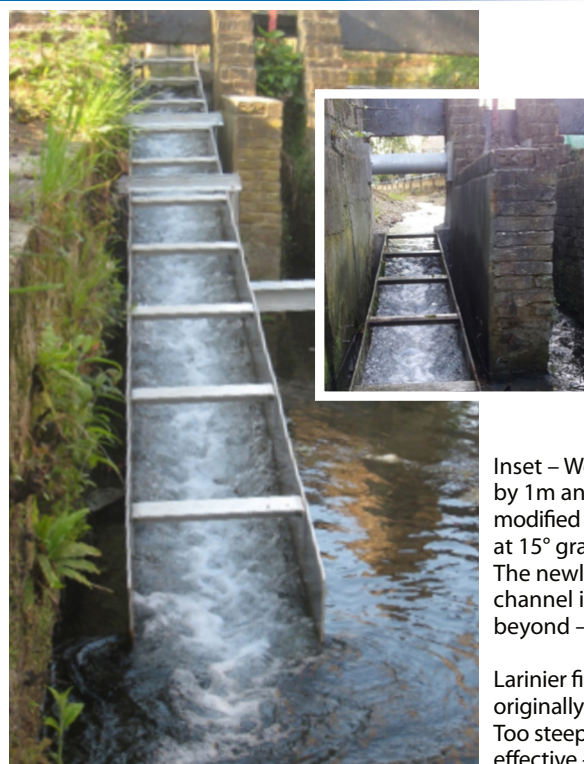
Inset – Weir lowered by 1m and fishpass modified and refitted at 15° gradient. The newly restored channel is visible beyond – 2014

Lariner fishpass originally installed. Too steep to be effective – 2012

Butter Hill Mill weir was part of an old mill structure, and a Lariner fishpass had previously been installed but had never worked due to its length and steep angle. The weir was not designated and surveys showed the structural integrity of the adjacent building was not dependent on the weir. The weir was lowered by 1m enabling the upstream impoundment to be removed and the fish pass to be modified (shortened and shallowed to a 15 degree gradient) over the remaining head drop to allow fish to pass upstream. Further work was needed throughout the previously impounded reach to address the excessive fine sediment build up and recreate the missing low-flow gravel channel.

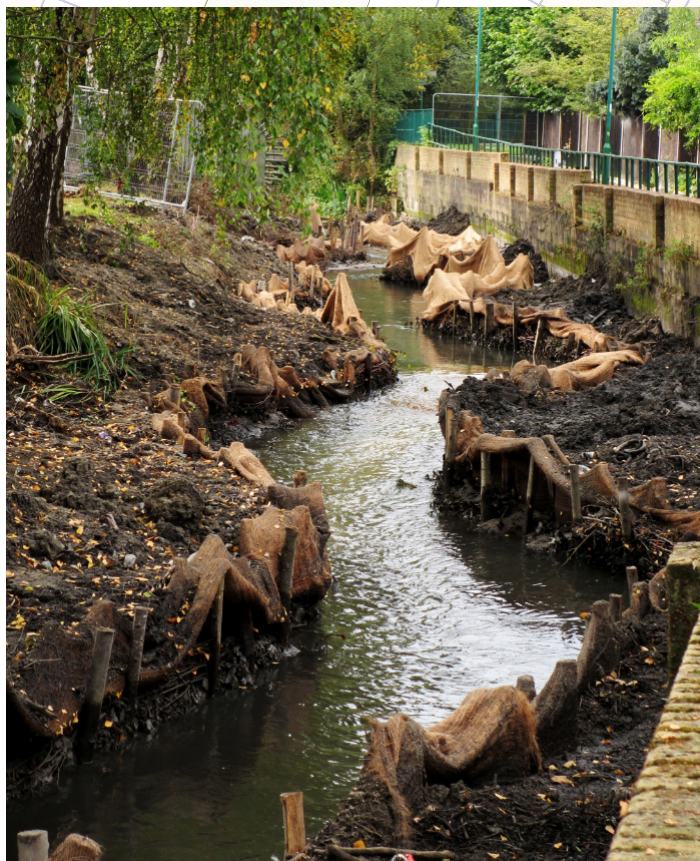
Desilted central channel.  
Spoil placed behind the  
faggot rows and coir matting  
– Sept 2014

1. Sinuous new bank lines were created with double height green chestnut faggots pushed into the exposed silt. The faggots were held in place using 1.5m chestnut posts which were driven down on either side of the faggots through the rubble strewn bed. The faggots were compressed and secured in position with fencing wire. Coir geotextile lined the back of the faggots with a short skirt laid on the exposed silt and the remaining width sat on the faggots whilst the central channel was excavated. The silt in the central channel was excavated by machine and placed behind the faggots (trapping the skirt of the coir matting). The coir geotextile was then rolled back from the faggots over the silt to prevent it from being mobilised under high flow events.

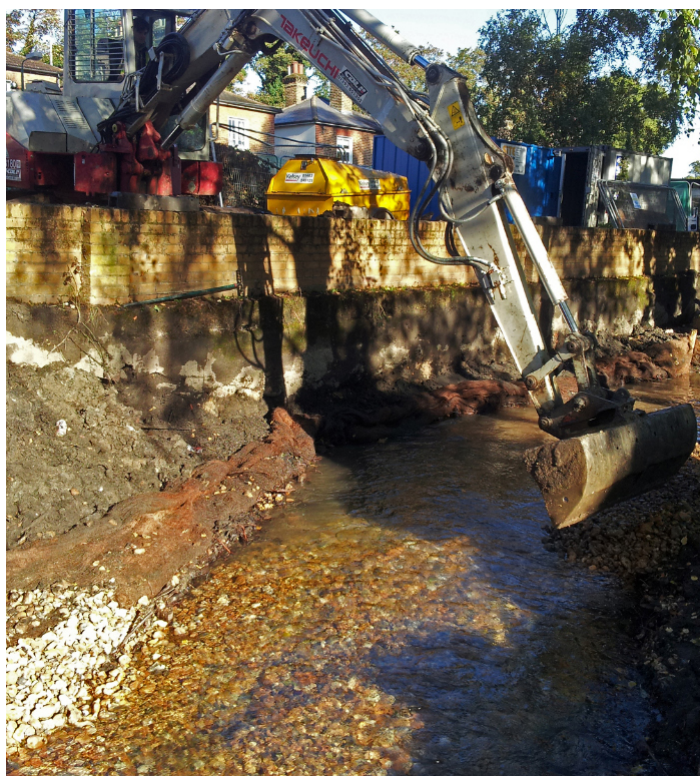
Filling the channel with gravel and pushing down the posts and faggots – Oct 2014

2. 110 tonnes of Thames catchment 40mm+ flint reject gravel was placed into the desilted central channel and sculpted to include pools and point bars.
3. The faggots and posts were pushed down further into the silt to follow the dish profile of the new bed. The gravel was raked up to cover all of the faggots to form a seamless transition between the bed and bank.
4. A number of tree limbs were pinned into the bed to add flow diversity and encourage scour to retain pool habitat.
5. Volunteers planted 2000 plugs of marginal plants on the new berms to help stabilise them further and kick-start colonisation of these wet edges. This was deemed necessary as there was no good upstream source of plants for natural colonisation.

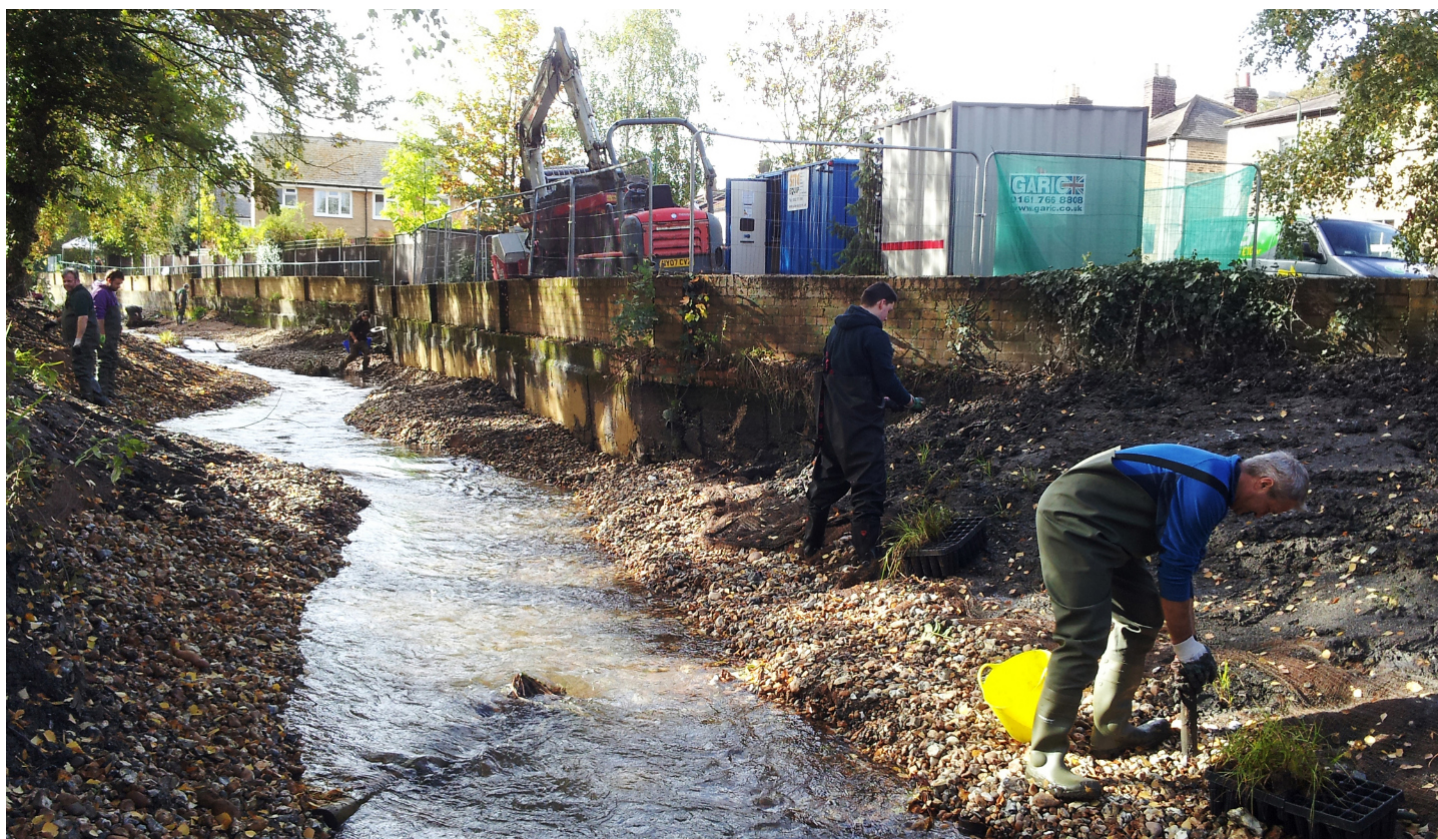
The shaped sinuous gravel bed and berms being planted – Oct 2014

The native marginal plant list was agreed with the EA and London Borough of Sutton's ecologist. A variety of plants included reed canary grass (*Phalaris arundinacea*), greater pond sedge (*Carex riparia*), lesser pond sedge (*Carex acutiformis*), purple loosestrife (*Lythrum salicaria*), yellow flag (*Iris pseudacorus*), hemp agrimony (*Eupatorium cannabinum*), soft rush (*Juncus effusus*), water forget-me-not (*Myosotis palustris*) and water mint (*Mentha aquatica*).

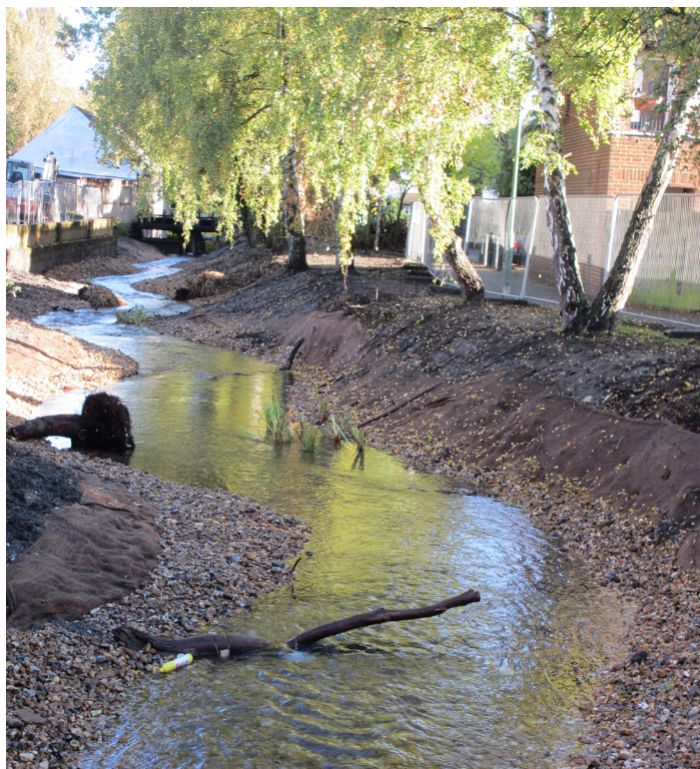
A shallow fast flowing gravel bed chalkstream again – Oct 2014

From observation, the hydromorphology of the restored reach has worked as predicted in terms of water depth, flow diversity and movement within the gravel but not excessive mobilisation in a downstream direction.

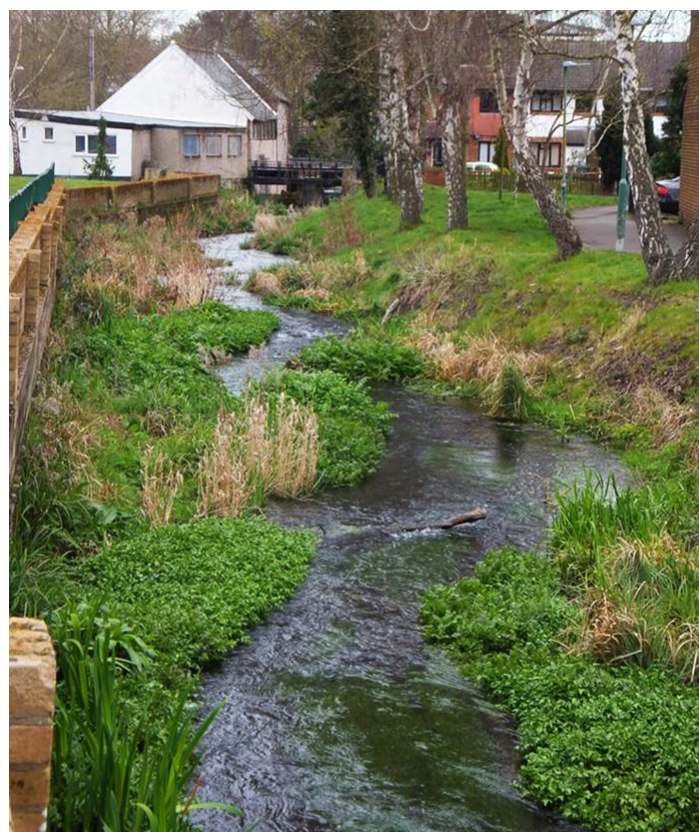
Rapid plant colonisation – Jun 2015

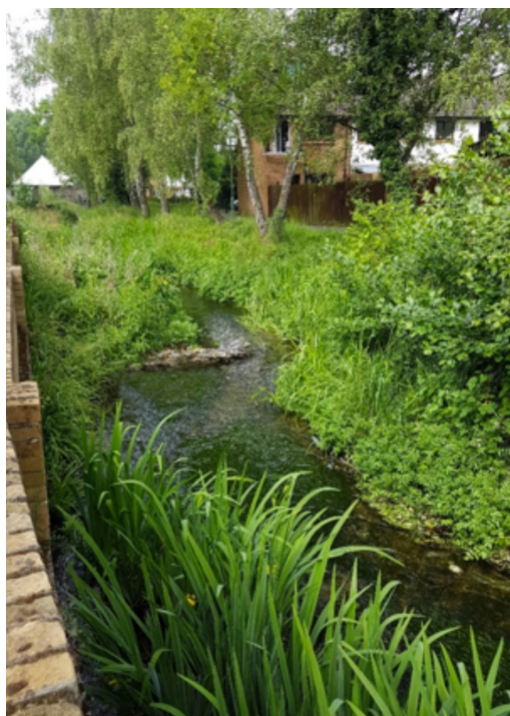
Established well-vegetated stream - 2019
