Enhancing Straightened River Channels

3.12 Establishing marginal habitat along a hard engineered bank

RIVER NENE

LOCATION - THORPE LEA, PETERBOROUGH TL18749817

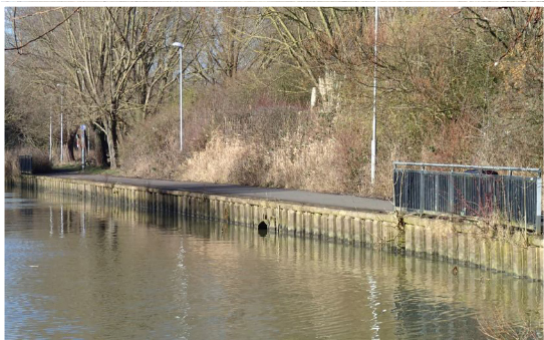
Sheet pile and concrete bank – Feb 2015

At Peterborough, the river is around 50m wide and has been modified to protect the nearby city centre and residential properties. It has been over-deepened, over-widened, impounded and constrained by hard bank protection. The north bank is reinforced with vertical sheet-piled concrete and brick walls, with a footpath alongside top. This looked unsightly and provided no marginal habitat for invertebrates and fish.

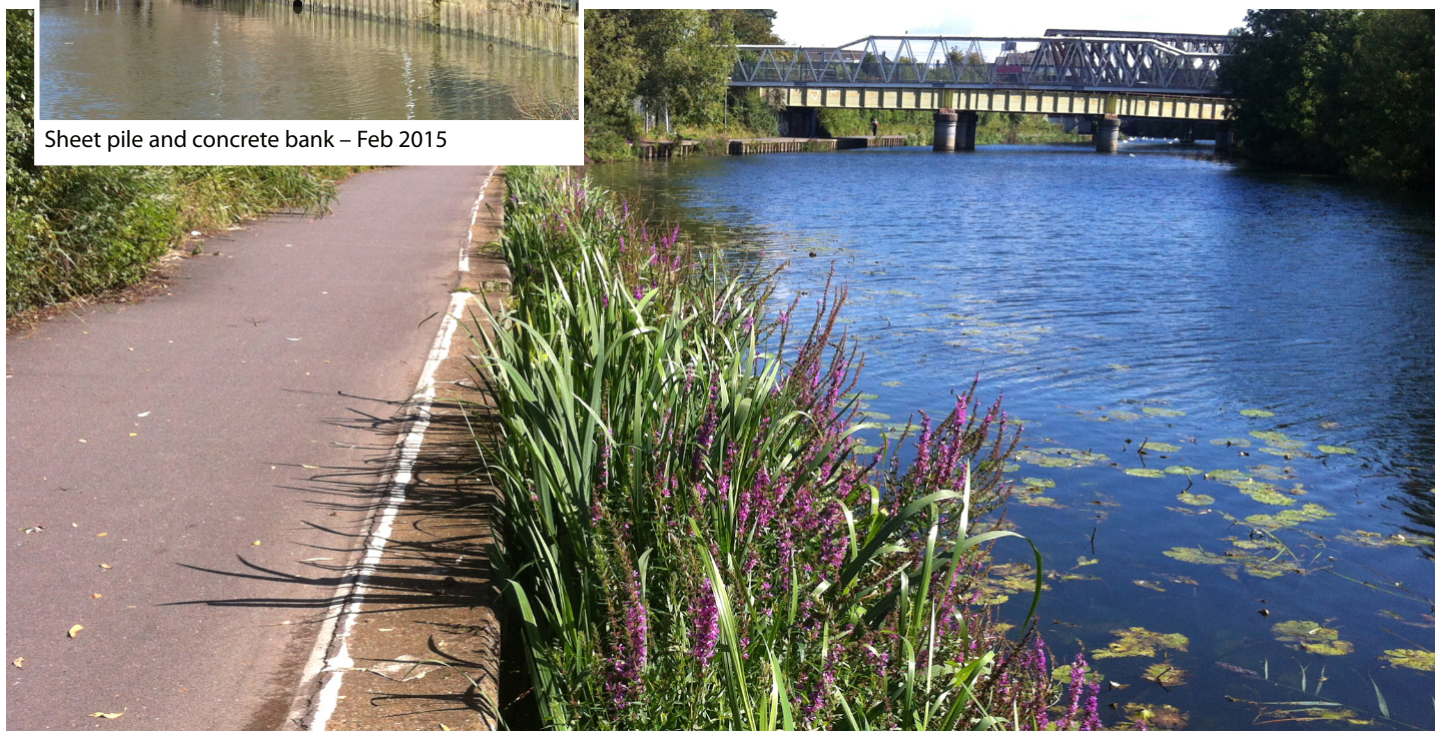
Colourful marginal edge habitat – September 2015

The transformation of the bleak concrete edge was very quick. Within two months of the pre-grown coir rolls being installed, the rolls had successfully vegetated. By the summer, the entire concrete and sheetpile wall was hidden behind a dense green border and the tall marginal vegetation was up to knee height, acting as a visual safety barrier to the drop off into the river.

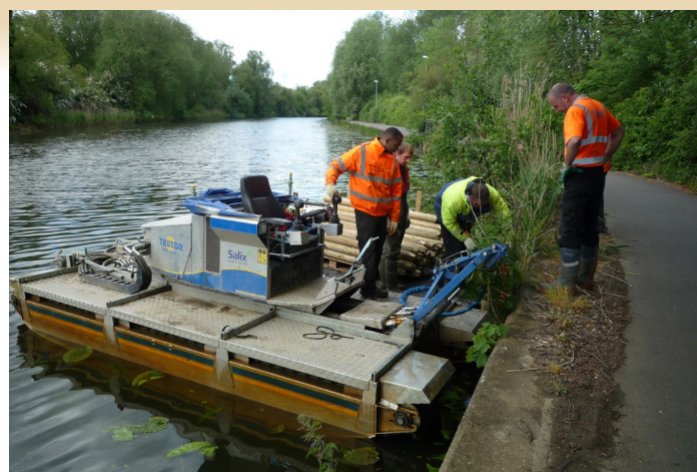
A Truxor provided access from the river – May 2015

A narrow path made access difficult for large sections of the bank. To get around this problem, a Truxor amphibious machine was used to provide access from the river itself.

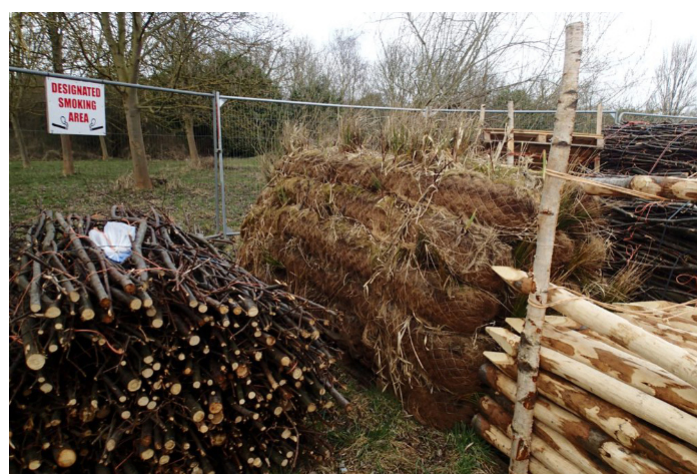
A 'tried and tested' method using simple components – May 2015

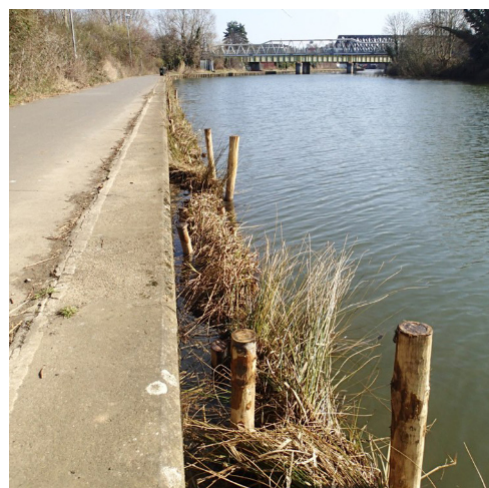
Pre-grown, the plants survive well and quickly thrive (see timeline below) – March 2015

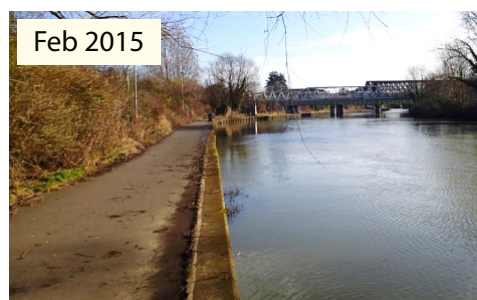
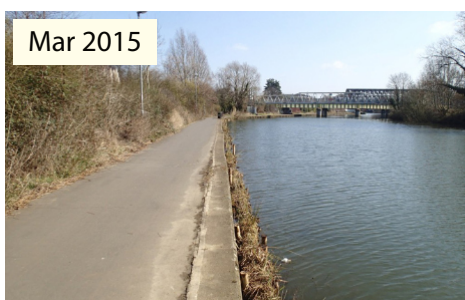
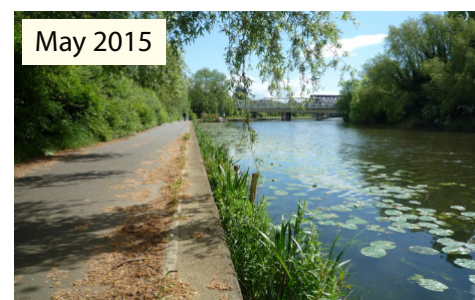
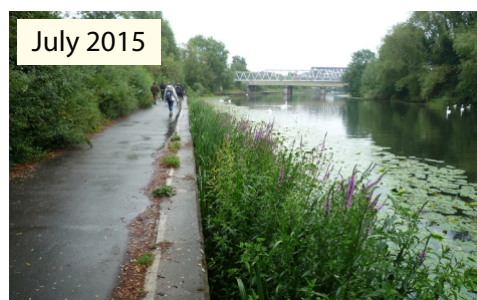
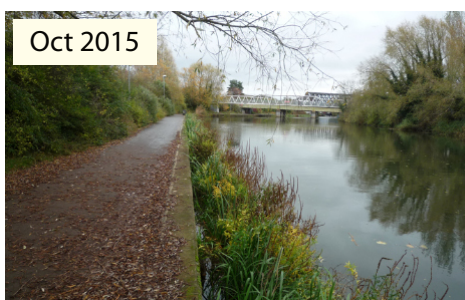
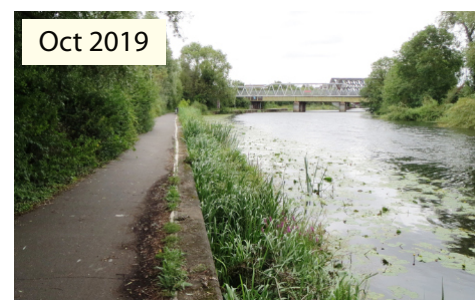
Timeline showing the development and visual impact of the new planted edge

After four and a half years, the edge is still as well vegetated, showing that the initial silt backfill and subsequent ongoing deposition is sustaining these marginal plants

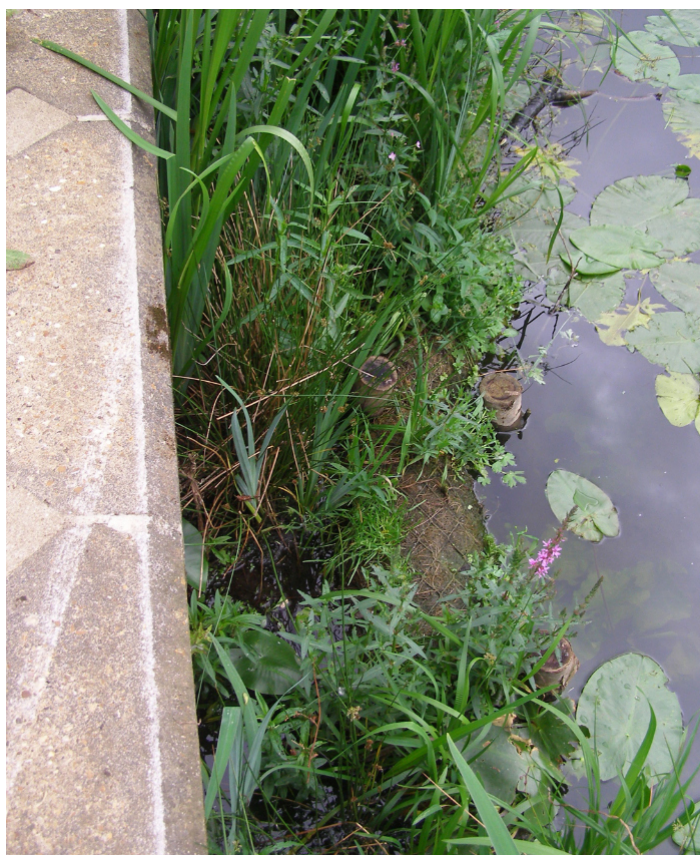
Close-up of the edge, sampled after
only 5 months – July 2015

Even within four months the habitat enhancement had clearly resulted in an increase in the number of supported taxa (23 taxa in the unenhanced control, rising to 37 in the enhanced section). ASPT and BWPM scores rose from 3.93 to 4.24 and 59 to 89 respectively. At this early stage, this did not result in an increase in Community Conservation Index (CCI), as all supported species in both sections are known to be common and widespread. CCI classified both control and enhanced sections as of low conservation value.
