River Restoration **News**

Issue 41 *December 2012*

Rottal Burn Restoration

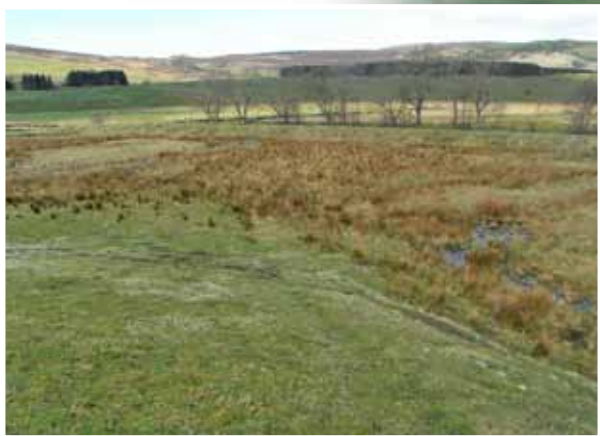
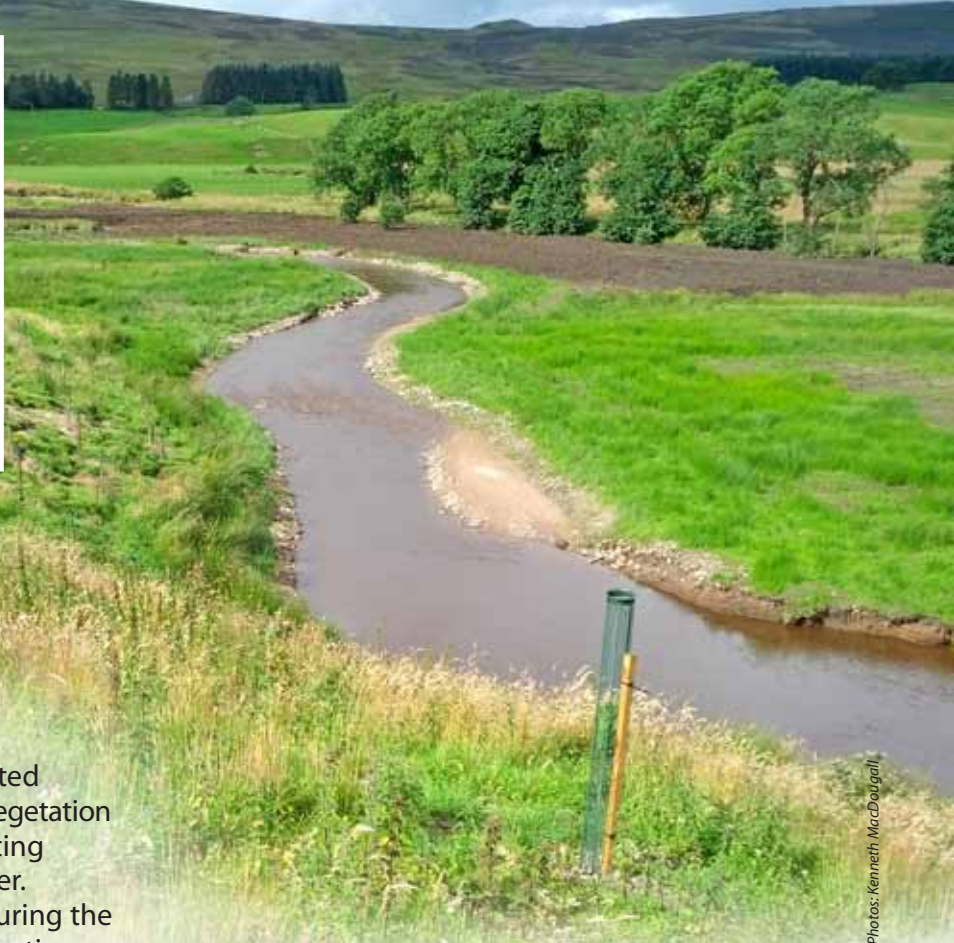
*Restored natural channel.
Inset (top left) shows the river
before restoration*

The lower reaches of the **Rottal Burn in Glen Clova** have been transformed this summer. The burn that flowed through 650m of straightened, embankment-lined channel since the 1830s has been restored to an open, meandering channel 1,100m in length. These works aimed to restore natural river process, providing increased and more varied in-stream and riparian habitat within a designated **Special Area of Conservation** for Atlantic salmon and freshwater pearl mussel. Within just 10 weeks of the burn flowing within the new channel, there is already a significant increase in the variety of habitat present and salmon have started spawning.

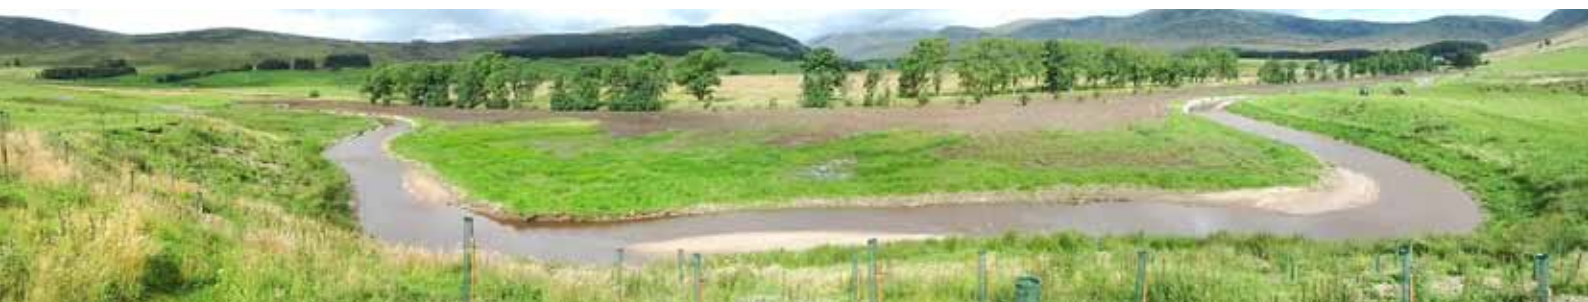
Panoramic view of the restored Rottal Burn

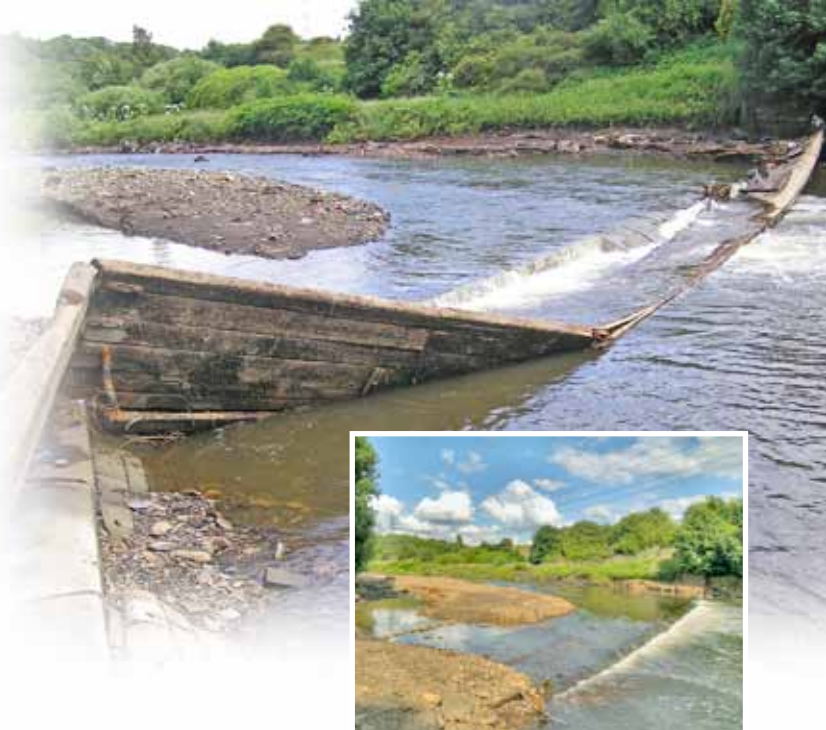
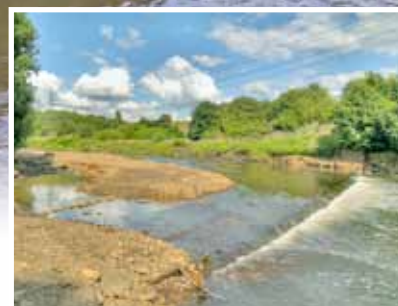
Weir on the River Irwell that had collapsed (main photo), and after restoration work carried out by the Irwell Rivers Trust and the EA

This pattern for conscious provision of monitoring of the effects and the opportunity to disseminate the subsequent lessons was also demonstrated within the professional category. Examples such as the Kentchurch Weir removal (Environment Agency and Atkins Global) and the **Irwell weirs removal** (Environment Agency, Irwell Rivers Trust) provide examples of precedent-setting projects. This showed what can be achieved through by the removal of a huge barrier (Kentchurch weir on the Monnow) and the removal of 15 weirs between 2011 and 2012 from the Irwell system at a cost of only £180k.

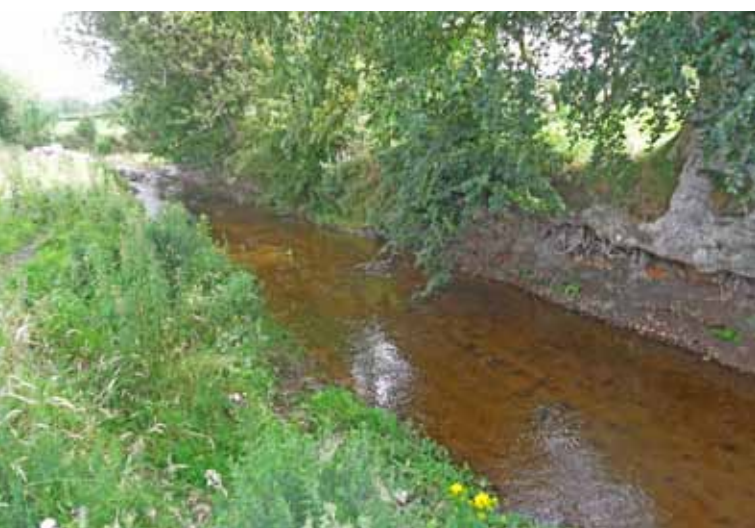
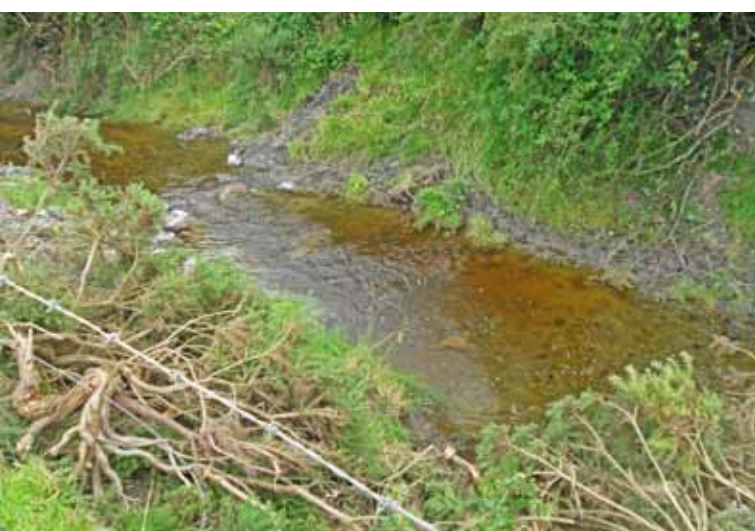
One of the pools created to provide habitat for juvenile salmonid fish as part of the extensive work on the Kells anglers project. The top photo shows the stretch of river before the work

In contrast, the Kells Angling Association, one of the oldest in Ireland, carried out extensive habitat enhancement measures along the Kells Blackwater. Boulders, deflectors, christmas tree revetment and riffles to name but a few, have all been installed with the aim of reducing the impacts of past drainage. Measures were all apparently achieved with 'no problems with bureaucracy', and the success of the schemes for salmonids was clearly demonstrated through the association's methodical monitoring programme.

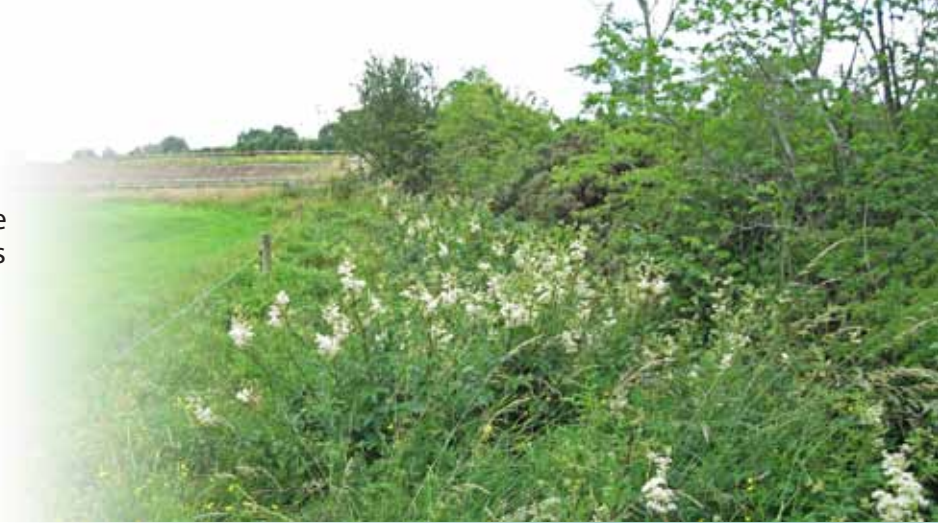
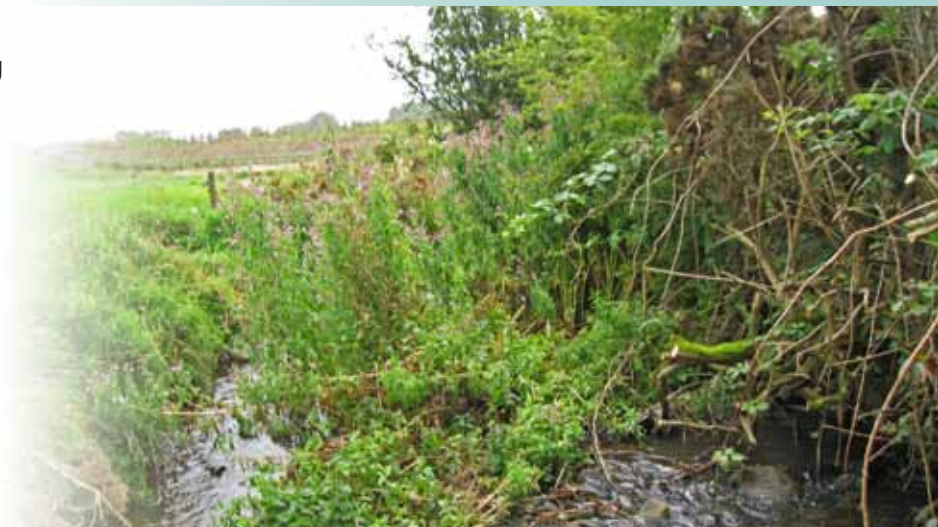
Amateur Category Winner Kells Angling Association

Two views of a tributary of the Kells Backwater showing before and after the work completed by the Kells Angling Association

Within the **amateur category**, the sheer scale of the work was impressive. Past drainage management has meant that a lot of damage may be impossible to “undo”, but the approaches used to achieve the restoration of habitats should be commended. The **Kells Angling Association** became the worthy winner of this year’s award, but the Chester Le Street and District Angling Club was also applauded for in their innovative approaches to making significant improvements in water quality.

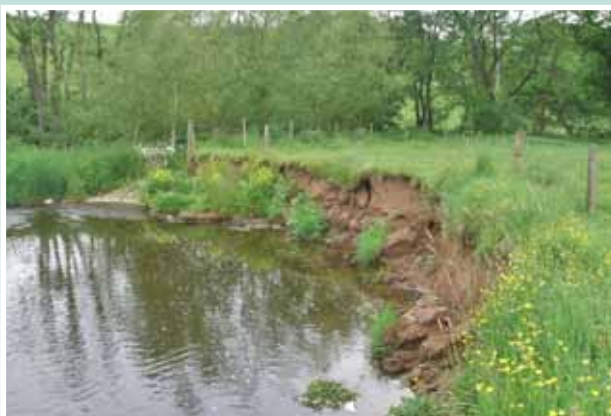
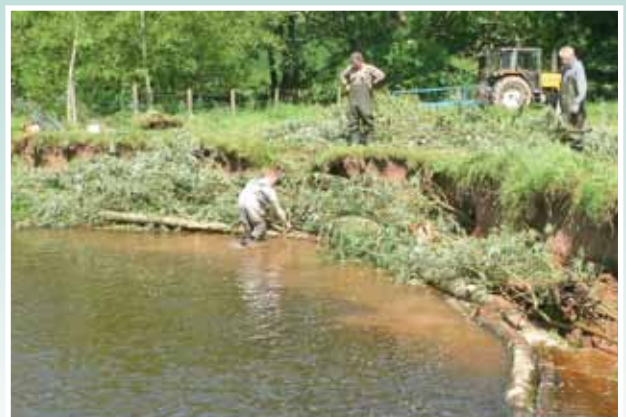
Professional Category Winner Eden Rivers Trust

Views of a stretch of the River Peterill, before (left) and during work (right), carried out by the ERT and it’s partners

The **professional category** was won by the **Eden Rivers Trust** for their work on the River Petteril. This tributary of the Eden was once the jewelled trout fishery in the crown of the Eden catchment – and has since suffered the heaviest impacts and degradations of all the major streams running into the main river. The Irwell weirs project came second, scoring only slightly less points to take second place.

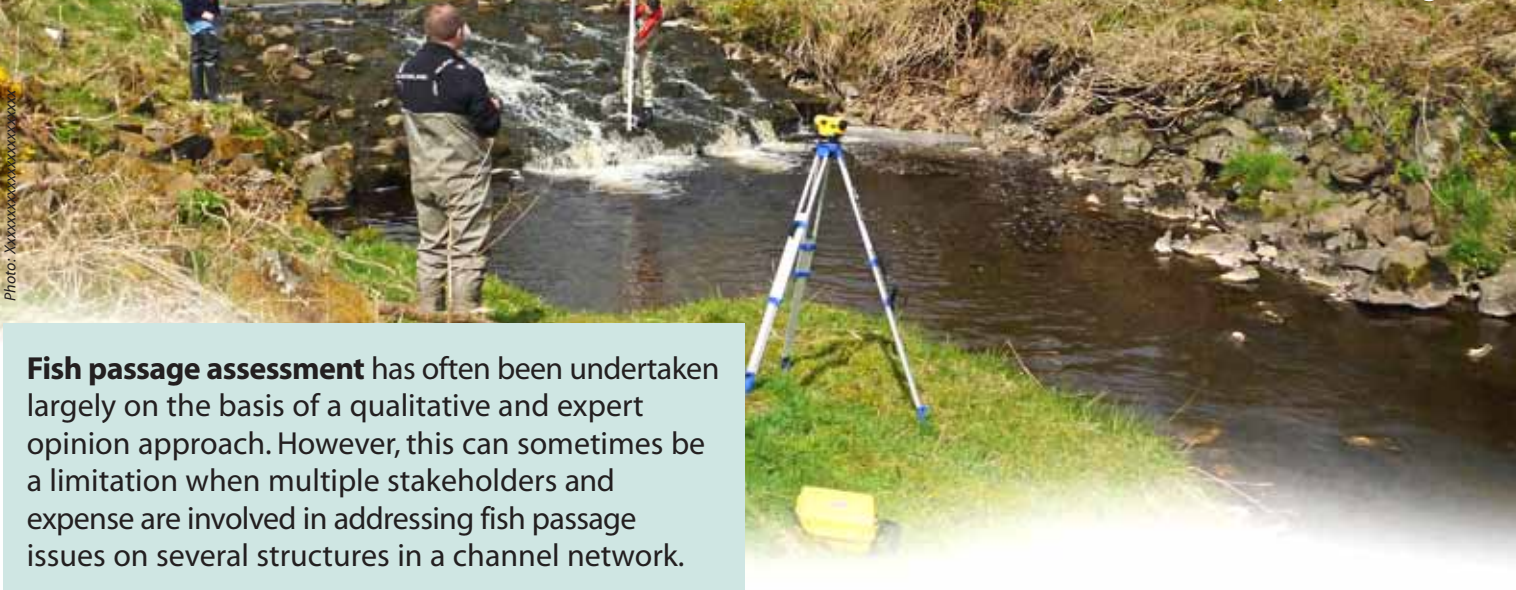
A complex weir with at least three possible access routes across the face. Each of these routes are assessed separately using the protocol to provide the basis of an overall passability score for the structure

The methodology relies upon the initial identification of all potential routes for fish across a structure. There may be several such routes available for fish at each structure, and the methodology requires surveyors to identify and assess all of them when on site. Each potential passage route is then assessed for a variety of fish groups that include both poor- and strong-swimming forms.

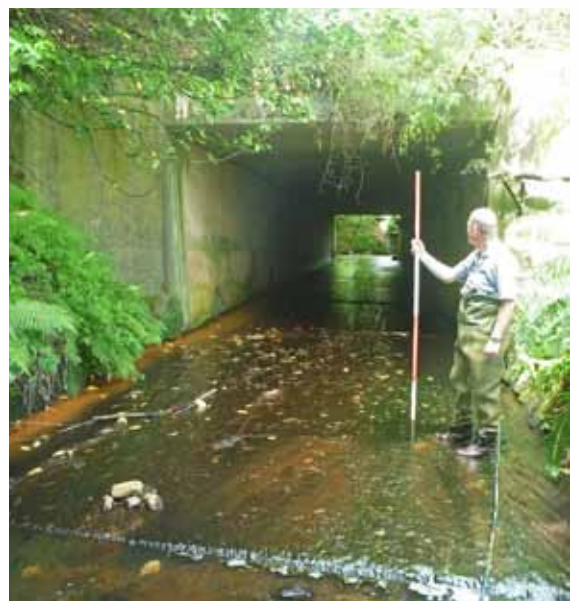
Structures such as this box culvert present challenges for fish passage by reducing water depth and increasing velocity along an extended length of channel
