# River Restoration NEWS

*Newsletter of the RIVER RESTORATION CENTRE*

Tel/Fax: 01234 752979 Email: rrc@theRRC.co.uk

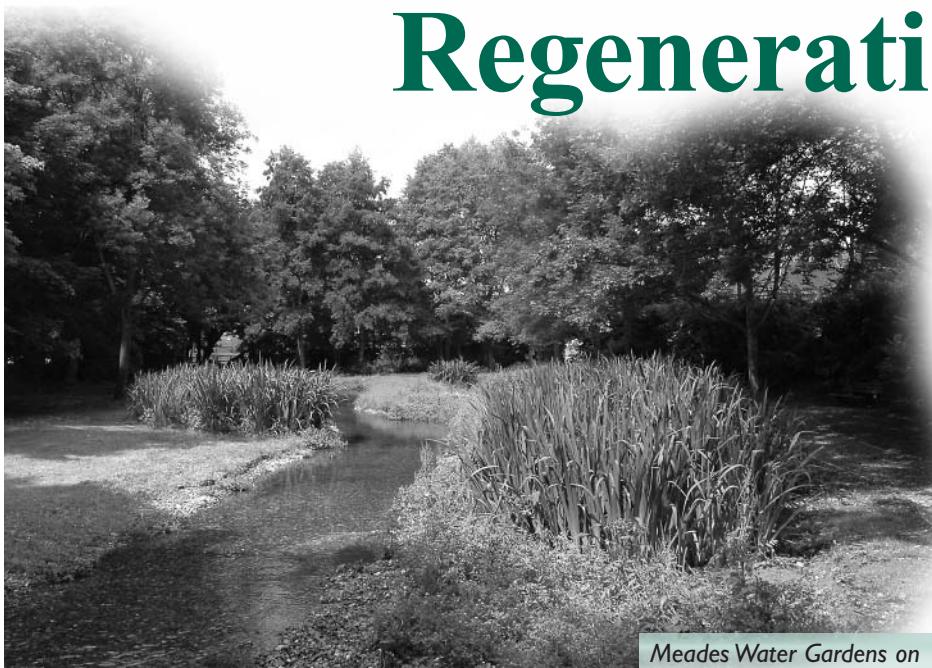
*Meades Water Gardens on the opening day, July 2008*

The Meades Water Gardens are a public amenity area through which the River Chess flows. Originally part of a mill pond and subsequently watercress beds, the land was given to the town in the late 1970's. Soon after, the council re-landscaped the area to create formal water gardens, excavating the beds and river to form two ornamental ponds.

The two weirs, which had been used to retain water in the ponds, were removed and the site was allowed to

drain. A temporary dam was built at the top of the site and river flow was piped around the working area. Working from the upstream end a new channel was dug through the accumulated silt following the line of preferential flow. Nicospan was installed to provide support to the new channel sides and to ensure separation of the silt from the gravel infill, which was imported to form the new river bed. Excavated silt was distributed around the site within the boundary of the old ponds. The new channel was tied into the original course of the river which flowed around the back of the island in the lower pond. A low-lying bund was installed in place of the weir at the front of the island to create a wetland feature.

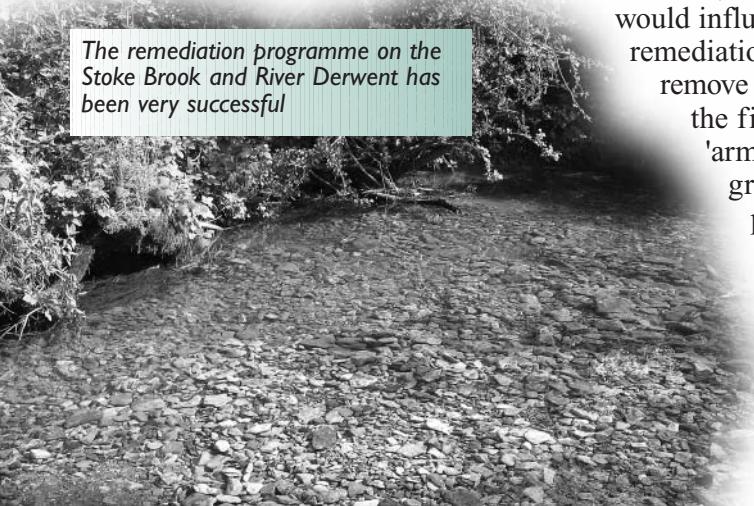
*The remediation programme on the Stoke Brook and River Derwent has been very successful*

The remediation works commenced in June 2008 and at the time of writing works were completed on Stoke Brook and progressing along the Derwent. Applying these techniques to the remediation of these rivers has meant very little if any impact on the integrity of ecological or landscape resources. Pre-works ecological surveys of water voles, fish and aquatic invertebrates are being used to judge the effectiveness and the deliverability of low impact remediation. So far, there have been no mature trees lost, no loss or damage to water vole burrows or bankside habitat and in a recent fish survey undertaken by the Environment Agency, fish density has increased in Stoke Brook despite the works that have taken place there. Kingfisher and dipper continued to breed along the rivers throughout the remediation operations and public interest from walkers has been universally positive.

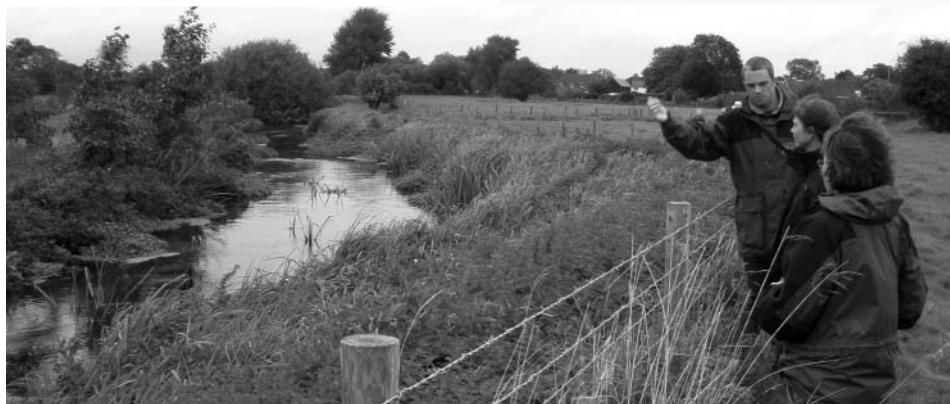
an extensive woodland area adjacent to the river for additional wildlife gain, as well as building an effective fish easement structure to bypass a mill leat obstruction, thereby making the restored reach more accessible to migrating salmonids.

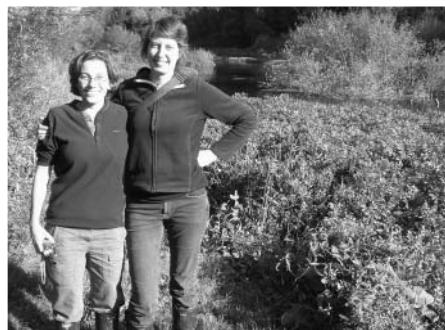
The Professional Category trophy went to Natural England and Partners for the STREAM (Strategic Restoration and Management) project on the River Avon; a £1million project improving over 7km of watercourse using both traditional and innovative techniques especially involving extensive installation of 'large woody debris'. Particularly impressive was the emphasis placed on engaging a myriad of stakeholders and the public at all stages of the project and the comprehensive monitoring programme to measure both physical and ecological change.

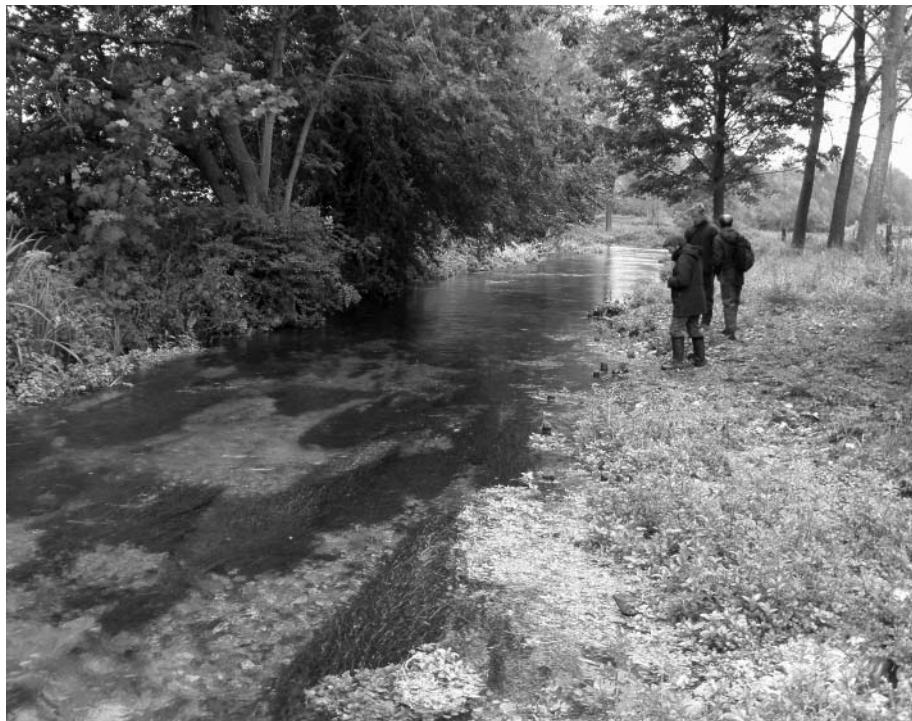
*Bourne Rivulet channel re-profiled*

The runner up was the Bourne Rivulet rehabilitation project on this chalk stream headwater of the River Test in Hampshire. A beautifully well thought out and crafted project demonstrating how working with and thoroughly understanding the character of the river can produce a mosaic of habitats, which is so important for all components of the riverine and riparian flora and fauna. Using simple techniques of subtly redistributing gravels won from previously dredged materials on the bank, careful re-profiling and installing flow deflectors and woody debris, this project illustrated how careful planning with minimal intervention techniques can be sensitively used to great effect, at relatively low cost.
