Case study 51. Wandsworth Riverside Quarter

Main driver: Habitat creation and improved defences.

Project stage: Constructed 2009

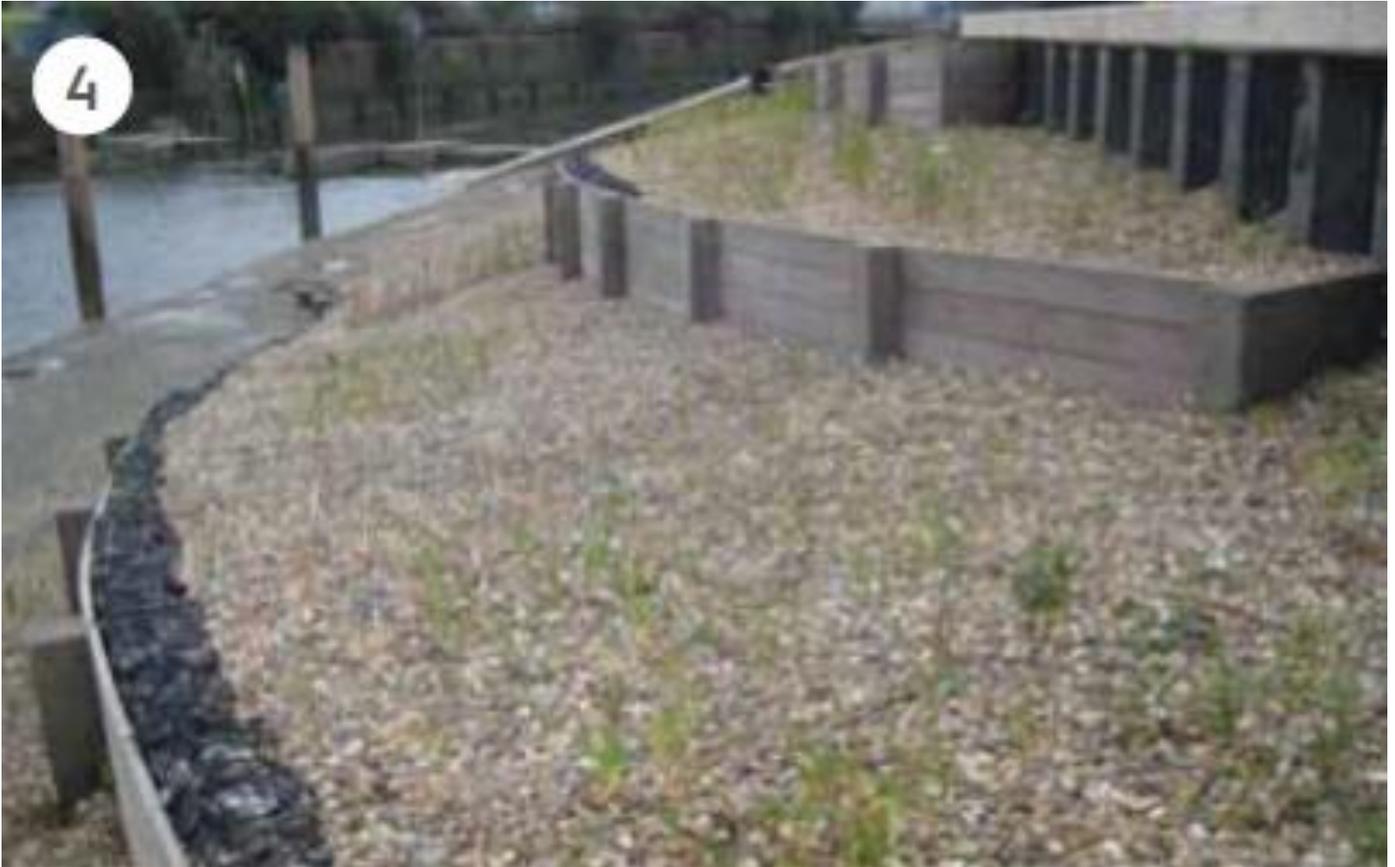
Photo 1: River Terraces following construction (source: Capita Lovejoy)

The site is located at the corner of the confluence of the River Wandle and River Thames in Wandsworth, south London (Photo 1 and Map 1). The site had been vacant for a number of years with tidal flood defences in a poor state of repair. A mixed use development was proposed for the site, which required the tidal defences to be upgraded to ensure they had a residual life commensurate with the lifetime of the development (100 years for residential development). This planning requirement presented an opportunity to deliver new line of setback tidal defences, which included environmental enhancements, in particular, the creation of intertidal terraces formed between the existing and new line of defences.

The aesthetic and visual aspect of the terraces was also an important consideration as the Thames Path would run along the top of the terracing. The existing river wall was cut down to bed level and a number of stepped, sloping terraces created into the corner of the site, with the new flood defence alignment being achieved at the back of the intertidal terrace. The design of the terraces was given careful consideration to ensure they would be accessible to a wide range of fish species by making them sloping and connecting to each other.

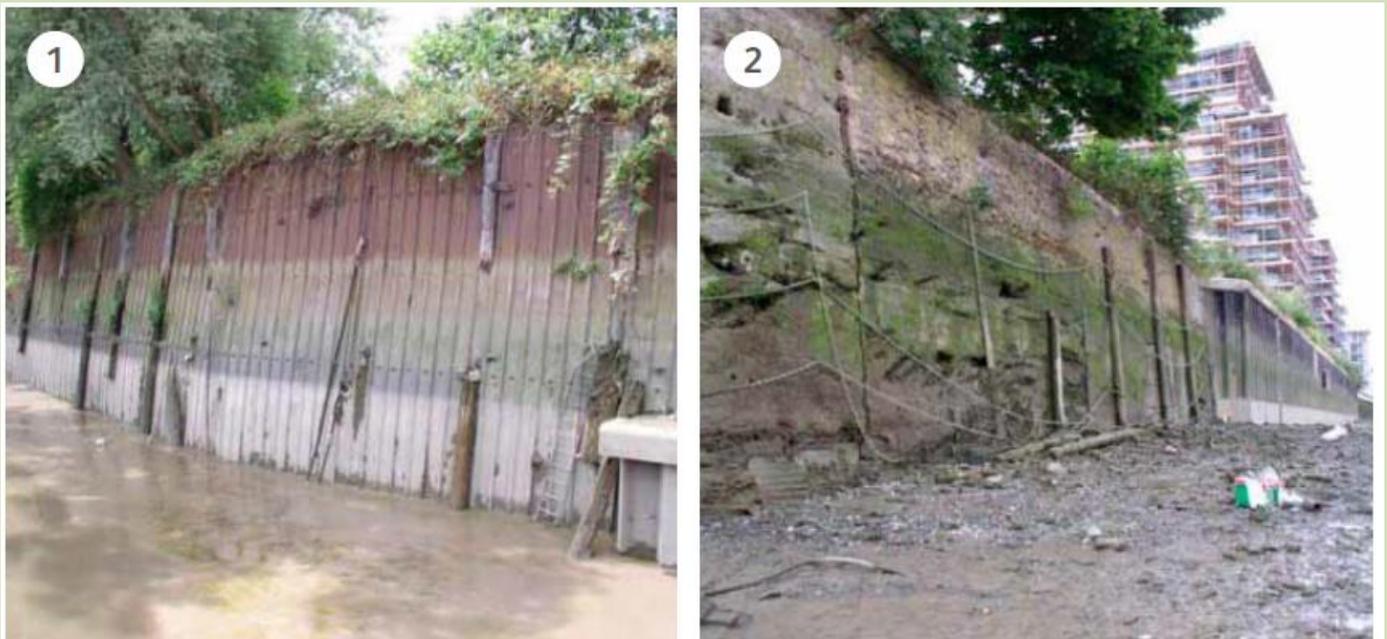
Photo 2: Tidal flood defences prior to works (source: Unicmarine copyright and database rights)

The tidal flood defences were in a poor state of repair (Photo 2), which required replacement to ensure they have a residual life commensurate with the lifetime of the proposed development (100 years for residential development) as required under National Planning Policy Framework.

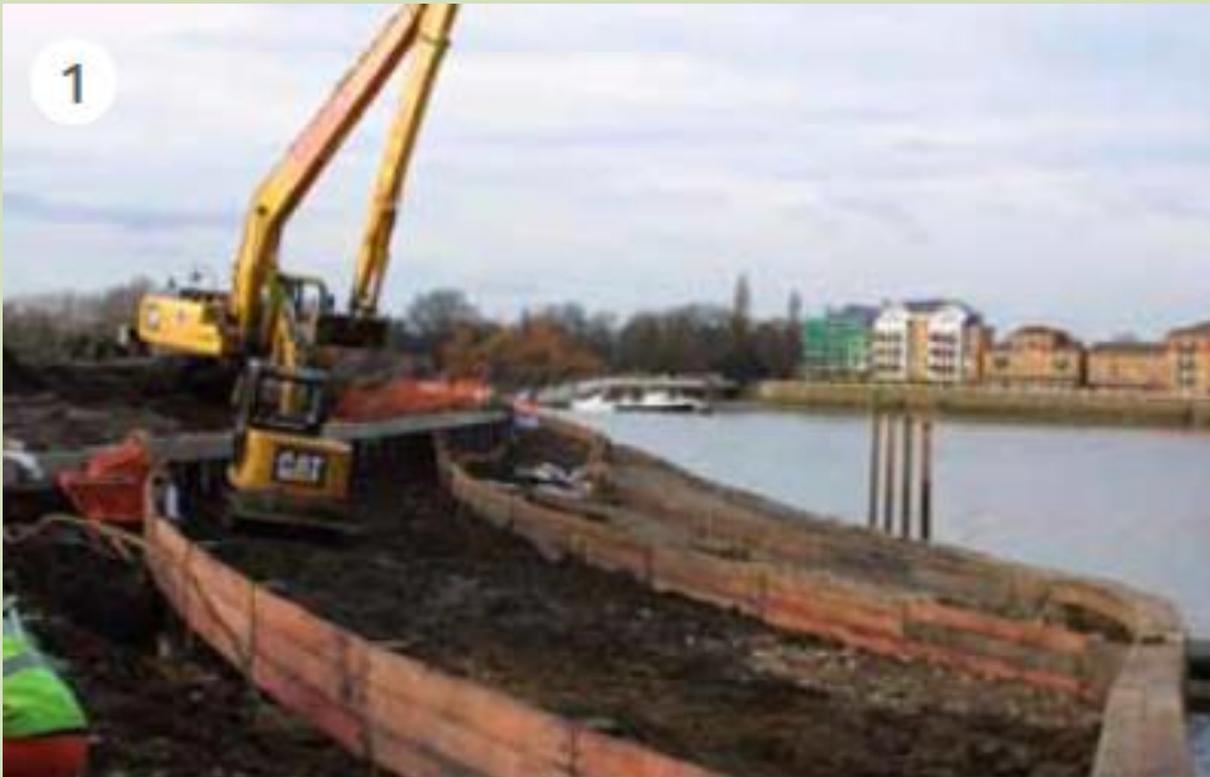
Photo 3: Construction of timber terraces (source: Capital Lovejoy)

- Laying contamination textile to reduce the risk of contaminated soils entering the Thames during the works
- Constructing timber terraces
- Placing backfill materials
- Laying root membrane
- Laying silt accretion geotextiles to encourage silt to accrete within the terraces
- Fixing coil rolls at channel margin
- Installing dead wood habitat staked at the margins between the slop and channel to encourage more diverse plant establishment and flow conditions.

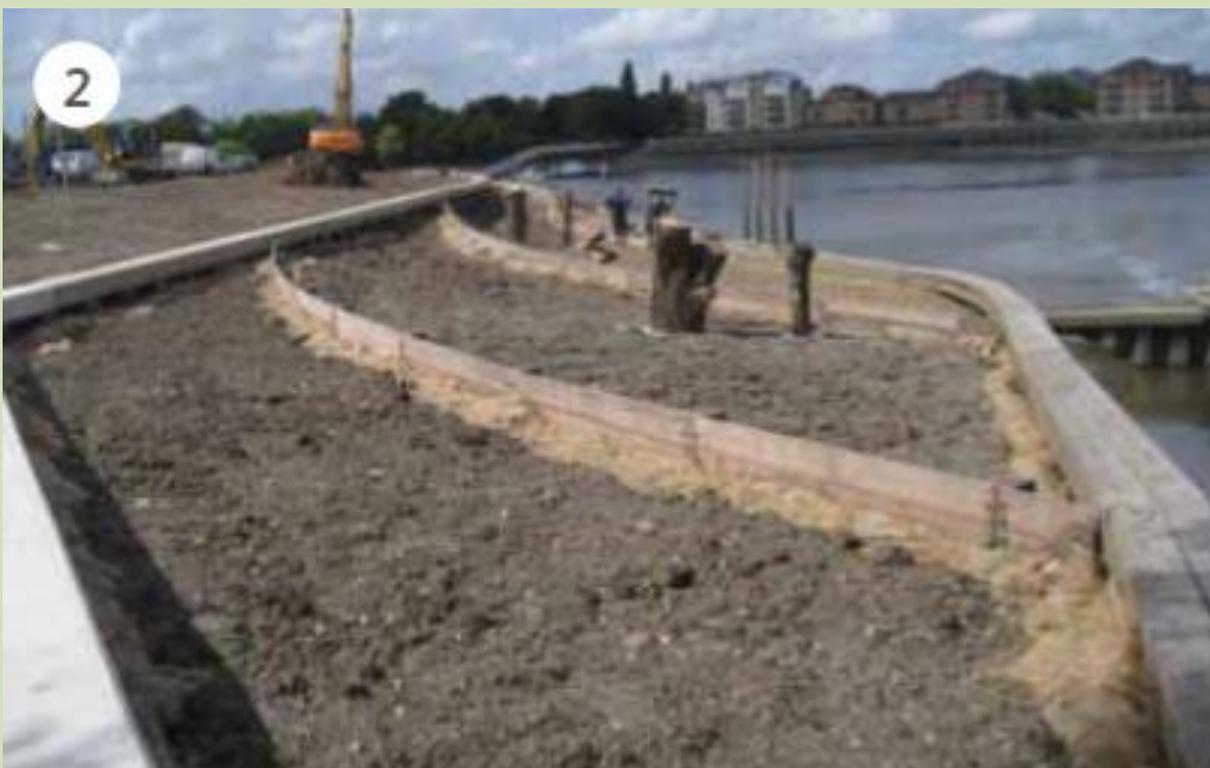
Photo 4: Backfilling behind upper terraces (source: Capital Lovejoy)

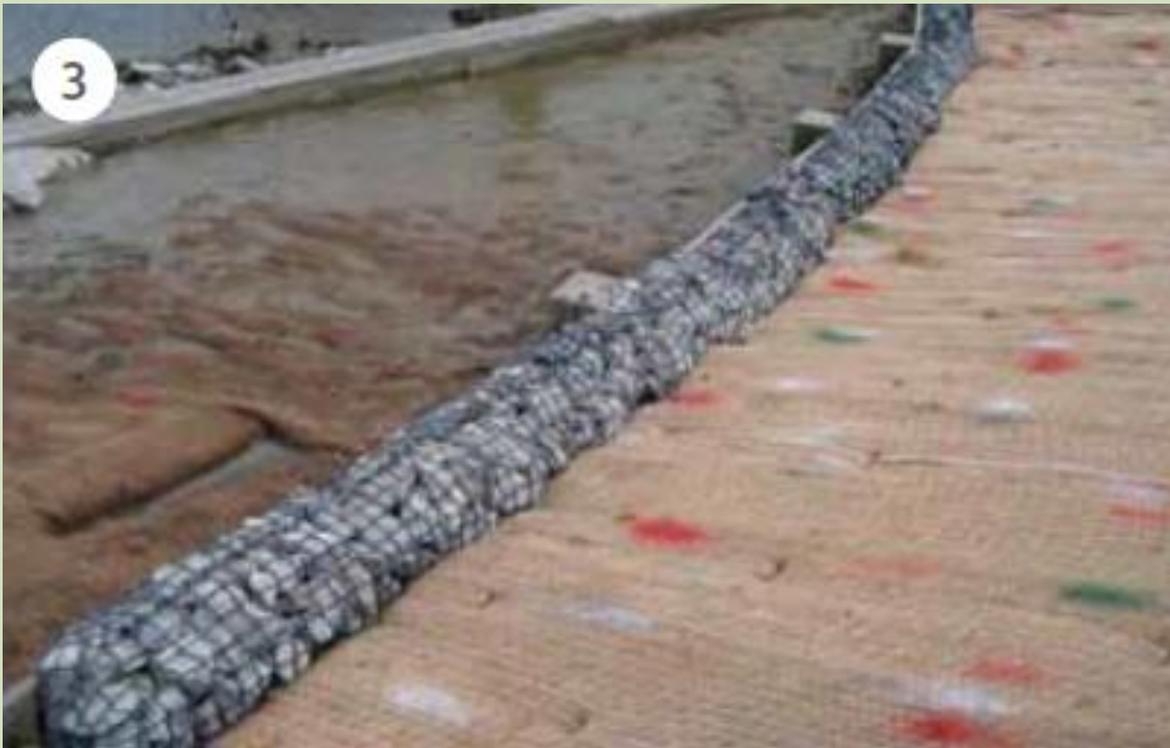
Photo 5: Installation of rock rolls and coir matting (source: Capital Lovejoy)

- Rock rolls were installed along with coir matting to protect and dissipate wave energy onto the terraces and encourage successful vegetation establishment.

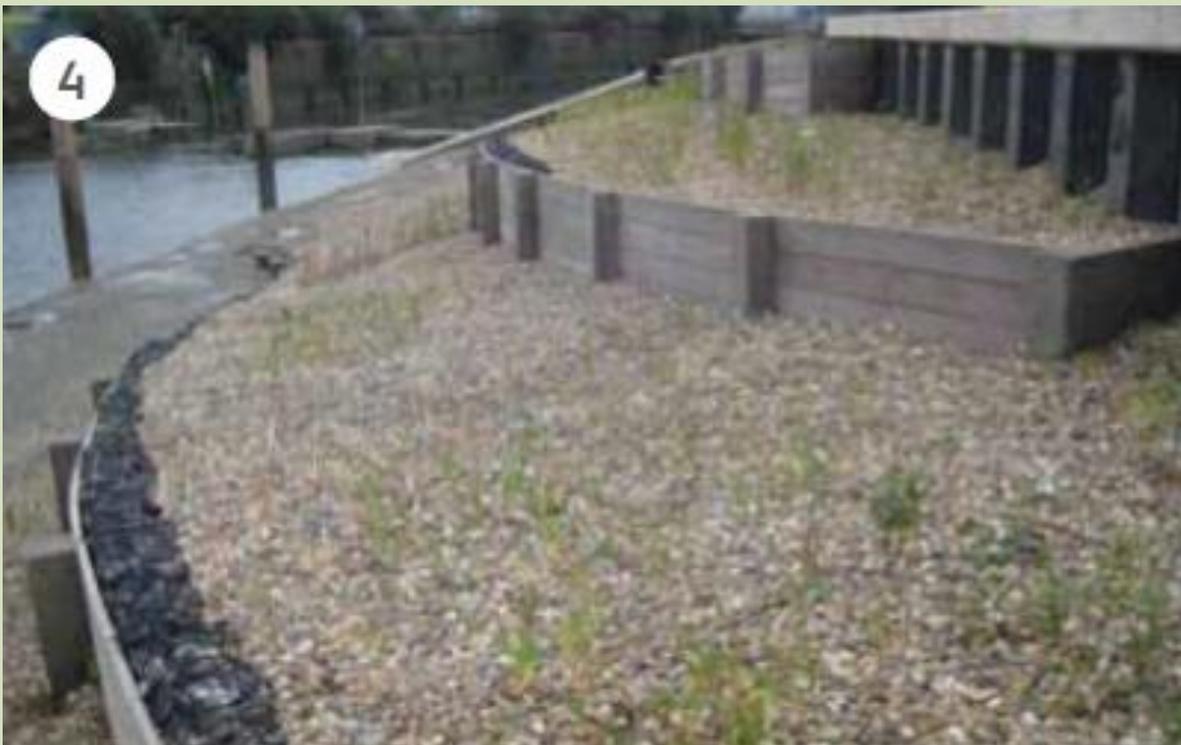
Photo 6: Placement of gravels and planting (source: Capital Lovejoy)

- Intertidal vegetation was planted and dead wood installed along the terraces.
