Case study 58. Waldringfield Flood Defence Scheme, Suffolk

Main driver: Improved defences and habitat restoration

Project stage: Constructed (2015 to 2016)

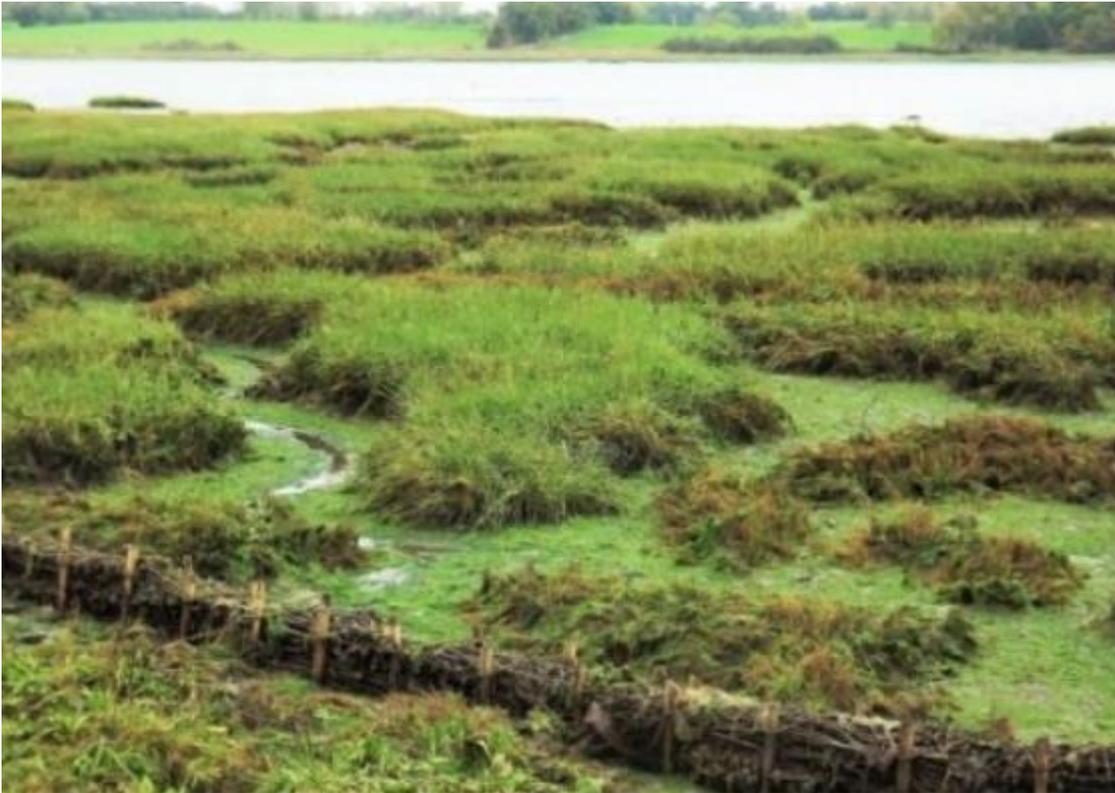
Photo 1: Saltmarsh on the River Deben at Waldringfield (source: Ipswich Star)

Saltmarsh along the shore of the Deben immediately north of Waldringfield was becoming eroded and degraded. This would likely increase the long-term vulnerability of the clay bank flood defence north of the village to erosion and wave overtopping.

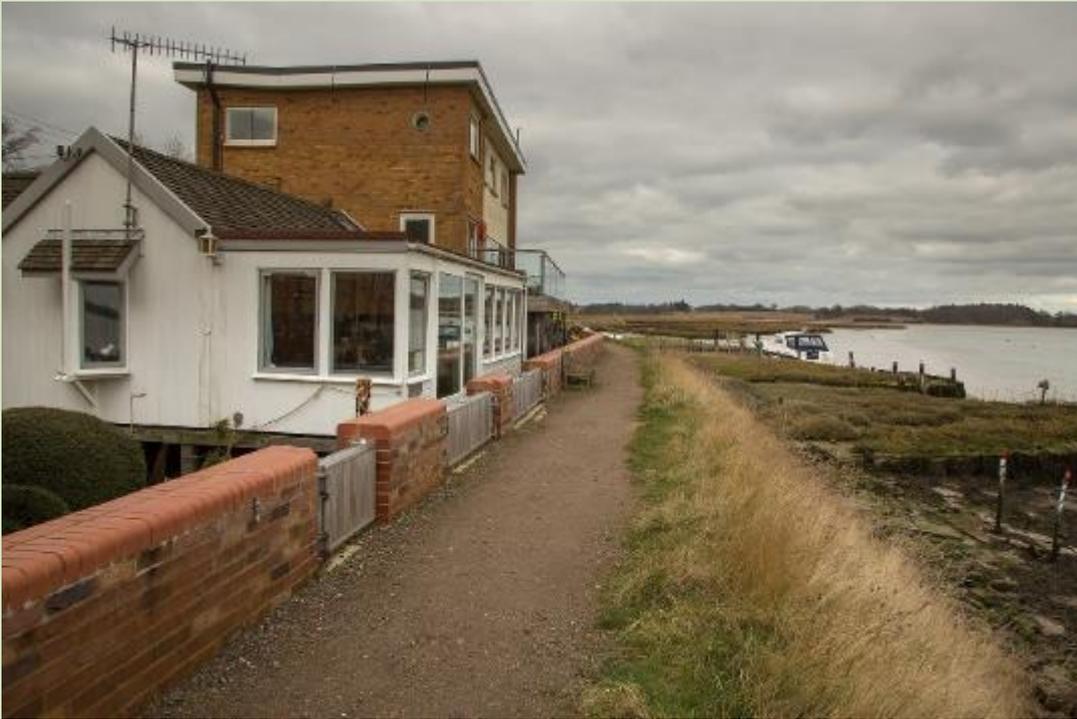
Photo 2: Brick-clad defence

The principal flood defence measure (non-WWNP) consisted of the construction of a brick-clad wall (Photo 2) along the crest of the existing defence embankment, together with a counterwall running inland along the northern flank of the village. Pedestrian access through the wall was provided by closable flood gates to each property. The design height of the defence was +3.8m Ordnance datum (OD). Most of the wall is approximately 0.6m in height (Area 2), increasing to 1.3m at the southern end (Area 3) and 1.0 to 1.6m for the northern counterwall (Area 1).

The brick wall and food gates were constructed from imported materials.

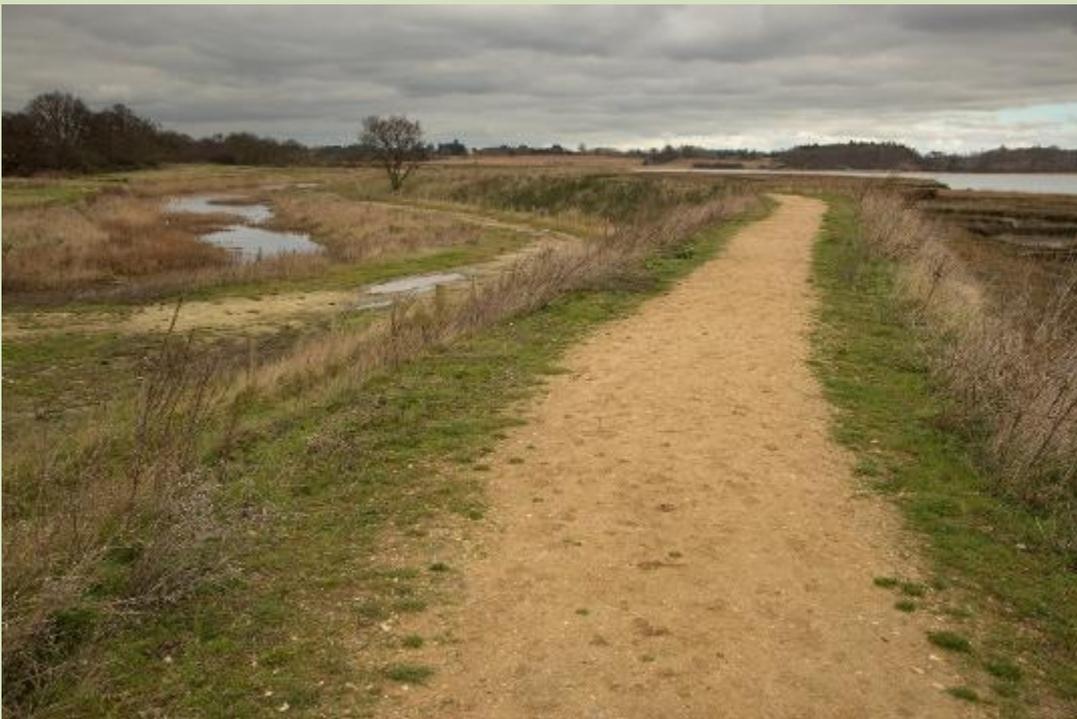
Photo 3: Clay embankment

The clay embankment (Photo 3) north of Waldringfield was raised and widened to increase the standard of flood protection (non-WWNP), but no brick wall was constructed in this section. In addition, measures were implemented to restore and reinstate saltmarsh north of Waldringfield by encouraging accretion of fine sediment (WWNP). These measures consisted of placing brushwood faggots held in place by chestnut stakes in a variety of configurations including shore parallel, shore normal (miniature groynes) and to form enclosed polders. The project has focused on 3 distinct areas of work designed and built by the East Suffolk Internal Drainage Board.

The embankment was raised and widened using material sourced from borrow pits landward of the embankment, which were landscaped to create a new freshwater wetland.

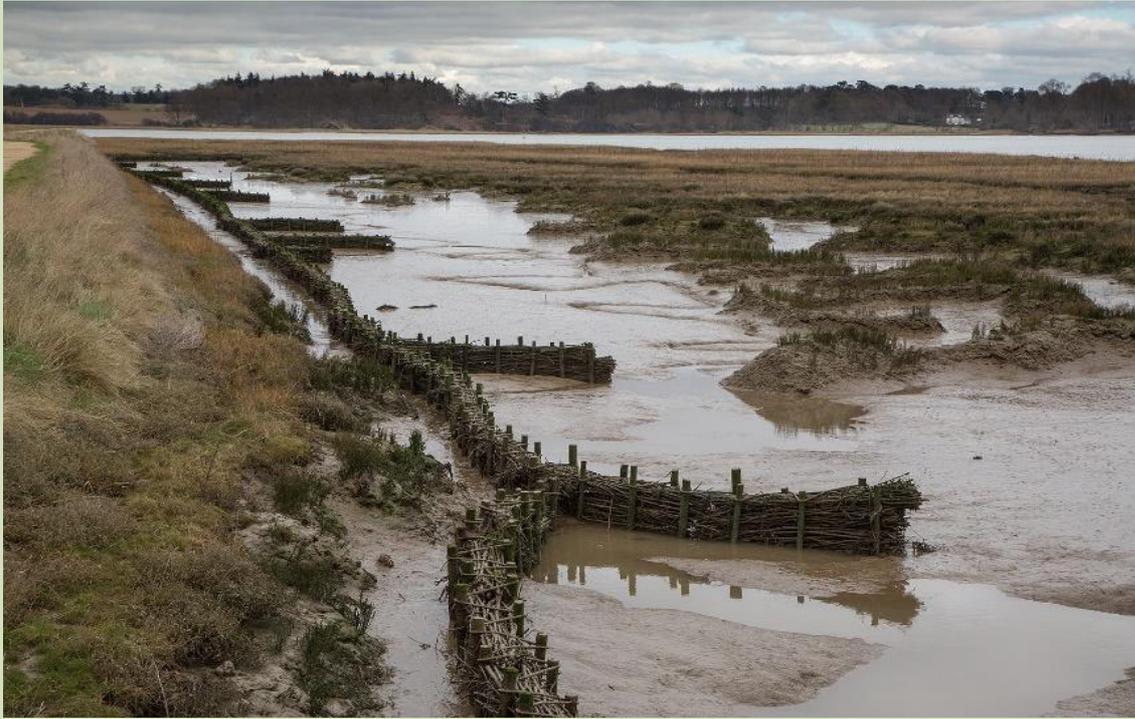
Photo 4: Low faggot fence

(i) Toe protection for the flood defence (Photo 4)

In the central section north and south of the main sluice, there is little or no saltmarsh at the toe of the flood defence. Historically this frontage had been excavated to allow large boats to moor up alongside the old lime kilns. As a result, this area is very vulnerable to undercutting by tidal processes. A low faggot fence was installed in this section and runs parallel to the entire frontage either side of the sluice. The fence is set off the toe of the wall to:

- encourage accretion between the wall and the fencing
- promote new saltmarsh growth
- provide some protection from waves and currents

The fencing accommodates wildlife through a series of gaps or fish passes. There are also small 'groyne' structures spanning from the main fence, which aim to push flows away from the toe of the wall- further encouraging accretion. This work was completed in July 2016.

Following a survey of the initial 200m of saltmarsh structures completed in November 2015, the June 2016 survey picked up a 7–10mm rate of accretion landward of the fencing. This is very positive feedback after 6 months, as it shows sediment is accumulating behind the polder fencing and bodes well for the fencing installed in 2017.

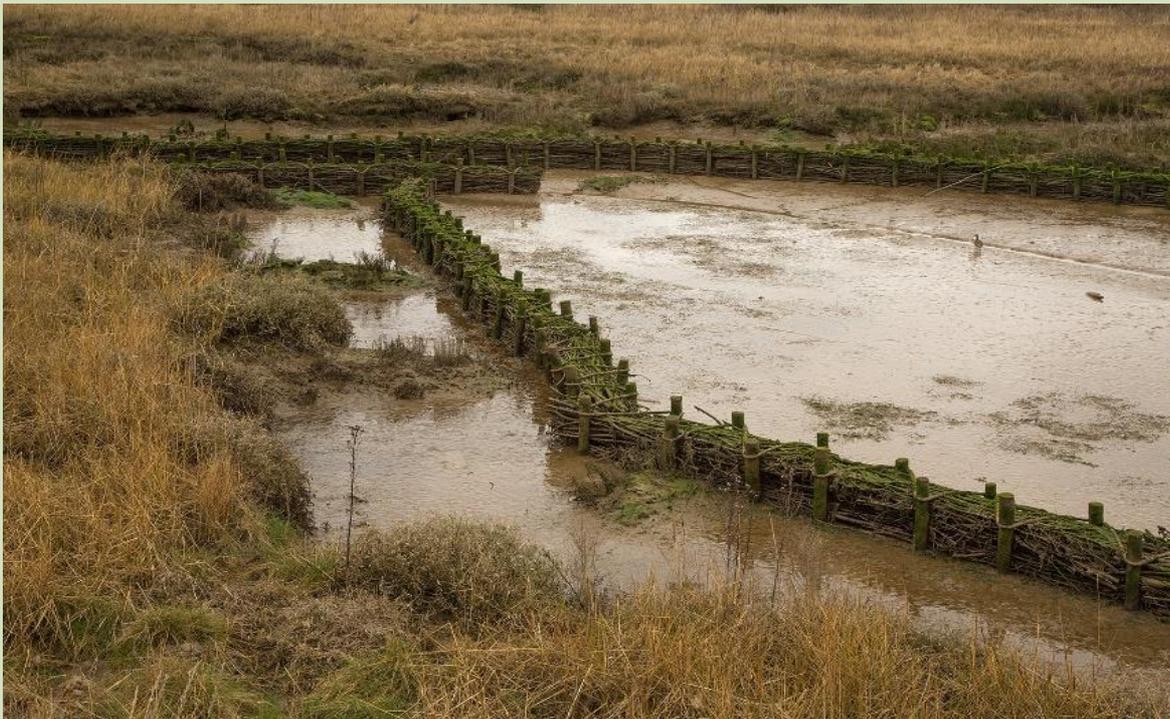
Photo 5: Stilling ponds

(ii) Stilling ponds (Photo 5)

This approach aims to use the materials to create low fences across small embayments to trap sediment and promote saltmarsh growth. These areas are common along the sides of larger creeks and within the marsh. It is hoped that these areas will create 'still water' allowing sediment to drop out of the water column and build up the intertidal area behind the fence. The conditions of the Marine Maritime Organisation (MMO) do not allow creeks to be closed off and the project has abided by these licence conditions. Most of this work is in the southern section of the marsh and fencing has been deployed along the sides of larger creeks and channels to capture bays for sedimentation to occur. Work was completed in September 2016.

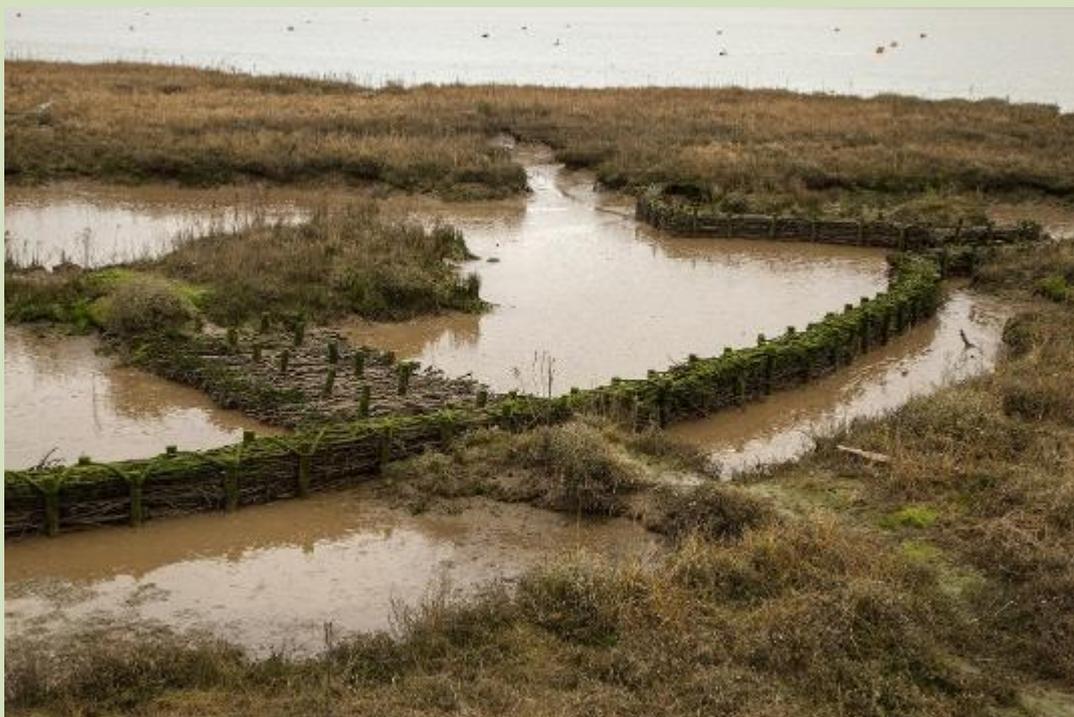
Photo 6: Internal marsh protection

(iii) Internal marsh protection to reduce fragmentation (Photo 6)

The Waldringfield marshes have been identified as ‘fragmented’ by Natural England and the Environment Agency. The creek systems are joining up and, as tidal flows then increase, saltmarsh is eroded. In a departure from the fencing approach, a different design is being trialled in those areas where this occurs. The aim is to create a ‘raised bed’ using hazel rafts and to try to separate the creek flows. The materials are laid out like a mattress and secured in position using similar methods to the fencing approach. In these locations, raising the mudflat by a few centimetres will hopefully reduce the connectivity between creeks and create new watersheds, thus reducing internal erosion of the marsh.

This work is largely complete at both the northern and southern ends of the marsh. It has been used most extensively at the northern end of the site where the marshes are very badly eroded and where creeks have joined and flows have increased as a result. The rafts should serve to slow flows and increase siltation locally, which in turn should create raised mudflat which in turn could become marsh. Most of this work has been completed in August 2016.
