Case study 60. South Milton Sands

Main driver: Defence improvement, habitat creation and recreation

Project stage: Constructed (2009), modified (2014), future plan needed

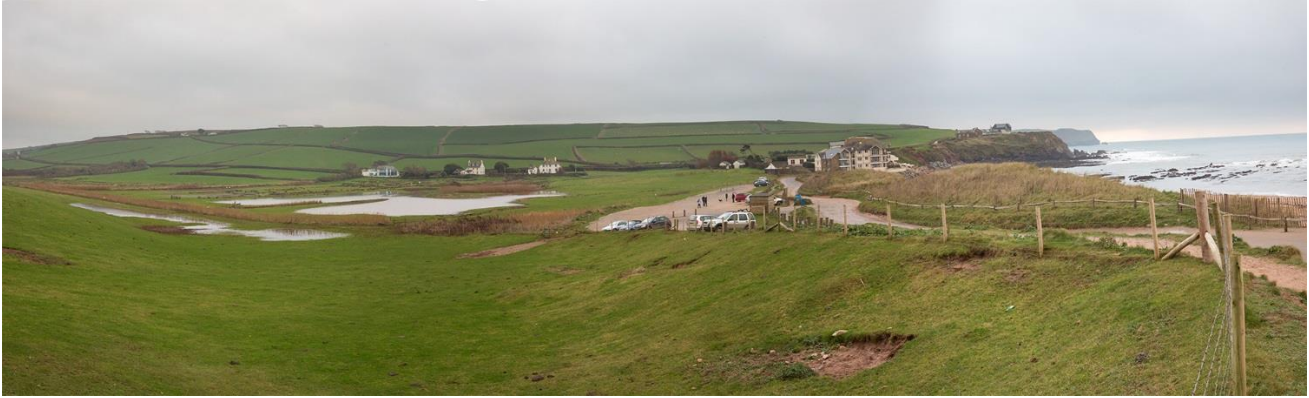
Photo 1: South Milton Sands, looking south (source: Robert Harvey)

Between 2003 and 2009, the National Trust restored South Milton Sands in Devon (Photo 1 and Map 1), a heavily used 4ha sand dune site with a small beach, a café and extensive car parking. The wooden piling defences constructed in 1990 were at the end of their lifespan and thought unsustainable given the erosion at the site. The designed scheme removed the failing defences and reprofiled the dunes, which allowed the dunes to erode and build according to natural processes. Once groundwork was completed, local people helped plant the marram grass on the dunes. Following consultation, the National Trust agreed to maintain a small area of defence to an existing slipway for a 10-year period. The project was viewed as a success.

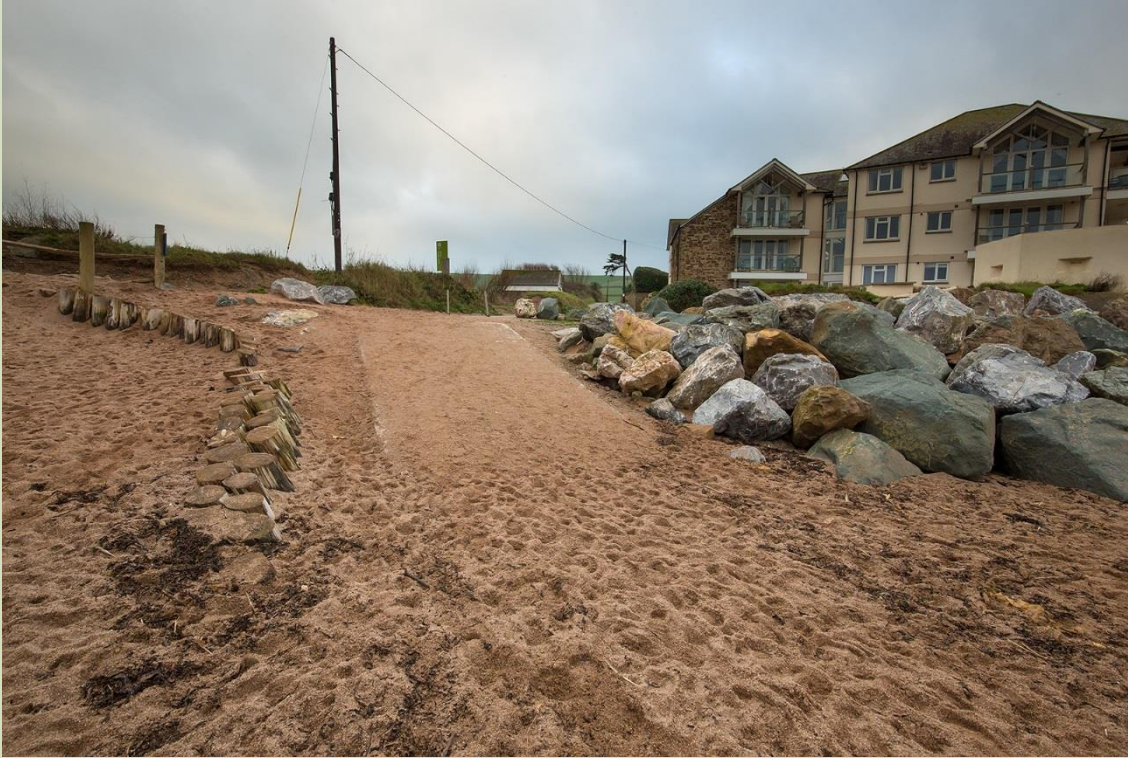
Photo 2: Slipway (National Trust) and rock revetment (not National Trust) (source: Robert Harvey)

Following options appraisal and extensive consultation, the wooden piling defences were removed (including rotten timber piling and many tonnes of rubble) and the dunes were reprofiled and reinstated using sand from the beach. Once groundwork was complete, local people helped plant marram grass on the dunes (see Photos 2 and 3).

Around the same time, the owners of Rock House apartments south of the National Trust frontage installed a rock revetment immediately adjacent to the National Trust slipway to protect their property.

A storm on 14 February 2014 eroded about 15m of the sand dunes and lowered beach levels by some 2m. The southern end of the access track and the slipway were undermined. Boardwalks to access the beach were broken. The dune ridge was overtopped at the southern end but did not fully breach. However, the loss of much of the dune ridge (including the area reinstated and revegetated in 2009) made the frontage highly vulnerable to breach in a future storm.

- Slipway reinstated with boulders
- Access track realigned inland
- Pedestrian access tracks reinstated and fenced

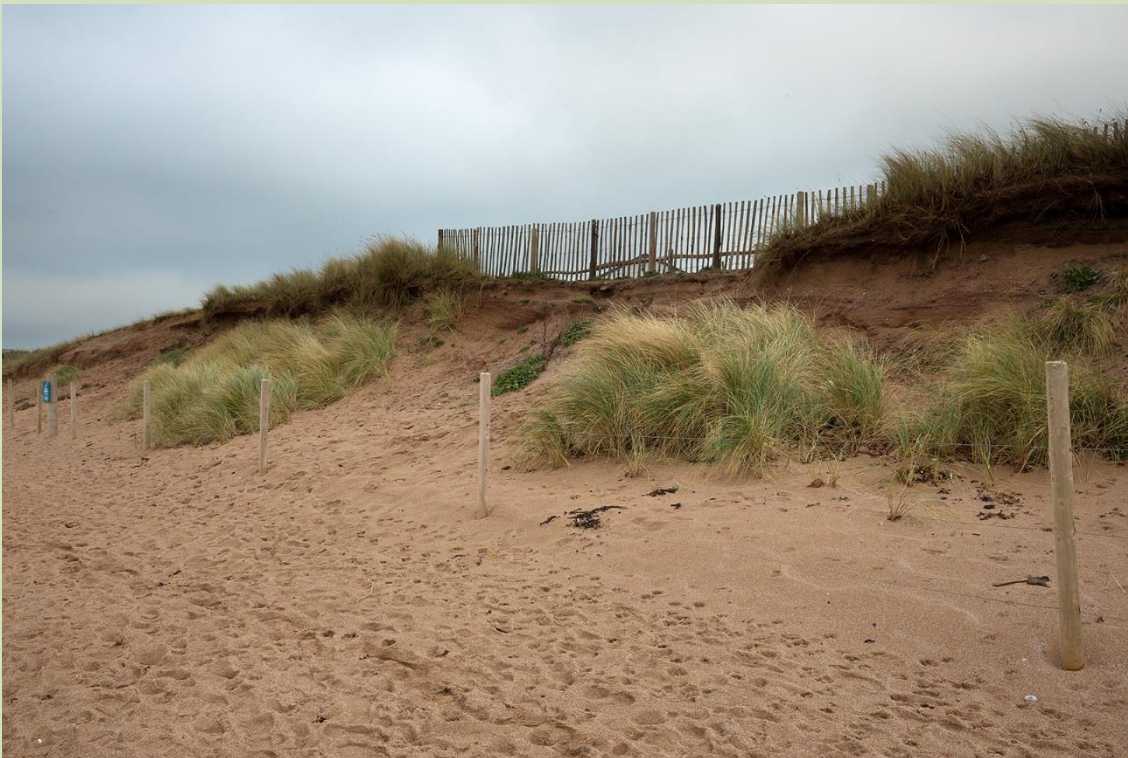
Photo 3: Eroded dunes and new embryo dune formation (source: Robert Harvey)

Beach levels have recovered since February 2014 and embryo dunes have re-formed at the base of eroded dunes towards the northern end of the frontage.

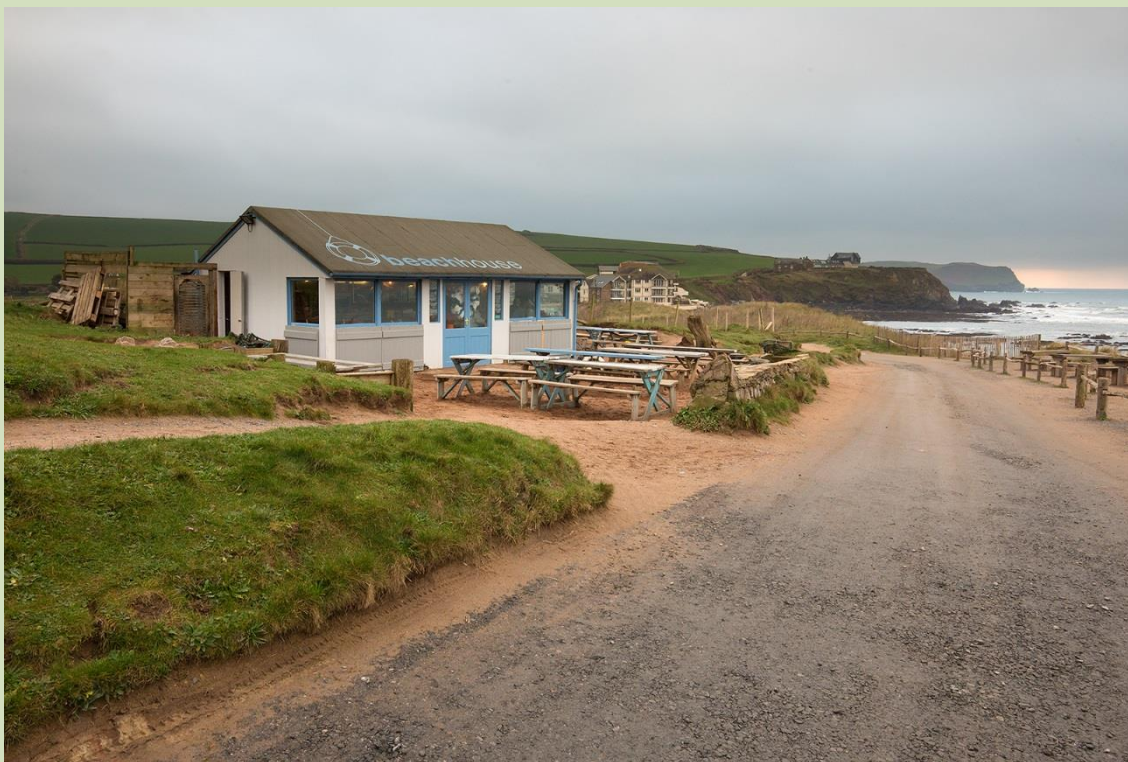
Photo 4: Beach House Café and access road (source: Robert Harvey)

The 20-year erosion line in the Shoreline Management Plan passes through the car park and close to the café (Photo 4). Sea level rise and increased storminess will make the existing defence line unsustainable.

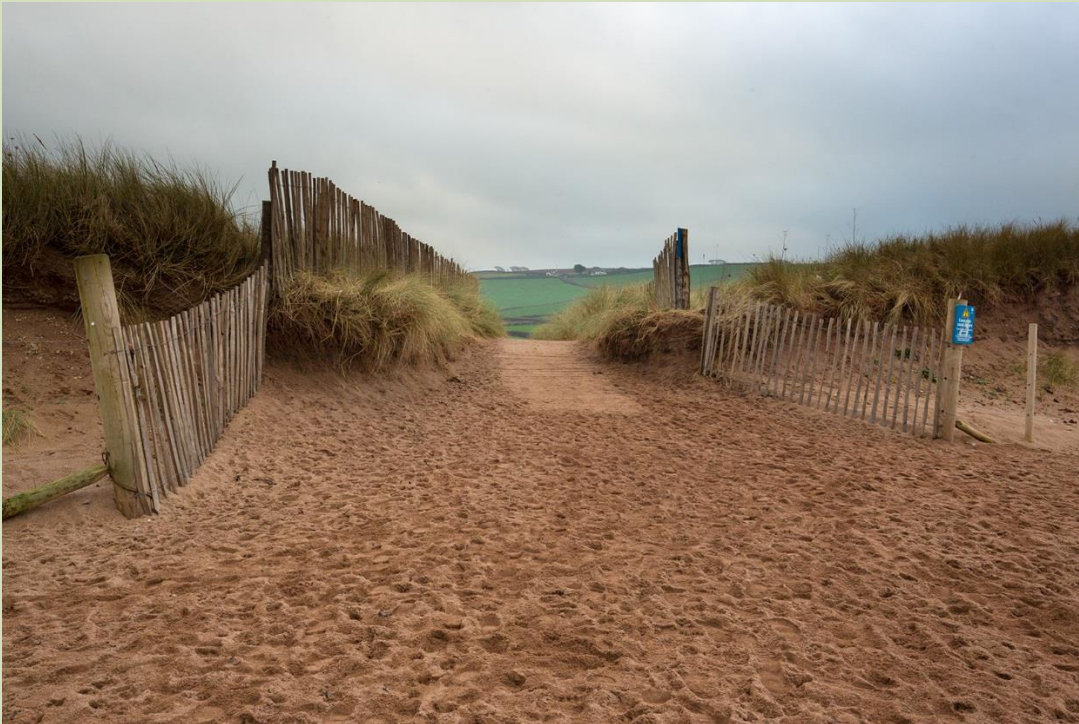
Photo 5: Reinstated pedestrian access to beach (source: Robert Harvey)

The project implemented in 2009 was seen as a success, in large part because of community engagement with the project (Photo 5). The project demonstrated that it is possible to implement a scheme that addresses flood and coastal risk management (FCRM), nature conservation and public recreation in a heavily used area.
