Project completion report:

RIVER RESTORATION STRATEGY
RIVER GOWAN EMBANKMENT REMOVAL

RIVER GOWAN EMBANKMENT REMOVAL-Site Location Fairbanks Farm, Staveley, Cumbria. NGR SD 4540598542

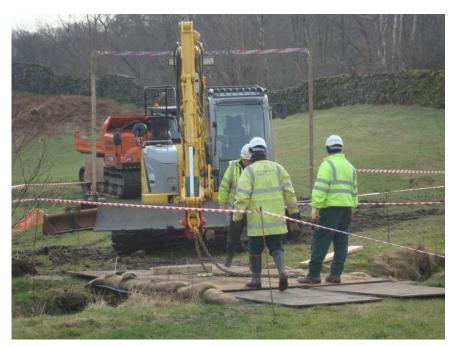
Figure 1 EA Operations team prepare access to site

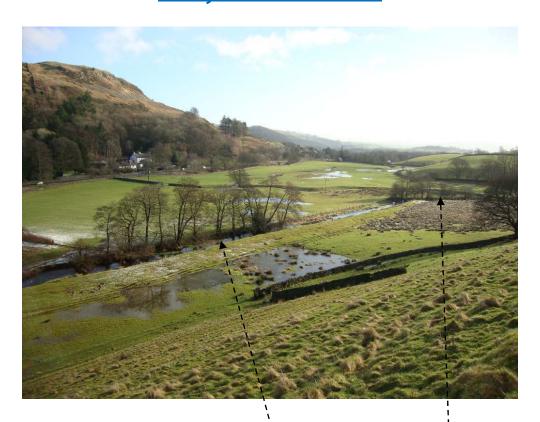
Figure 3 River Gowan, pre-works Feb 2013

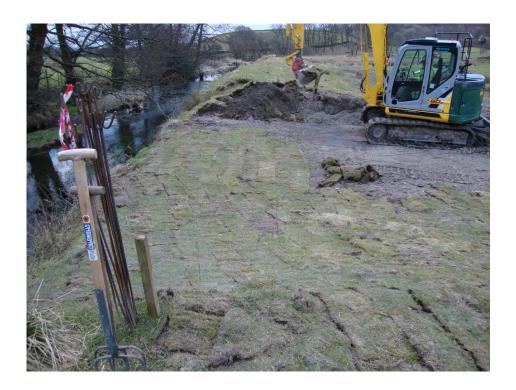
Figure 4 Embankment profile and turf replacement Feb 2013

The main principal was to reduce the unnatural bank height and reestablish the natural slope, form and level of the river bank. In the first instance, a landscape contractor, hired by the EA, was employed to mechanically remove the turf in advance of the excavation. This proved difficult due to the rough and irregular nature of the embankment and subsequently, the EA digger drivers skilfully removed the turf with their buckets to expose the underlying material. The turf was then placed to one side for relaying later. During the initial excavations that followed it was immediately apparent that the embankment material, mostly gravel with clay and soil, formed a distinct substrate and colour horizon in comparison to the underlying natural bank material. This "horizon" was

followed throughout the embankment removal to re-create the natural bank level.

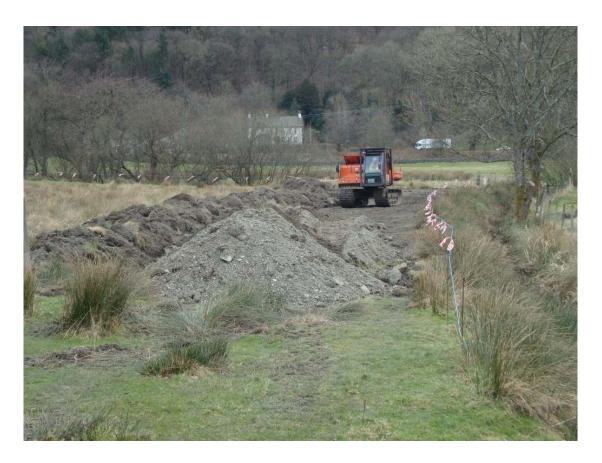
Figure 5 Bund construction from embankment spoil Feb/March 2013

As the embankment material was removed it was loaded into a dumper truck and moved downstream. At this downstream site, the excavated material was employed to create an 80 metre long by 10 metre wide bund; the purpose of which to allow the containment of flood waters following the lowering of the river embankment and therefore the reconnection of the river to its natural flood plain. Additionally and very helpfully, the use of this "waste" material on site circumvented the triggering of complicated and expensive waste regulation requirements.

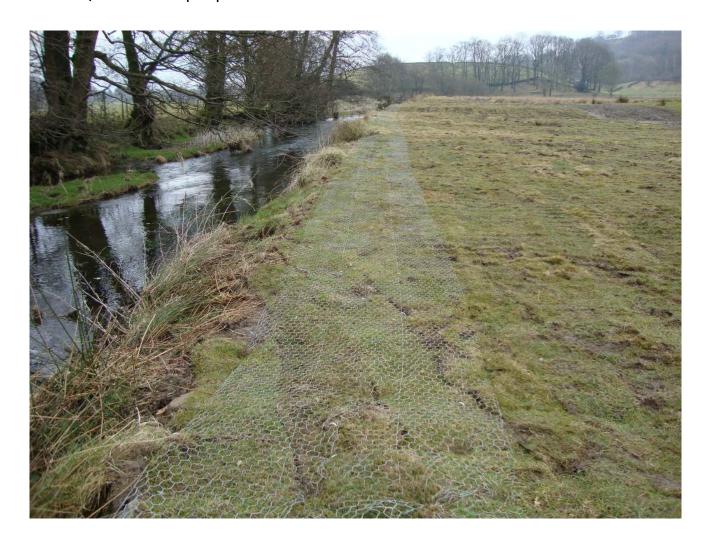
Figure 6 Turf re-laid, netted and pegged following embankment removal March 2013

As the embankment removal proceeded and the correct level was reached, turf was re-laid onto the exposed soil and netted and pegged; as a soil/sediment input protection measure to the river.

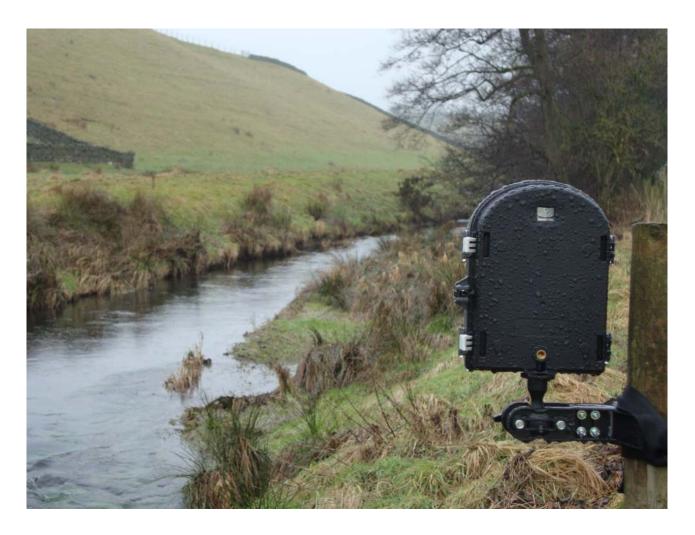
During the course of the embankment removal, two time lapse cameras captured progress.

Figure 7 Riverside time lapse camera Feb 2013

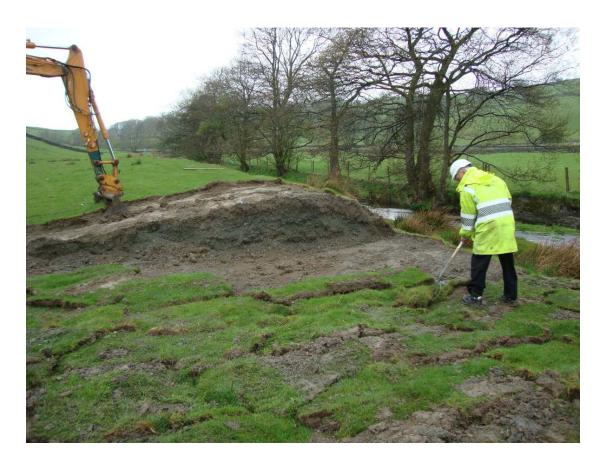
Figure 8 Phase 2- embankment profile April 2014

Phase 2- During April and May 2014, the methods and principals adopted in phase 1 were again used to remove a further 220 metres of embankment from the River Gowan; this section immediately adjoins upstream of the 70 metre section previously removed in 2013.

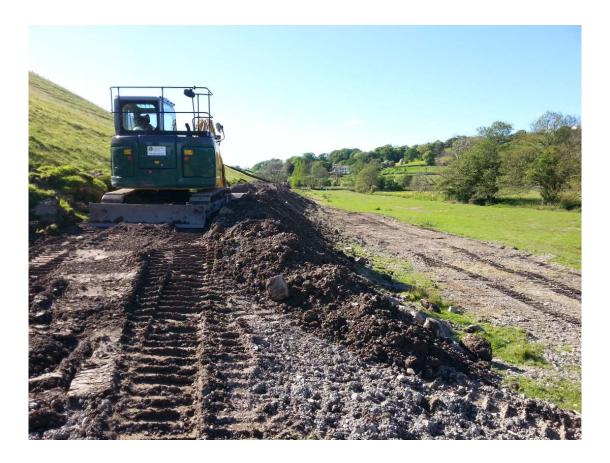
Figure 9 Embankment spoil formed into a track at the foot of Brundriggs drumlin April 2014

In this phase, LIDAR data obtained from the Environment Agency added to the topographic survey data already acquired and informed precisely the correct positioning of the waste material taken from the embankment to prevent interference with the opening up of this floodplain. Agreement was reached to place this material at the foot of the drumlin (Brundriggs) adjacent to the works; this was formed into a raised access track for use by the farmer.

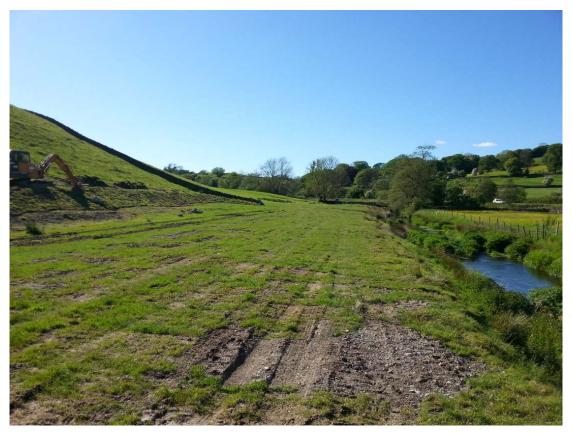
Figure 10 Embankment removed and track nearing completion April 2014

Following completion of the embankment removal and the creation of the track, a shallow swale was cut into a ridge on the floodplain to link low lying areas either side of phase 1 and 2.

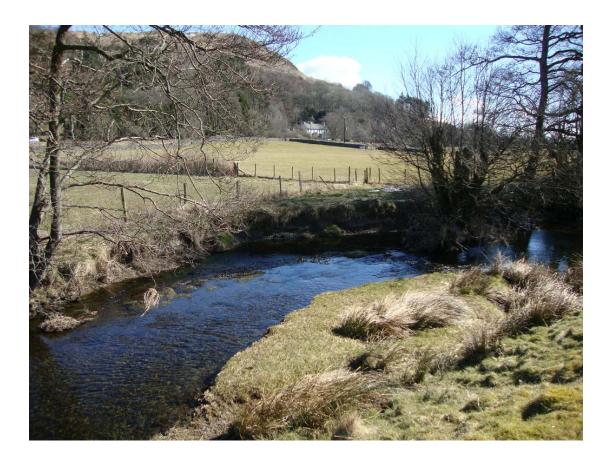
Figure 11 Bank erosion point pre stabilisation work April 2013

This left bank erosion point was protected by the staking of felled Alder boles into the bank toe. Inert hazel fascines and the Alder brash were fixed in place behind the toe protection with a combination of chestnut stakes and heavy duty sisal ties. A new fence installed concurrently on the entire left bank allowed a buffer of this bank to encourage stabilisation. The cost of fencing was met through the "Source to Sea" Catchment Restoration Fund-this was handled under contract through Cumbria Woodlands (Rebecca Oakes)

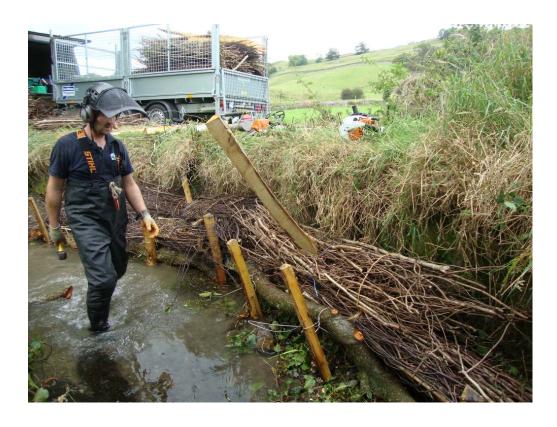
Figure 12 Soft engineering installation in progress September 2014

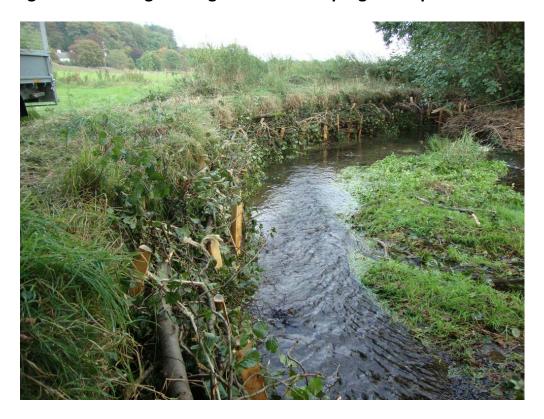
Figure 13 Soft engineering completed September 2014

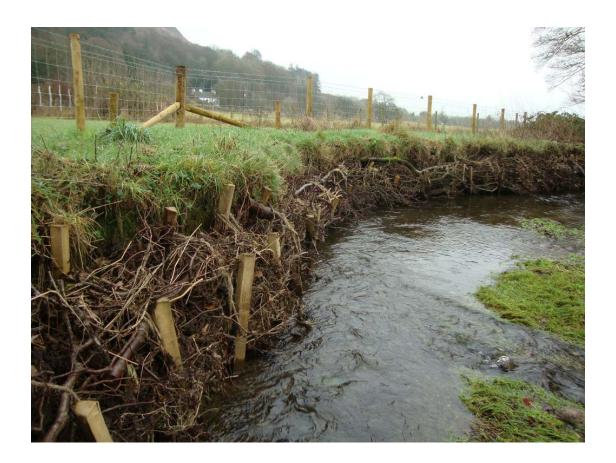
Figure 14 Soft engineering and new fence following autumn floods

December 2014
