Test & Itchen River Restoration Strategy - Appendix B Progress Report

River (& local name)	Reach Code	SSSI Units	Management Option
Test (Polhampton)	T001	84	Conserve & Enhance

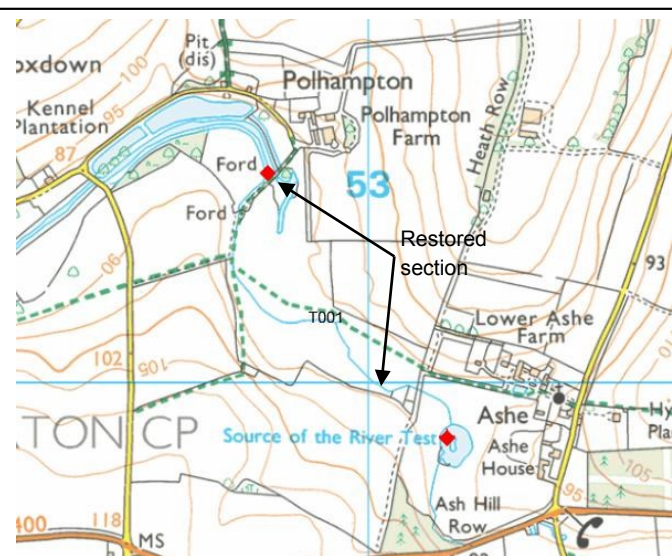
Photograph after (date)

Restoration has taken place for approx 50m at the bottom end of this reach by an external contractor, Robert Bull in 2013 and continues downstream into T002. It was funded independently by the landowner. The work included, opening up of the approx 2m wide channel, clearance of the channel, pollarding of bankside trees and inclusion of woody debris to create sinuosity. Future management will be low key to create a very lightly fished wild fishery.

It is recommended that the channel is maintained in a low key way with little 'management'.
