Test & Itchen River Restoration Strategy - Appendix B Progress Report

River (& local name)	Reach Code	SSSI Units	Management Option
Test - Tufton	T023	84	Restore
<p>Restoration Potential- Issues to address in Appendix B of the strategy:</p> <p>SU 4565146879</p> <p>Channel is over wide and various attempts have been made to narrow the channel through willow faggoting and the creation of an island at the downstream end of the reach. A large weir exists near Tufton.</p>			
<p>Restoration actions in Appendix B of the Strategy:</p> <p>Restore the channel through:</p> <ul style="list-style-type: none"> - Structure removal or partial removal/lowering - Continue channel narrowing through in-channel measures. 			
<p>Restoration actions carried out: 2010</p> <p>These works were carried out at the start of the T&I River Restoration Strategy, 2010, under the guidance of the then Project Officer Tim Holzer. There were initial difficulties with local residents who wanted things to stay the same and did not see the benefits of narrowing. The large weir is also very close to a private house so there were concerns over any change. Eventually a lower crescent weir was built by Robert Bull to replace

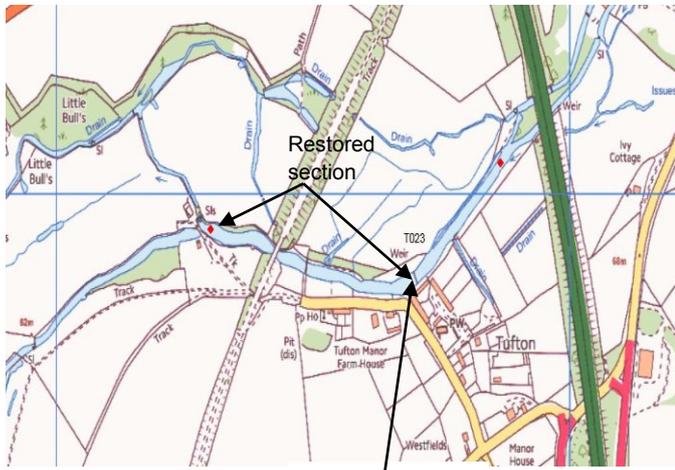
Map:		Photograph after (date)

<p style="text-align: center;">Location of weir</p>			
<p>Restoration actions carried out (continued):</p>			
<p>Actions not carried out and justification:</p> <p>Complete weir removal due to local residents and reducing upstream water levels too much for the upstream owner. Softer bankside restoration along tlb. Not able to happen due to resistance from residence.</p>			
<p>Future work and recommendations:</p> <p>That bankside and in-channel vegetation is managed to promote variation, cover and habitat throughout the year.</p>
